THE LIMEKILNS AND ASSOCIATED STRUCTURES ON ÎLE AUX AIGRETTES, MAURITIUS

THE 2003 STUDY

Geoffrey and Françoise Summers

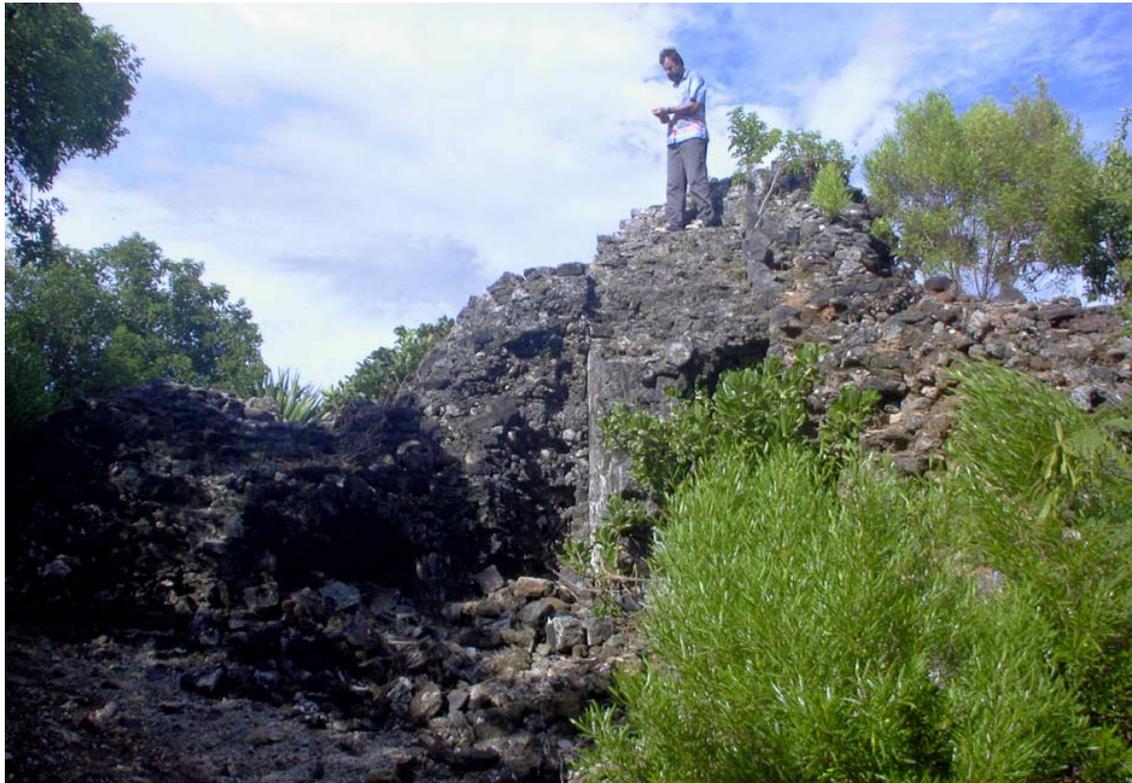
Geoffrey Summers stands on the remains of the spiral staircase that was partially bonded into the outer basalt face of Kiln I. Kiln 2, largely in shadow, was built against this staircase. The vegetation, although attractive, is destroying these structures. (ma03jv0201)

The lime kilns should be cleared of plants and, where necessary, poison should be used to prevent the regrowth of roots which destroy the lime mortar and which also push stones out of the walling. Eradication of plants should be carried out by MWT experts under strictly controlled conditions.

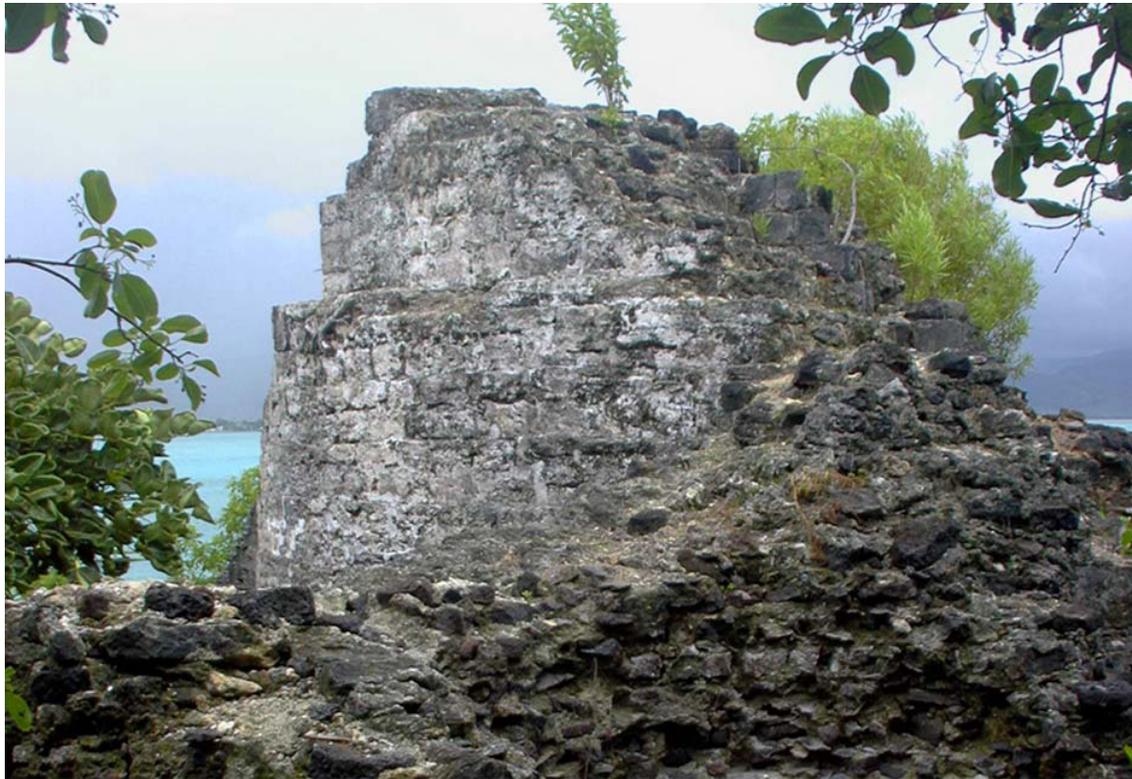
The upper part of Kiln I showing the manner in which the upper portion of the staircase was transformed. The basalt face of the kiln can be seen emerging from behind the remains of the spiral staircase. (ma03jv0209)

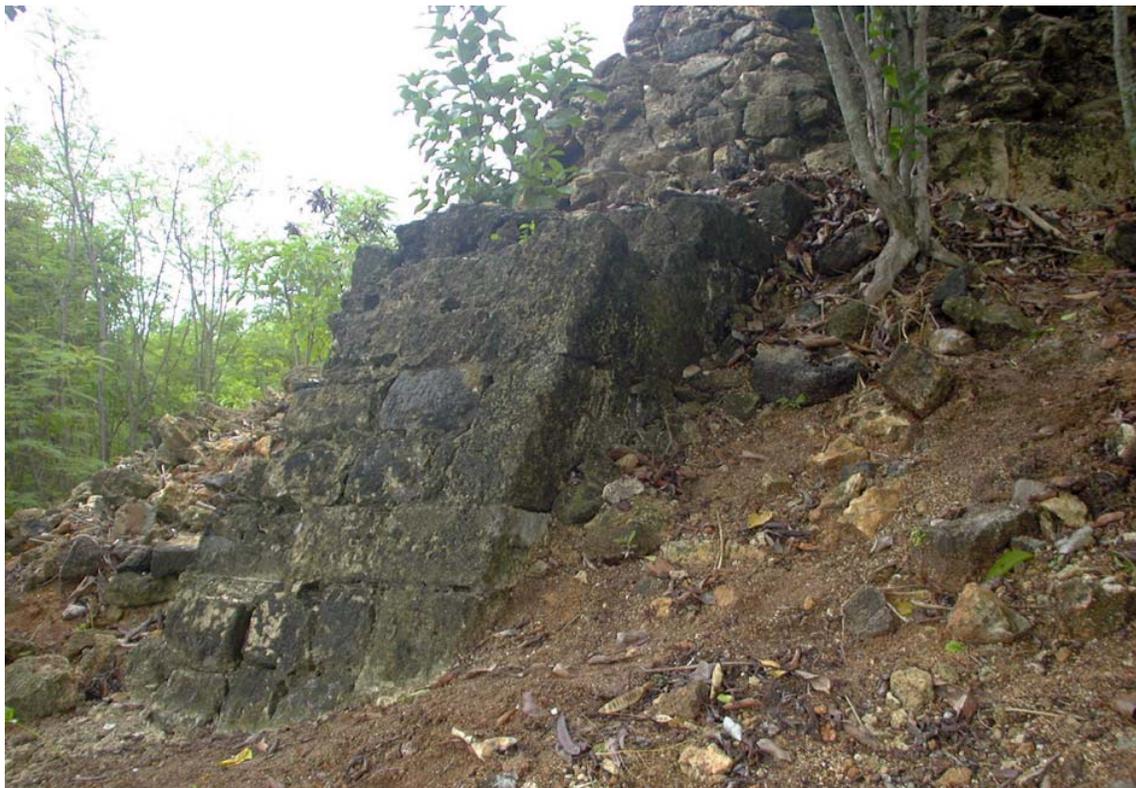
The first buttress is constructed of coral and is bonded into the furnace wall. The 1922 photograph shows that this buttress did not extend to the top of the furnace but ended on a level with the tops of the recessed features on either side. The width is 1.15m. There are thus a number of outstanding problems in correlating the extant remains with the evidence of the photographs. The most likely explanation for these discrepancies is that the recesses represent repairs to the face of the original kiln wall.

Kiln I. The first buttress is constructed of coral and is bonded into the furnace wall. The 1922 photograph shows that it did not extend to the top of the furnace but ended on a level with the tops of the recessed features on either side. The width is 1.15m. (ma03jv0311)

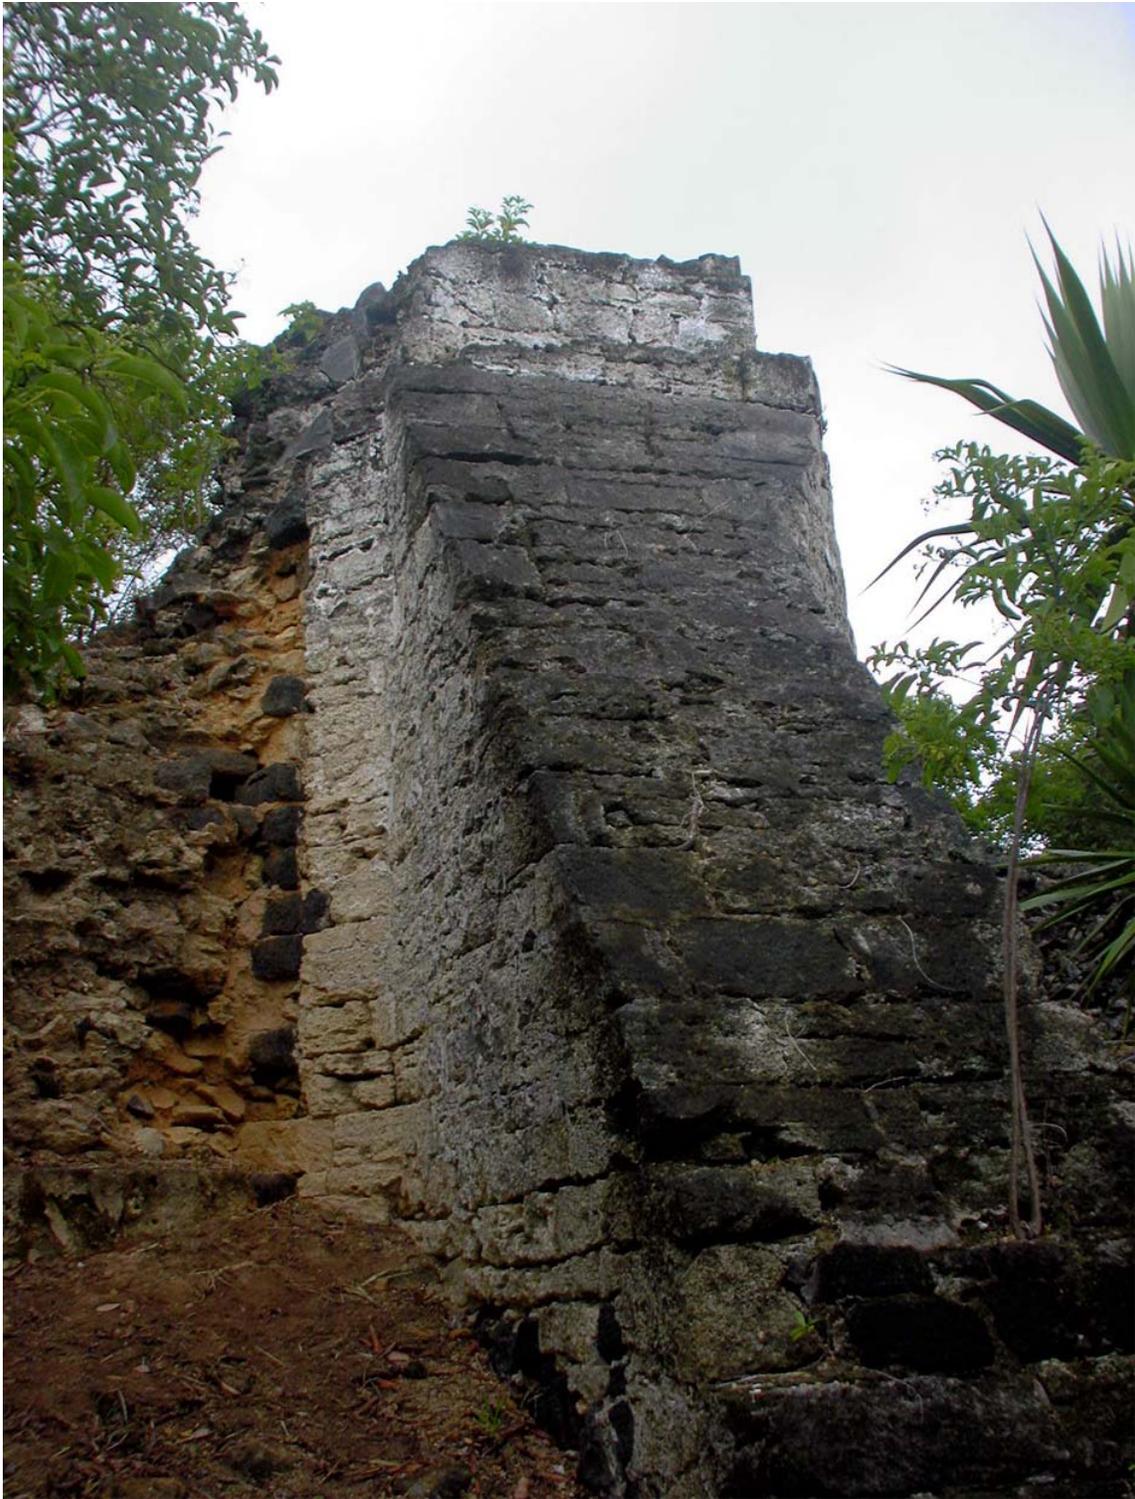
Kiln I Butters 2 is also the end of the spiral staircase. The butters itself is completely preserved and it can be seen from this image that it is generally butted against the basalt facing of the furnace although the two have occasionally been bonded together – showing that the butters and the spiral staircase were an integral part of the original design rather than a later addition. (ma03jv0305)

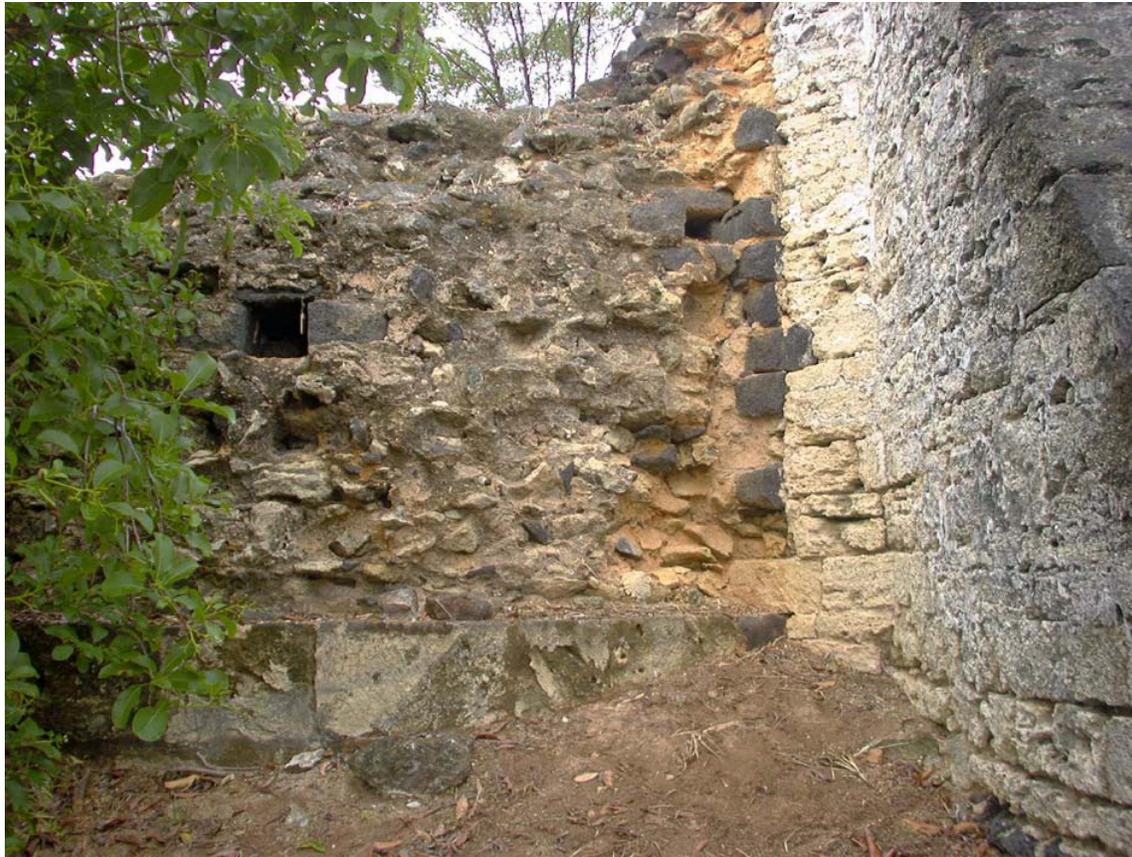
The junction of Kiln I wall and Buttriss 2. Note that the lower face stones of the kiln wall, which are probably at the level of a foundation below the base of the chamber, are made of cut coral blocks. Above these blocks the face was mostly basalt. The basalt was robbed in WW II. Two basalt lined, tapering, poke holes can be seen in the kiln wall. The buttriss, at right, also forms the end of the spiral staircase. It can be seen that some attempt was made to bond the buttriss to the kiln wall but for most of its height the buttriss is simply butted. (ma03jv0306)

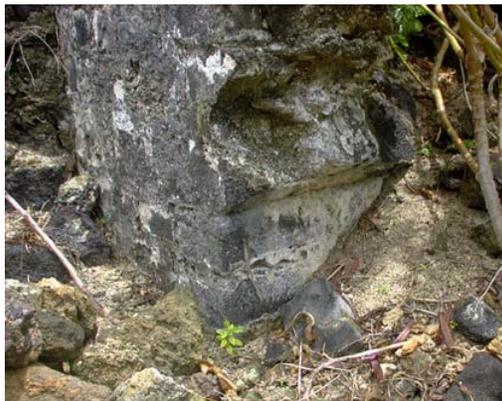
The springing of the arch under the staircase of Kiln 1 is partially preserved. (ma03jv0213)

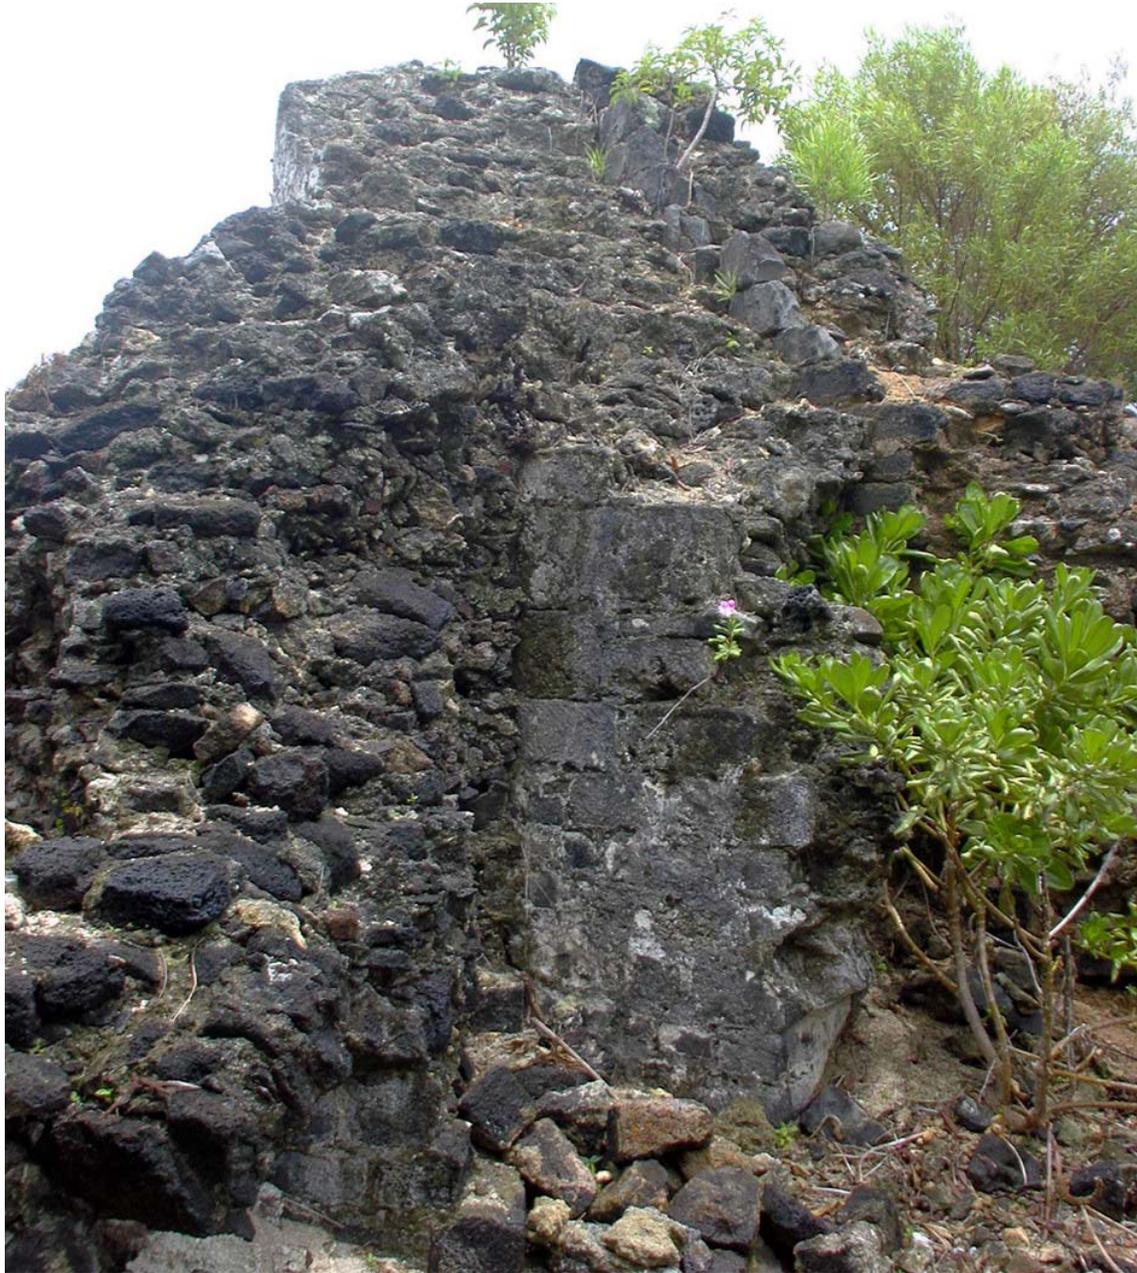
The wall of Kiln 2 butts against the stairs of Kiln 1. The steps and lining of Kiln 2 have been robbed. The basalt facing of Kiln 1 is preserved behind the staircase from which it protrudes. The springing of the basalt arch beneath the stairs can be made out to the right of centre at the bottom of the picture. (ma03jv0211)

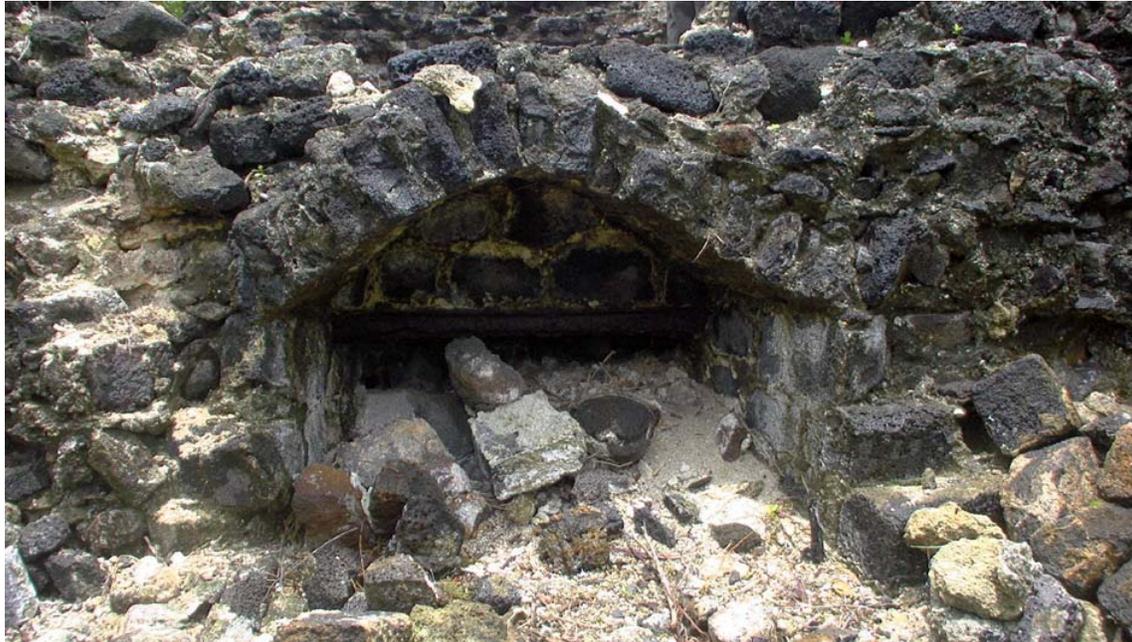
The splayed draw hole of Kiln 2. The slightly pointed arch is constructed of uncut basalt stones set on edge. The internal iron lintel is heavily corroded. (ma03jv0212)

The Kiln 2 draw hole is reasonably well preserved, although the original face is now lost and the lower part is currently buried. None of the original lining is visible and it is not known whether it has fallen or was robbed in WW II. There is no reason to suppose that the lining was made of any material other than basalt and it might be expected that some of the stone remain *in situ* at the base of the chamber.

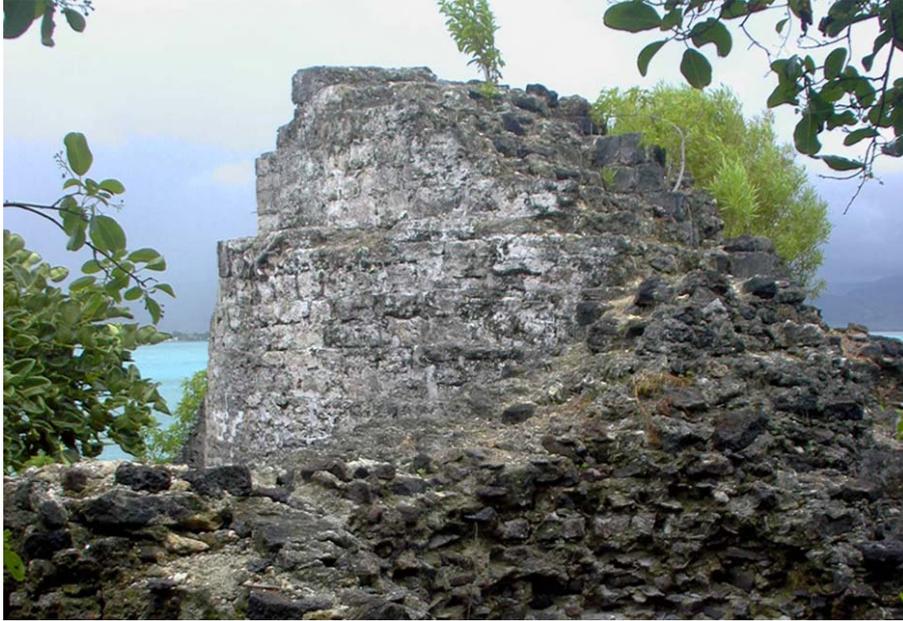
The basalt lining of Kiln II, seen in the foreground, has apparently been robbed. (ma03jv0209sm.jpg)

Where the inner side of Kiln II can be seen it is observed that the lining has either fallen or been removed. It would be both expedient and visually attractive to reline the extant walling.
