# **ILE DE LA PASSE**

## **REPORT 1**

### **ARCHEOLOGICAL AND ARCHITECTURAL SURVEY**

**Geoffrey and Françoise Summers**

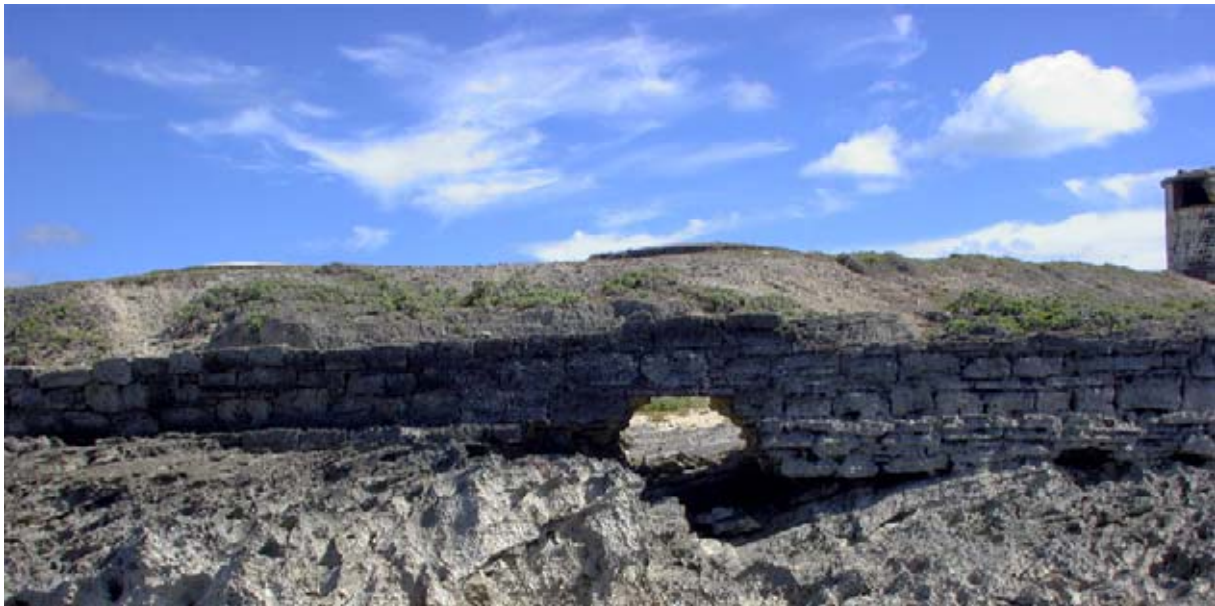
*The outer face of the Lower Battery Wall A 3, showing the need for repair, with the Upper Battery behind. (02jv1822)*

Some stones from the lowest course of the outer face have become displaced and ought to be reset or replaced. In one place the sea has broken through the fossil coral beneath the wall. While there does not appear to be any immediate danger, these two breeches are a potential threat, especially if an increase in the number of visitors significantly adds to the load of human traffic that crawls through the openings. Otherwise the entire structure, including the very irregular and broken inner face, would appear to be stable. Indeed, the rough and uneven nature of this particular face is, in itself, a considerable deterrent to walking along the top of the battery.

The top of Wall A1-2, together with the cannon emplacements therein, could be cleaned to reveal more detail. Any such cleaning should, of course, leave the blocking in place, and would need to be followed by consolidation and some deterrent to frequent foot traffic.

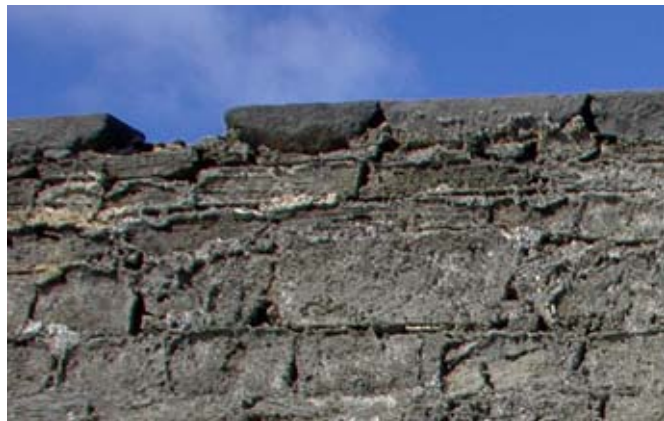
A small number of stones have become dislodged from the lowest course at the front. More seriously, much of the basalt from the top is missing. We were informed that some basalt slabs had been taken from here in the recent past. Urgent remedial action is needed. The low return at the south end is very ruinous and would derive some benefit from cleaning and consolidation.

*Basalt coping stones on wall B. (m02jv1702)*

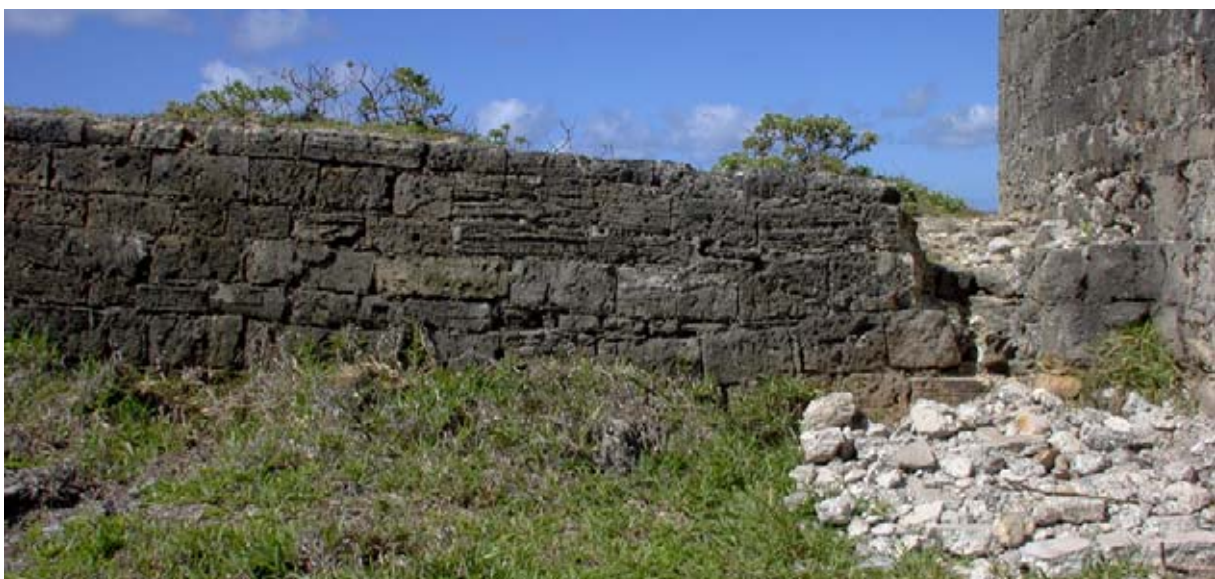
In need of slight repair, most essentially at the junction with the Storehouse (Structure 2) where a modern track is causing rapid erosion. When the WW II reinforced concrete roof of the Storehouse was recently demolished some of the debris was sensibly piled up in the corner to retard further damage and erosion where the footpath traverses the wall.

*The junction of Wall E and the Storehouse (Structure 2). The two walls are bonded together but camp fires that have been frequently lit in the corner over recent years have caused serious deterioration of the stone. (02jv1924)*

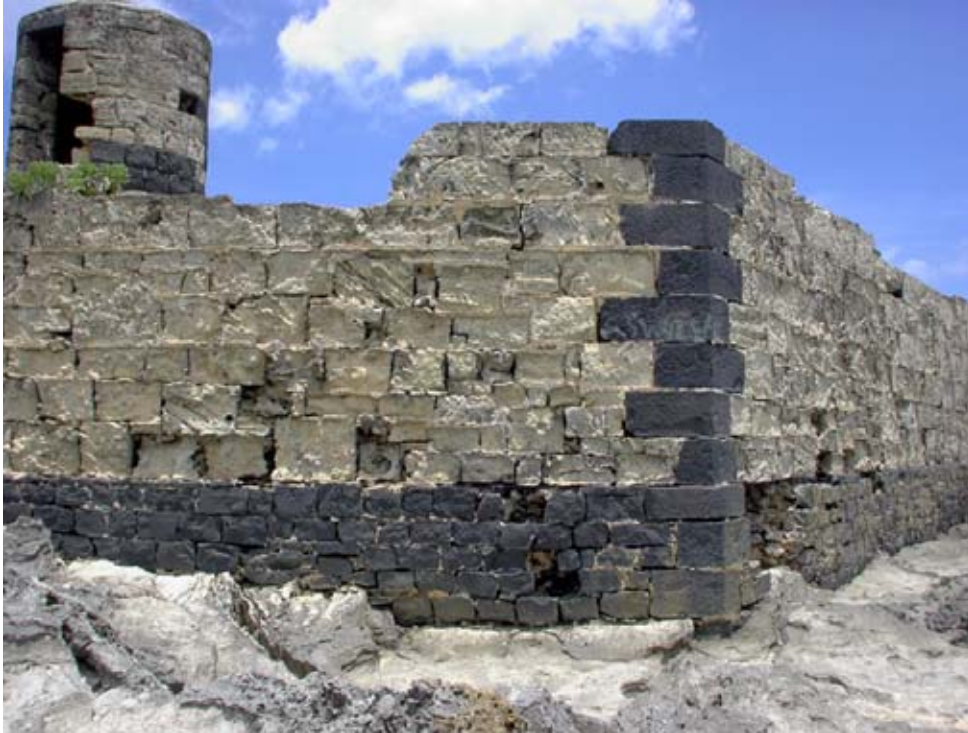
*The corner of Wall F3 and F4 showing the need for repair and erosion of the coral blocks. Immediately in front of the footings is the rock-cut trench that once contained the additional basalt of the external buttress. The North-West Sentry Post stands above. (02dpjv0216)*

There are a few other places where repair to the outer foundation would be prudent. Especially important is the need to underpin the corner by the Landing Point.

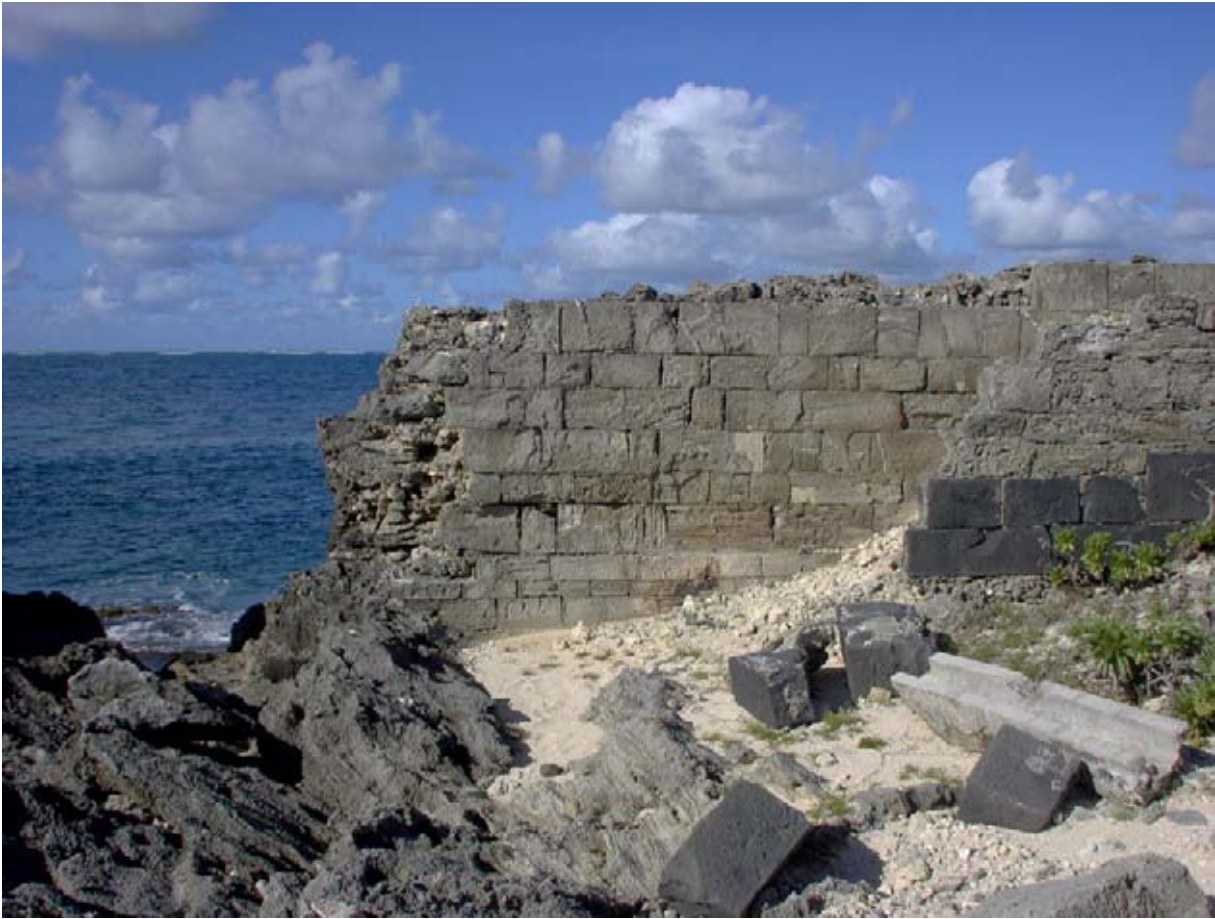
Stretch F5 has been broken through by the sea. While this breach provides an interesting section through the wall, showing its construction, it is certain that remedial action is a priority. Consolidation of the base of the wall on the south side of the breach is very urgently required, and could be accompanied by consolidation of the broken southern edge and further protection of the rampart behind. The north side of the break appears to be more stable, not least because the bedrock is higher here. It would appear that seawater flowing out is causing as much or more damage than waves from the front.

*The breach in Wall F and the broken end of the Wall G retaining the Ramp leading to the top of the North-Western Platform. Note the fine basalt ashlar of Wall G and the eroding rubble fill of the platform. The piece of concrete at bottom right is part of a WW II drain that, together with the displaced basalt blocks, has been thrown into its present position by the sea. (02jv1003)*

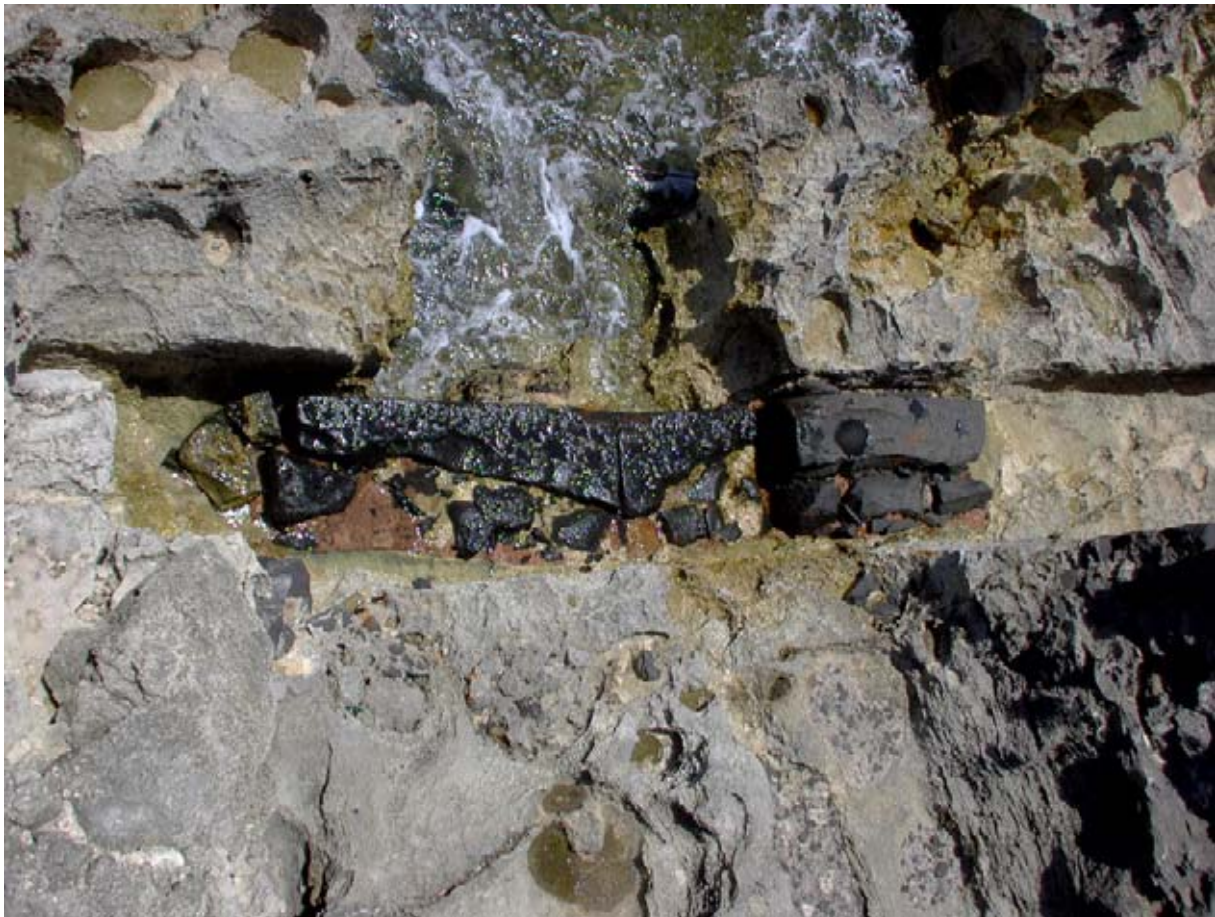
*At high tide the buttress in front of Wall F is washed by the sea. (02jv1211)*

At the first of the two buttresses just described one basalt block has been dislodged and ought to be reset before it ends up in the sea. If a suitable mix could be found there would be a case for some additional consolidation. The iron clamps will continue to slowly decompose and have already lost any structural utility. What little is left of the second buttress appears to be stable.

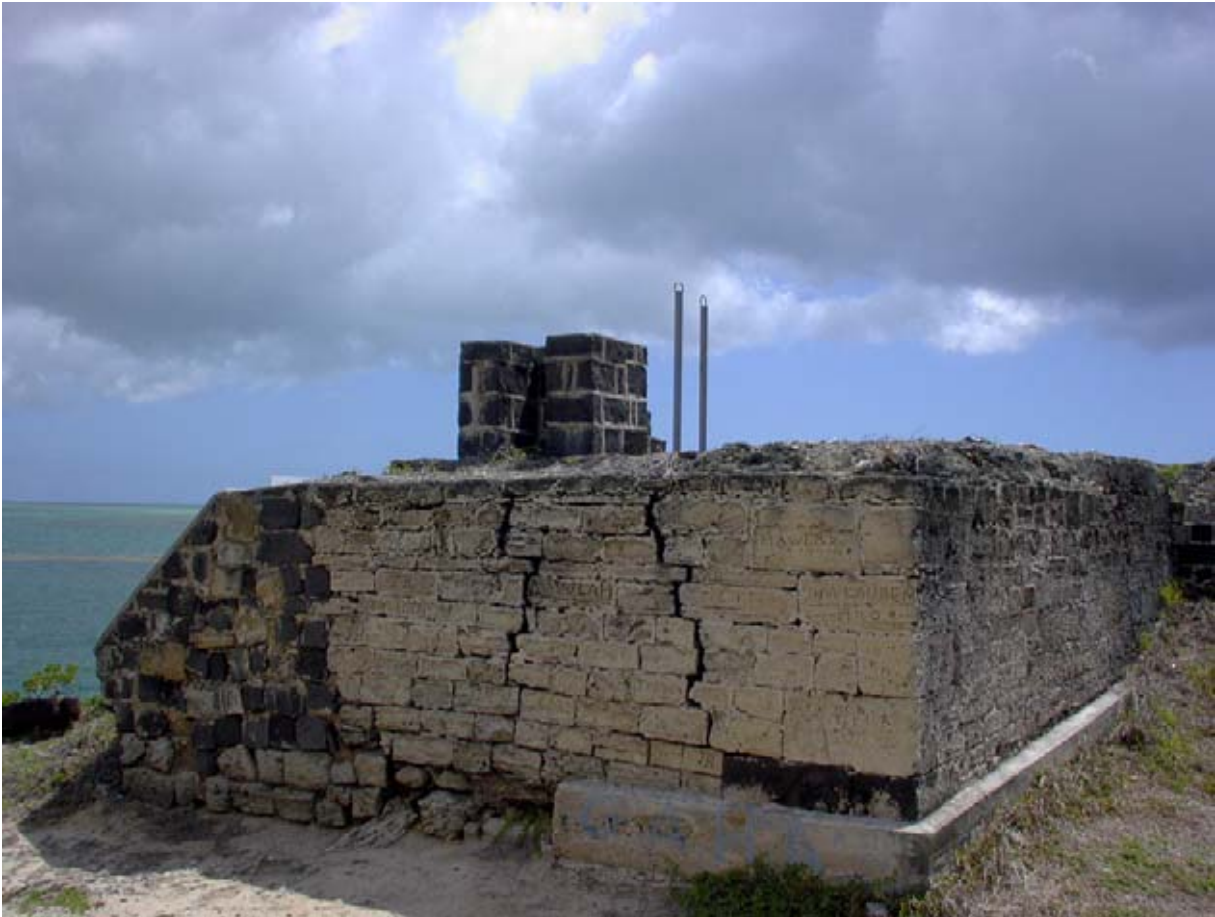
The walling at the western end has been rebuilt on at least one occasion and some of the original walling has been underpinned with modern concrete. Further consolidation of the late repair is required.

*The need for repair. (02jv0110)*

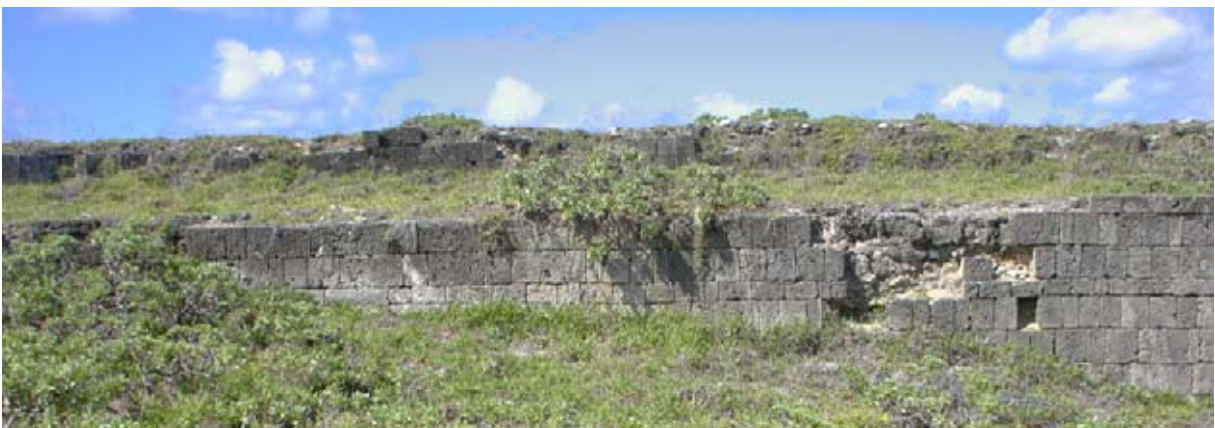
*An extension of the picture above showing the need for repair. (02jv2005)*

Much could easily be replaced in original positions and the stonework of the inner battery wall could be repointed. There are other places where some slight repair would be advantageous, such as the replacement of the displaced basalt steps on the staircase at the south-east end and repair to the face of the northern stretch of the Terrace Wall.

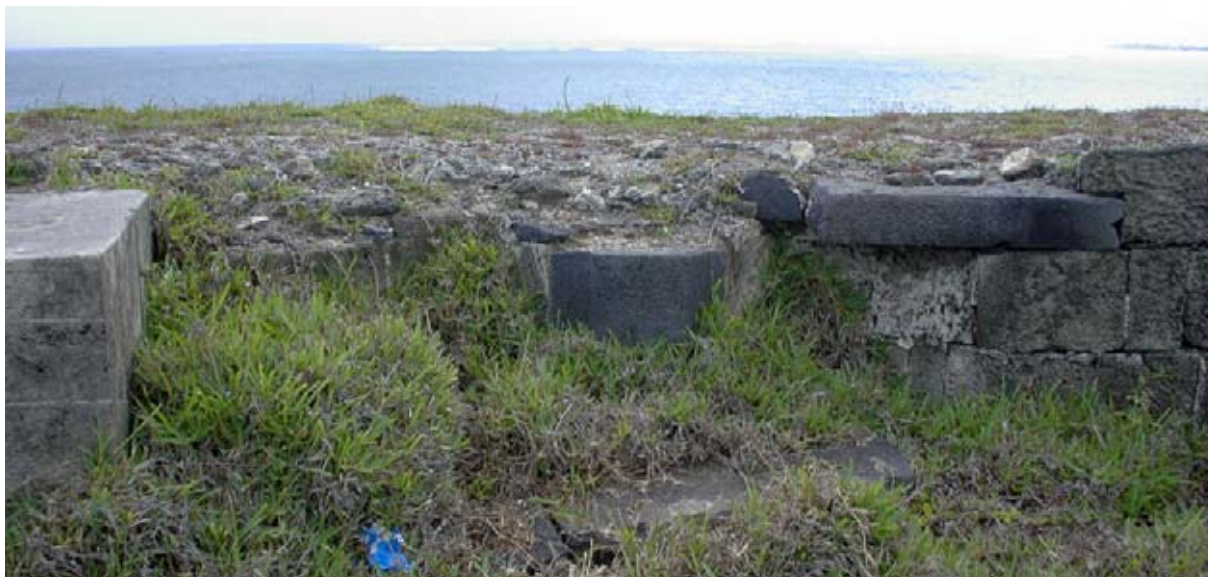
*One of the emplacements with triangular niches divided and capped by basalt ashlar. Note the displaced stones in front and WW II concrete at left. (02jv0409).*

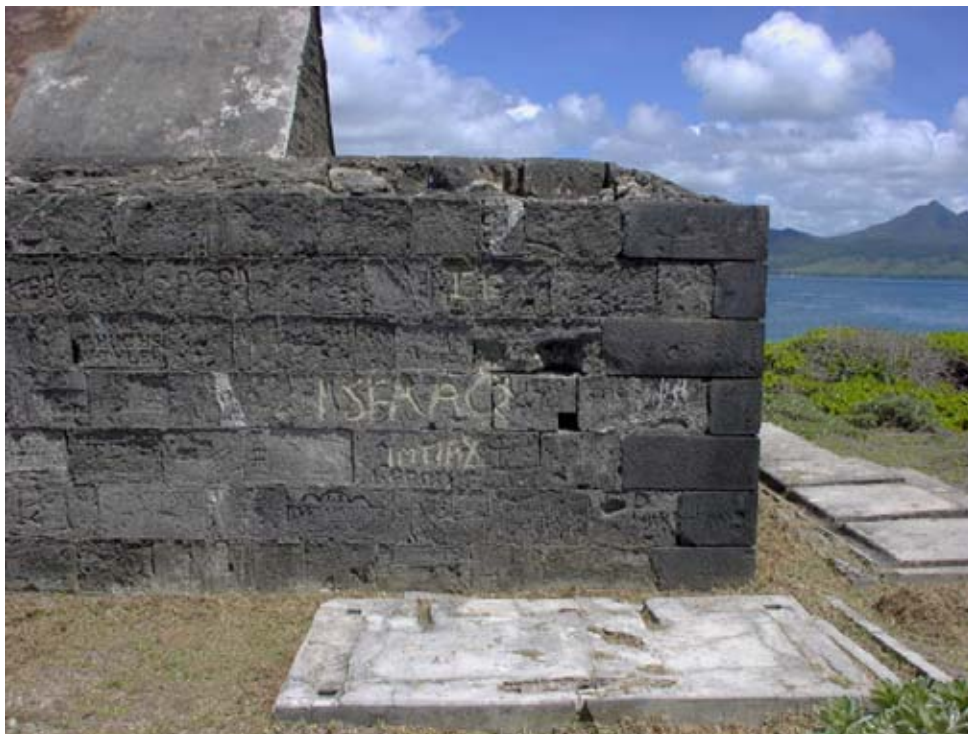
In excellent condition, only requiring a minimal amount of repointing and some slight repair, especially at the corners of the roof. At two points the slanting top of the enclosure wall was levelled in order to seat water tanks for the WW II showers and washing facilities (Structures 25 and 26).

*The slanting top of the enclosure wall was levelled in order to seat water tanks for the WWII showers. (02jv1111)*

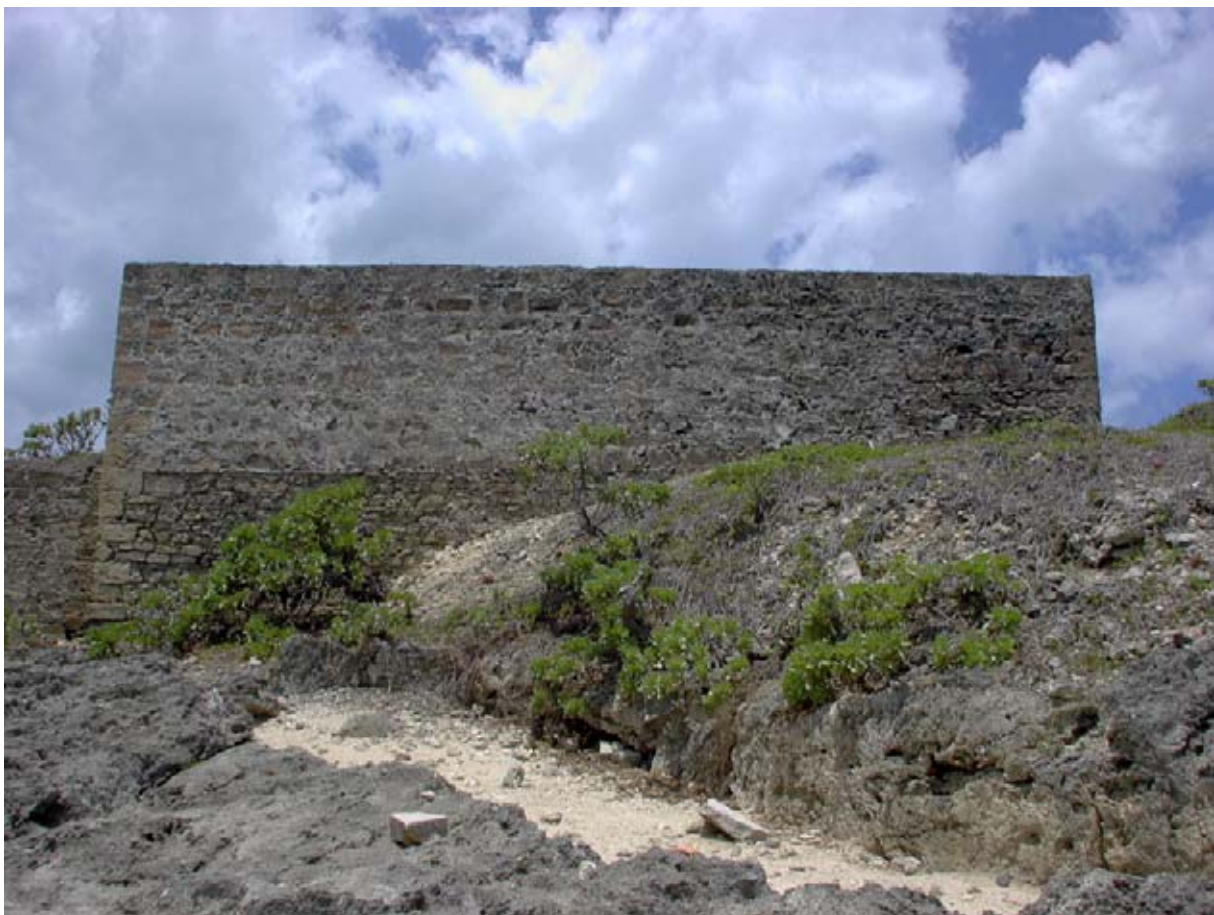
*The rear of the Storehouse. The terrace wall retaining the foundation was protected by a bank and berm which has washed away below the rendering on the left. (02jv012).*

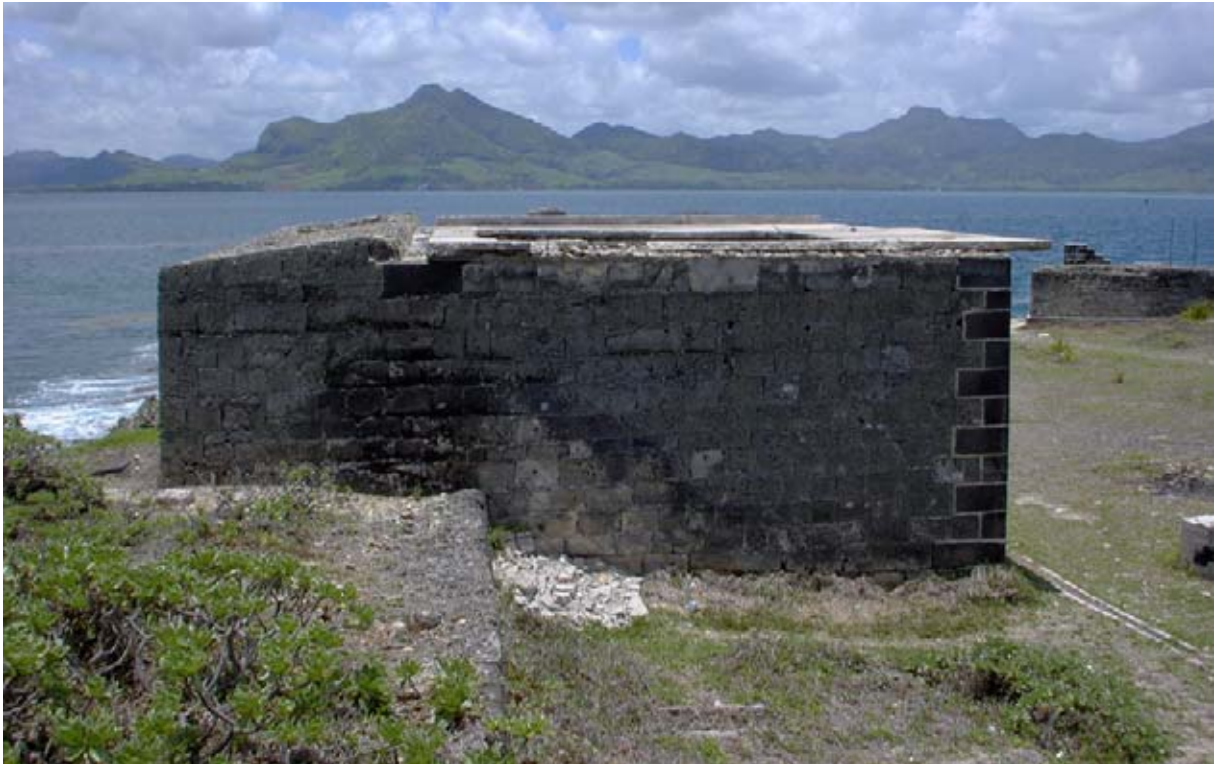
*South side of the Storehouse showing the roof drain, the blocked vent and Wall E with the berm on the left. Part of the broken WW II roof has been piled in the corner to limit further damage from fires. The drain at right is WW II. (02jv0121)*

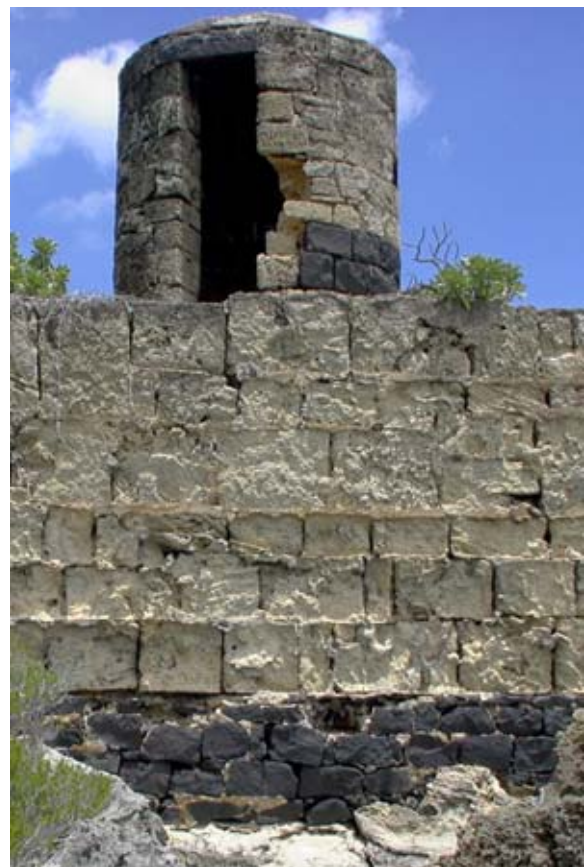
*The North-West Sentry Post, at left, atop the defences, showing recent damage to the door. (02jv0217)*

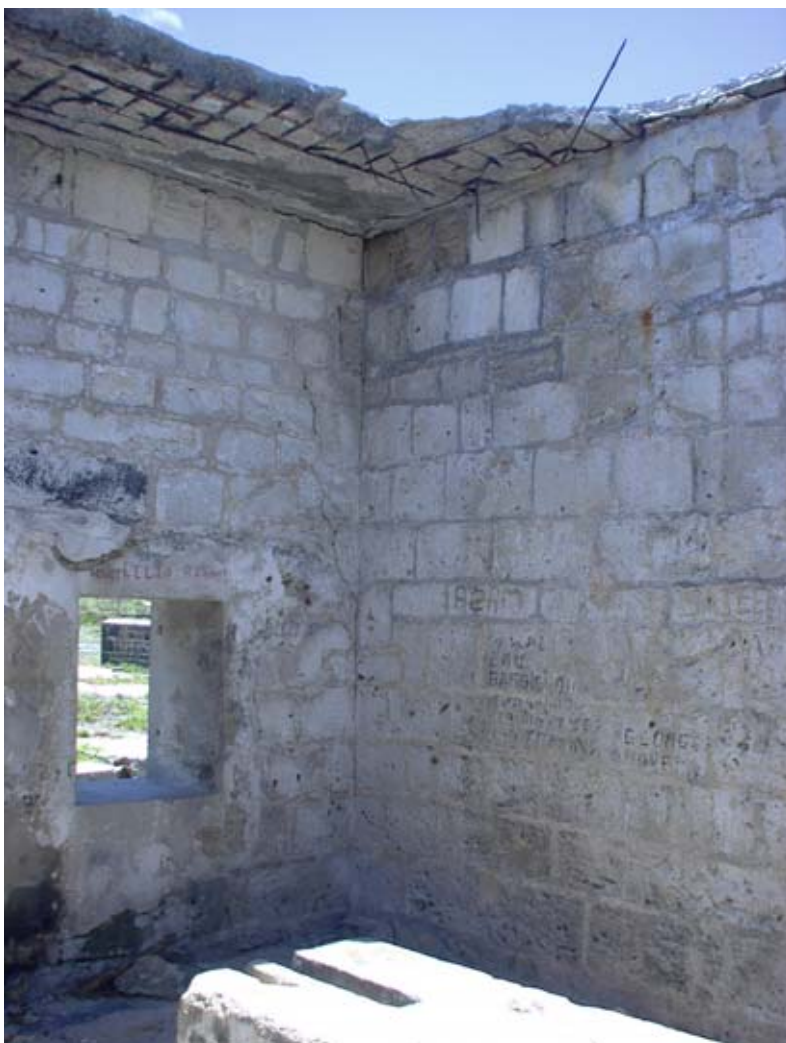
*Most of the concrete roof has been removed in the southern room of the Storehouse. (02jv0811)*
