# ILE DE LA PASSE

## REPORT 2

### BASIC ARCHITECTURAL SURVEY OF STANDING STRUCTURES

Geoffrey and Françoise Summers

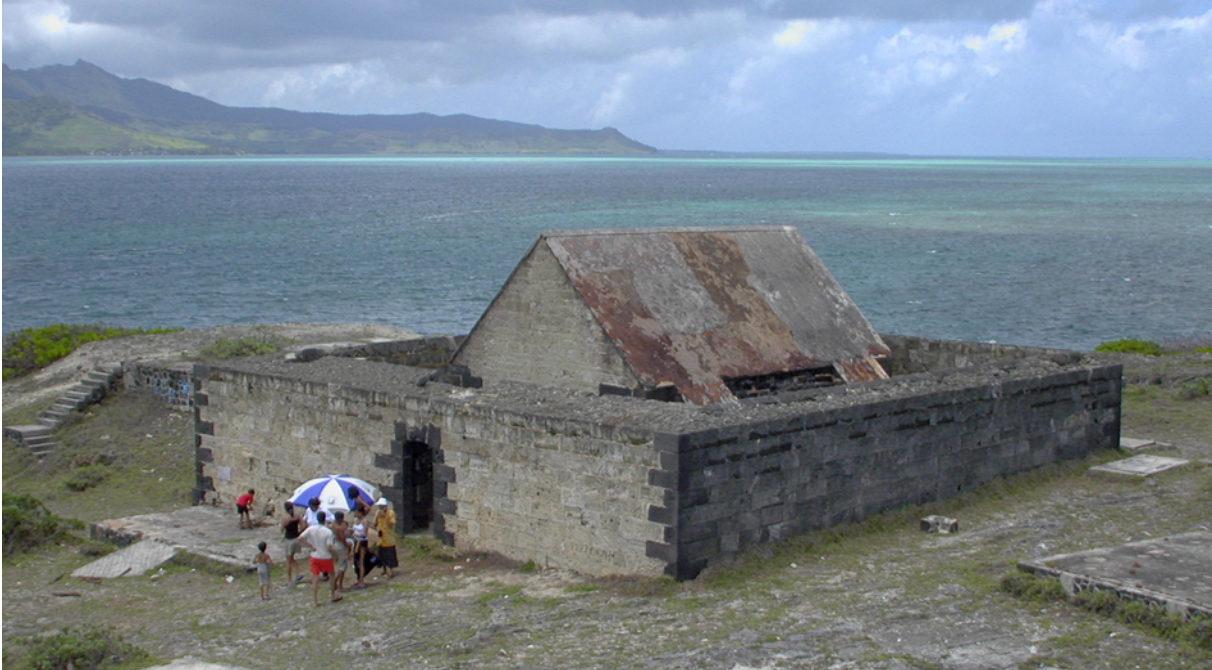
*The Powder House, Structure 1, as seen from the Upper Battery. (02jv0316)*

The building is generally in good condition requiring only minor repairs. The sloping top of the enclosing walls was levelled in places, presumably to house water tanks for WWII washing facilities. The weathering of the coral, a soft material, is unavoidable. In some places where fires have been lit, the surface of the coral has cracked and peeled off. More recent graffiti are unsightly.

The Powder House is clearly the most important structure on Ile de la Passe and its preservation should be closely monitored. Minor repairs are needed to some corners of the roof. The top of the enclosure wall, where it was levelled to seat WW II water tanks, needs to be examined. Further damage caused by fires lit in proximity of walls must be prevented. There is no immediate need to replace doors and windows. Nothing that would distract the visitor from fully appreciating the unique architectural features and qualities of the Powder House should be imposed on or inside this structure. Expert advice will be needed if recent painted graffiti are to be removed.

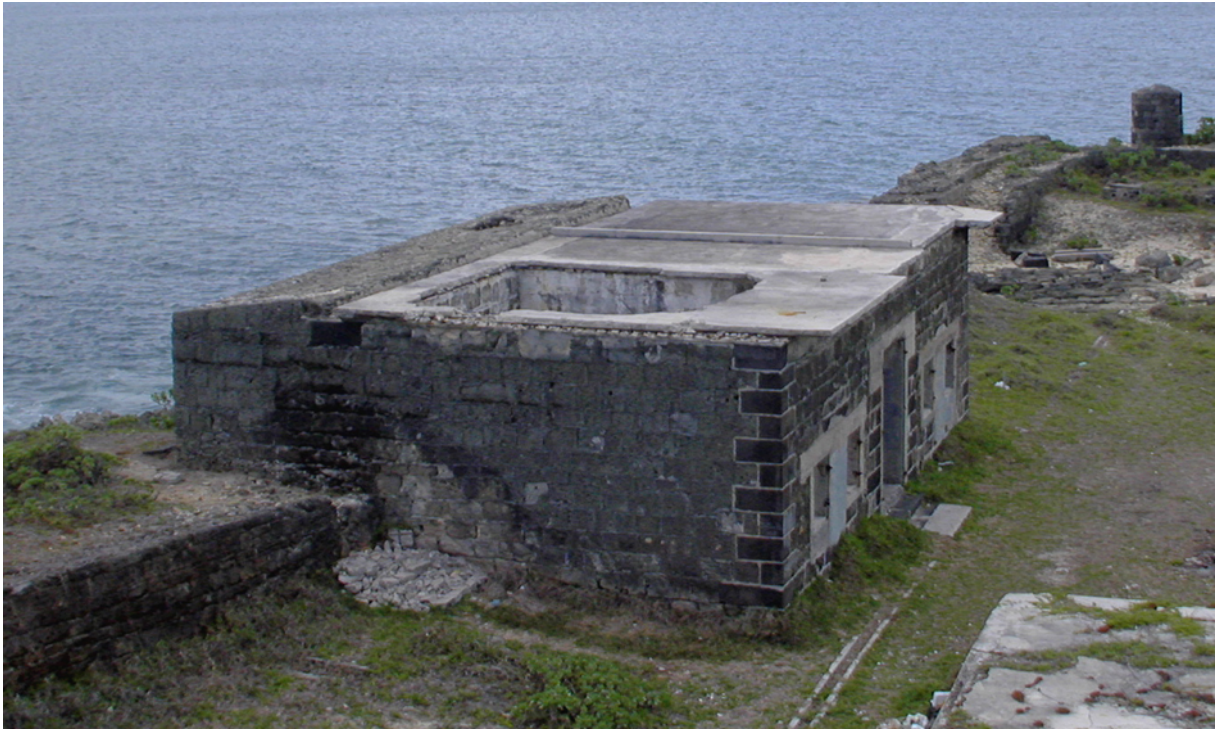
*The Storehouse as seen from the Upper Battery showing the broken concrete roof.  
(02JV0308)*

The reinforced concrete roof is in a dangerous state and the remaining portions will have to be carefully removed so as to avoid damage to the walls. Concrete partition walls also reveal advanced corrosion of reinforcement.

The advice of a structural engineer is urgently needed for action to be taken on the reinforced concrete.

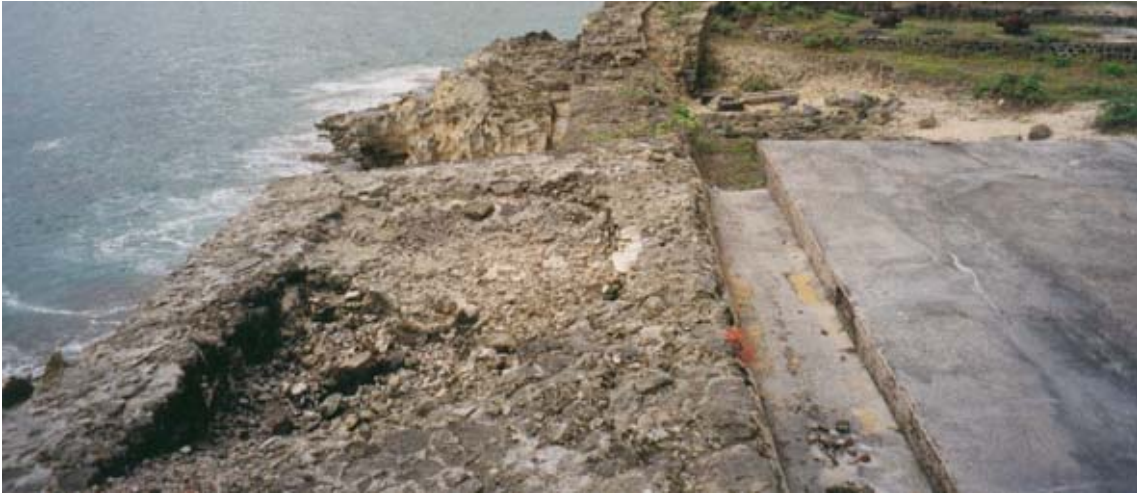
*Northern part of roof showing rubble core of back wall and gutter between original back wall and WW II concrete roof. (02cn0104)*

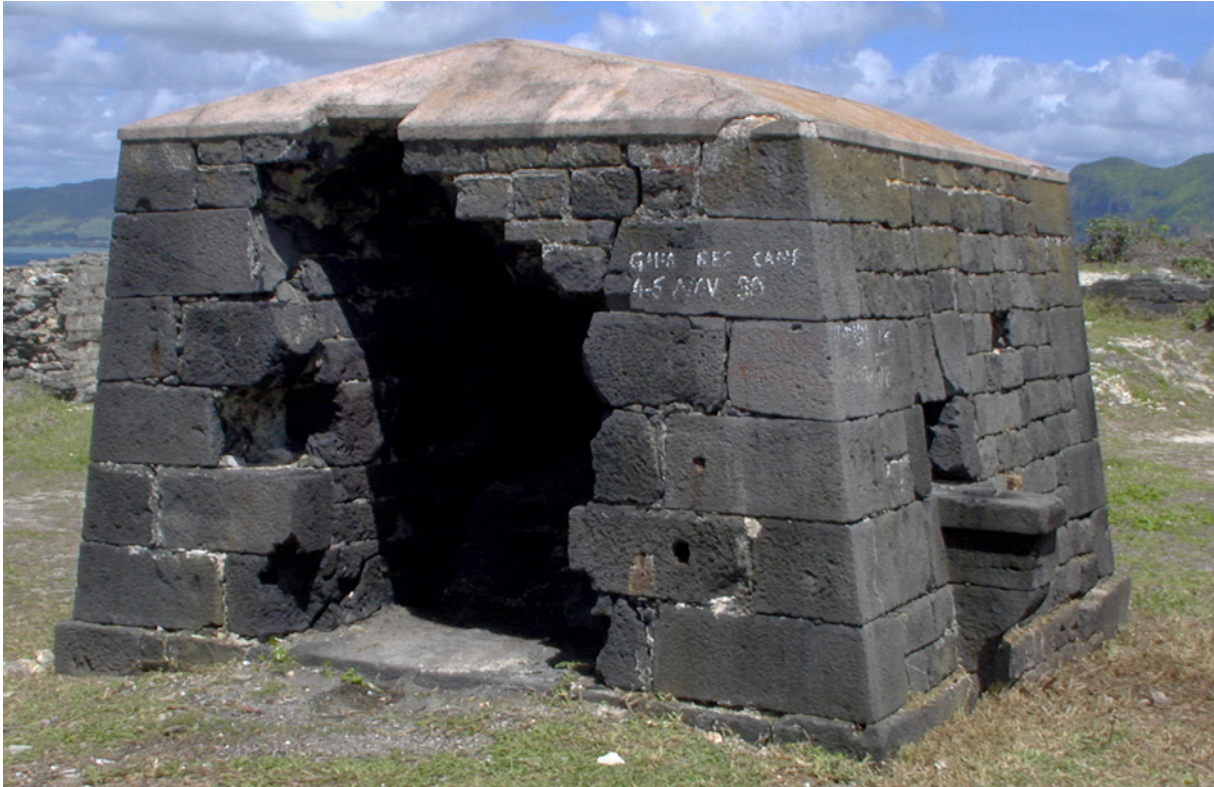
*The Shot Furnace, built by the French Period, has suffered damage; its restoration will need specialist and professional care. (02jv1023)*

An important portion of the ceiling has collapsed and more is in danger of collapsing. The base of the rear wall is in a bad state as a result of campfires that have been set against it. The west wall has been underpinned with concrete in the recent past. Some of the basalt has cracked, presumably as a result of heat when the furnace was in use. Other stones have been dislodged by visitors. Much of the brick lining is missing. The original ironwork is in a very poor state.

The repair and restoration has to be preceded by detailed documentation and recording. A study of literature sources and archive materials might help to understand better this very complex construction. Repair and restoration work should be carried out by specialists and experts. This is a building of great importance and interest. Any temporary shoring should be done with great care.

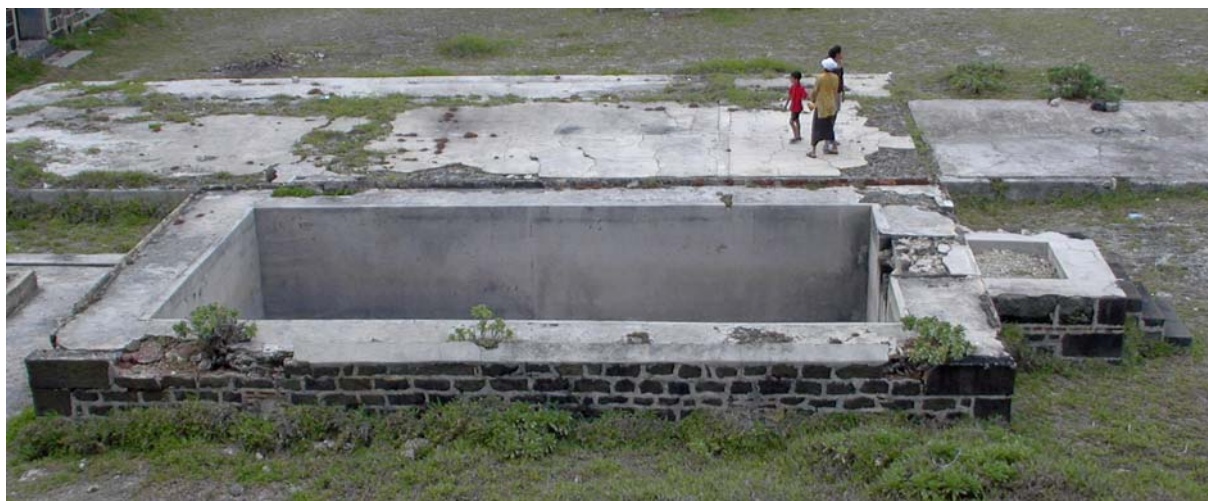
*The Cistern photographed from the Upper Battery. (02jv0308)*

The cistern is in an overall remarkably good state of preservation. A few blocks along the upper course have been displaced and some of the rendering has cracked and broken away.

The displaced blocks, most of them lying nearby, should be put back in their original positions and mortar, of an appropriate composition, used to repair the surface rendering.

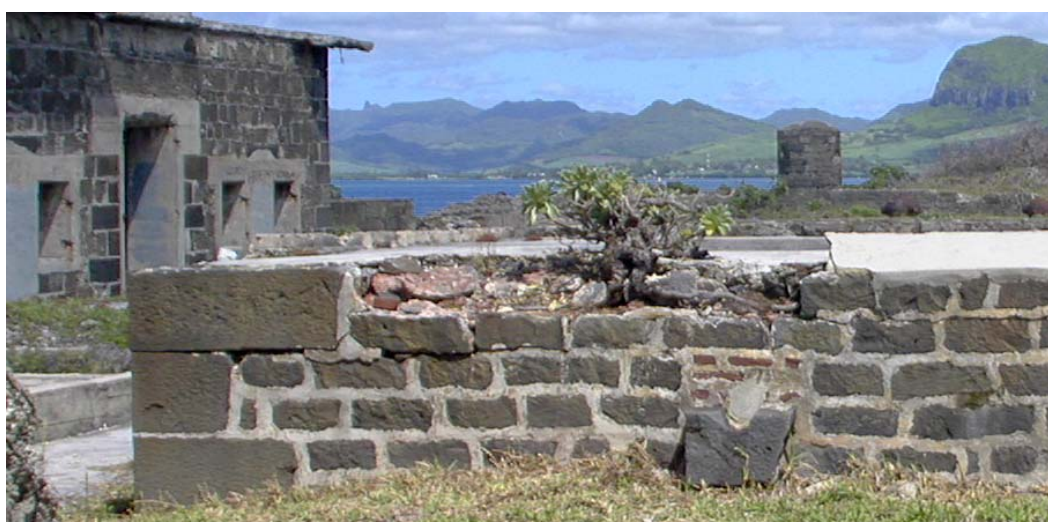
*South-west corner of the cistern where blocks from the uppermost course should be replaced and vegetation carefully removed. The blocked basalt 'spout' shows a red brick blockage with a circular hole perhaps allowing for a pipe and later blocked by a cement mortar. (02jv2107)*

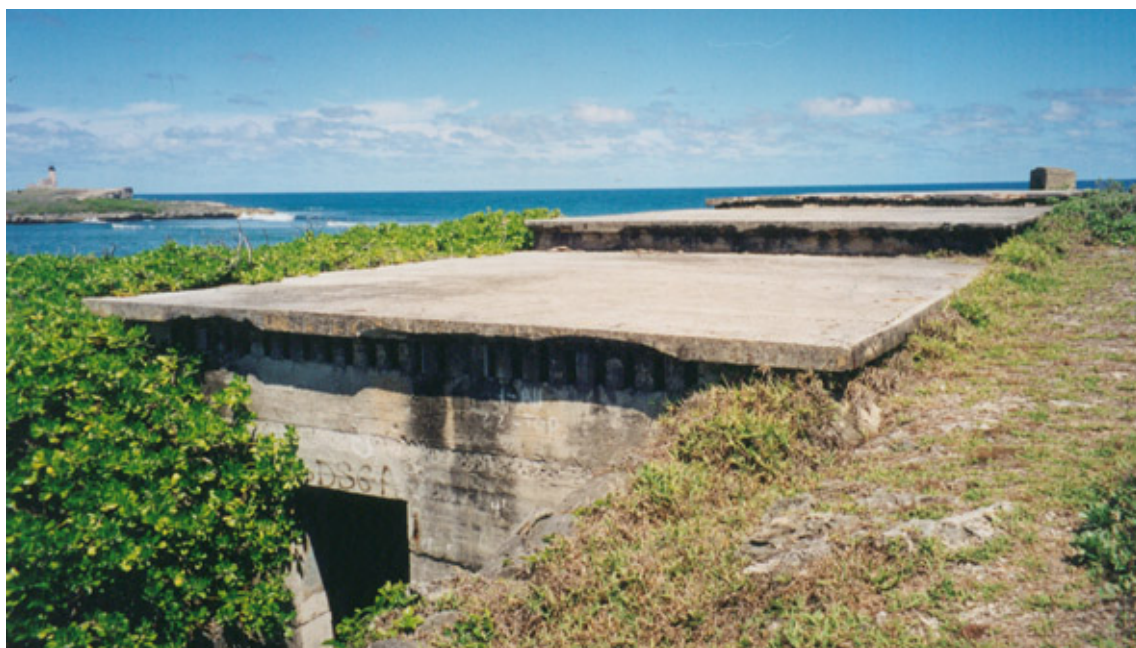
*The Underground Generator Halls have a single entrance, ventilation is provided by rows of small vents under each of the roof slabs. (02cn0415)*

The reinforced concrete structure is in a serious condition because the reinforcement is corroding. As the metal corrodes it expands and splits the concrete in which it is embedded. The interior, in January 2002, was foul.

A structural engineer is required to assess the strength and safety of the concrete walls and roof, and to make recommendations accordingly.

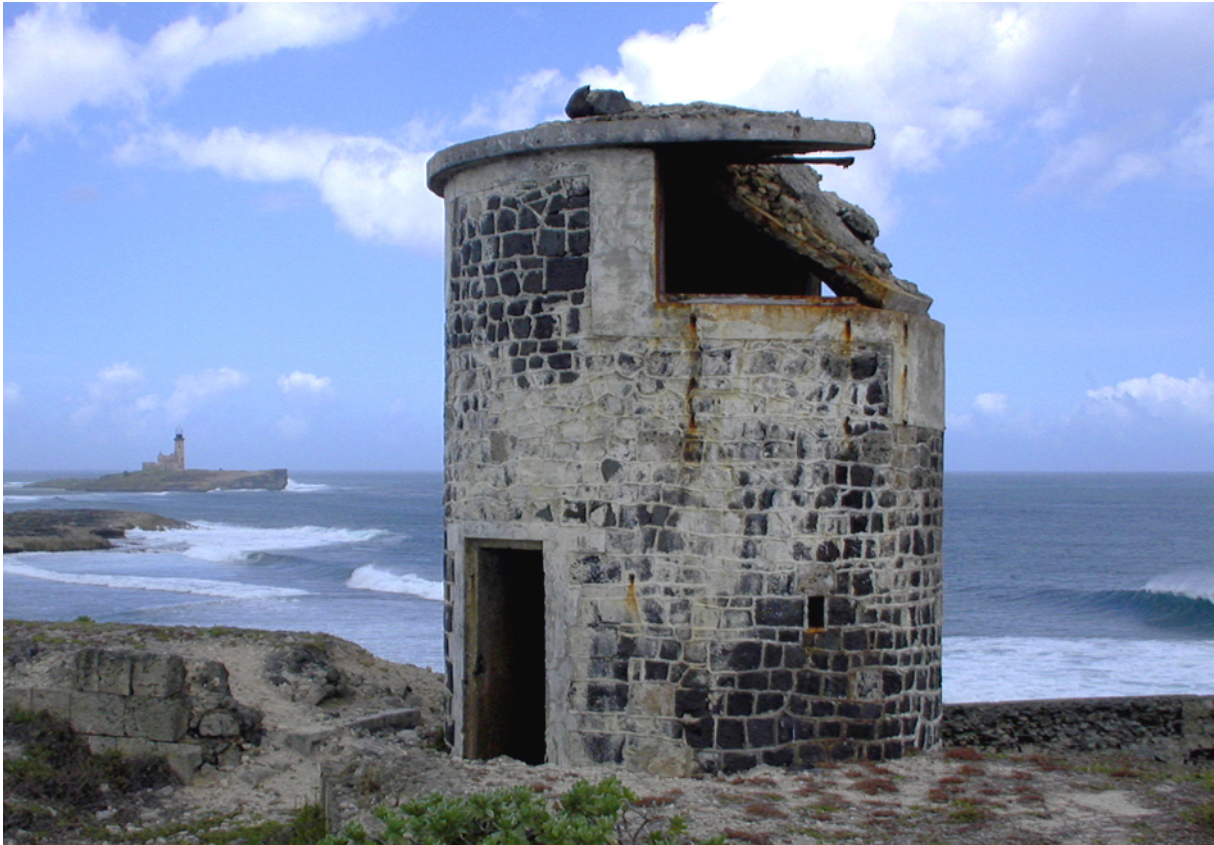
*The Observation Tower with its partially collapsed roof. (02jv0401)*

The roof has partially collapsed, cracking the upper part of the wall which otherwise appears to be structurally sound. The wooden floor, at the first storey level, has been completely removed. Remains of iron fittings on the wall indicate the position of stairs or a ladder and other installations.

As it stands the Observation Tower presents a danger to visitors. The concrete roof slab and steel beams should be completely removed and a new roof erected. A number of alternatives for the new roof are possible and the choice will depend on the final scheme chosen for the adaptation of the tower to a new function. This is discussed in *Report 3; Management Development and Research: Recommendations and Proposals*.

A structural engineer must be consulted over the steps to be taken regarding the roof, especially if the concrete slab was to be partially removed as a temporary measure awaiting sufficient finances to implement the complete refurbishing of the tower,

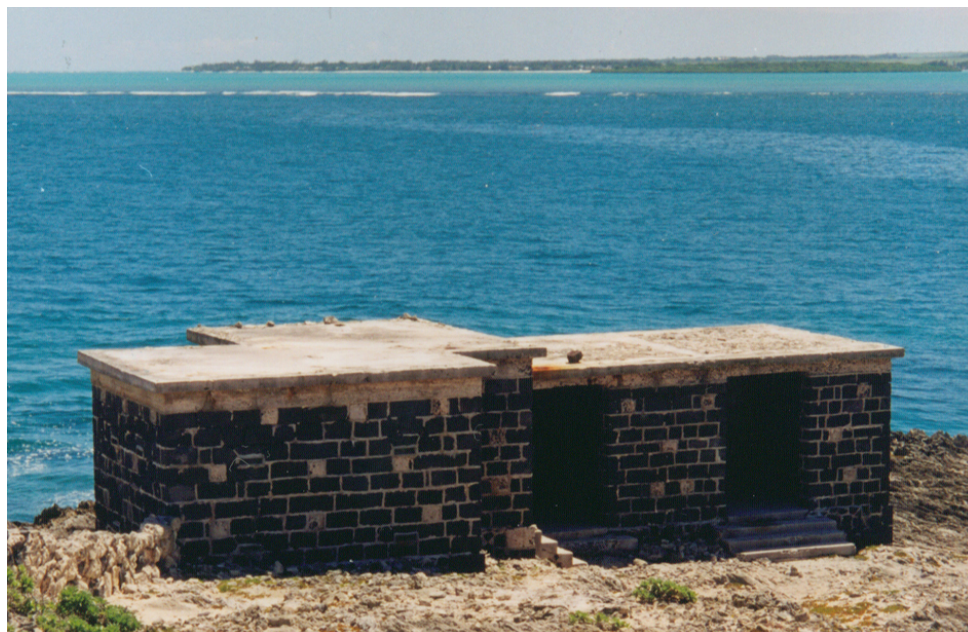
*The Western or Searchlight Building overlooking the pass. (02cn0427)*

The walls appear to be structurally sound, although some of the blocks have been displaced over the inclined vents. The roof is in poor condition and some of the reinforcement has been exposed, showing advanced stage of corrosion.

A structural engineer should advise on whether the roof has retained its structural soundness and can be repaired or whether a new roof is needed. Walls should be repaired and perhaps repointed when studies have defined an appropriate mortar, possibly a lime mortar.

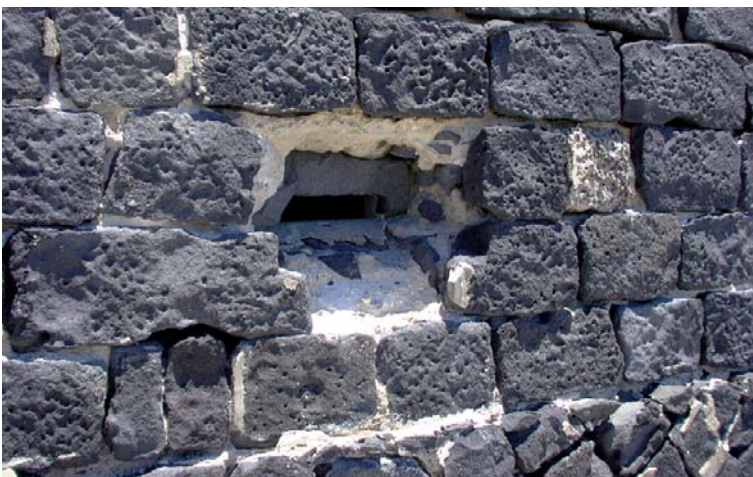
*A broken vent reveals construction details.*
