WORLD WAR TWO MILITARY INSTALLATIONS ON THE SOUTHEAST COAST OF MAURITIUS: A PRELIMINARY SURVEY

Geoffrey and Françoise Summers

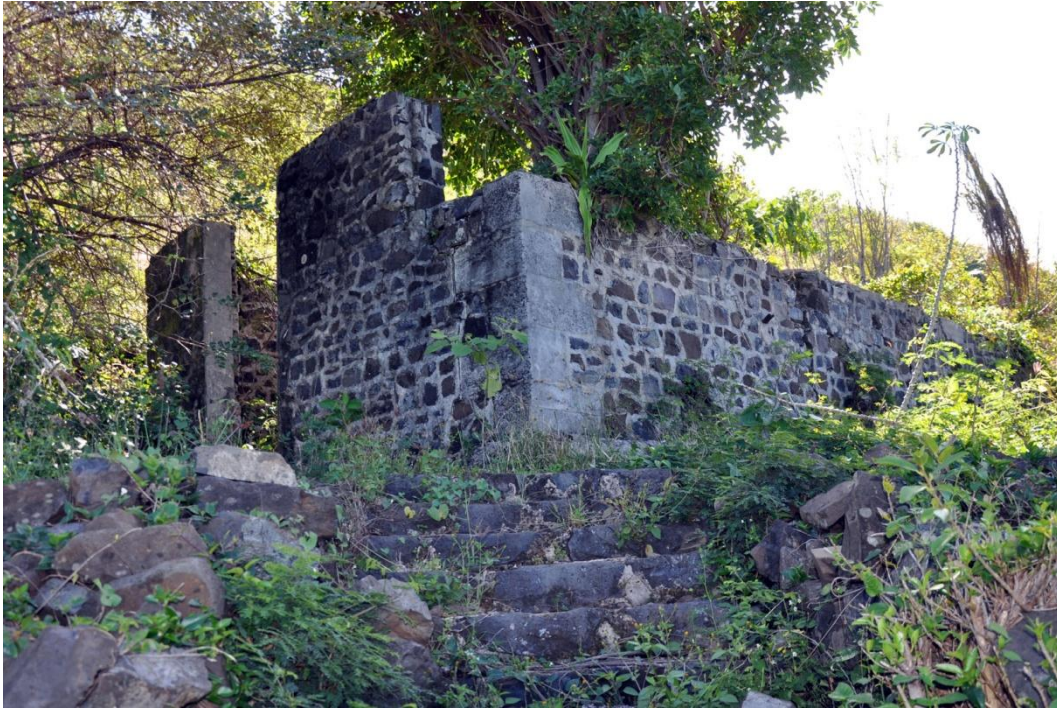
Figure 10. Pointe aux Feuilles, the northern observation post with steps. GDS 2012 1016

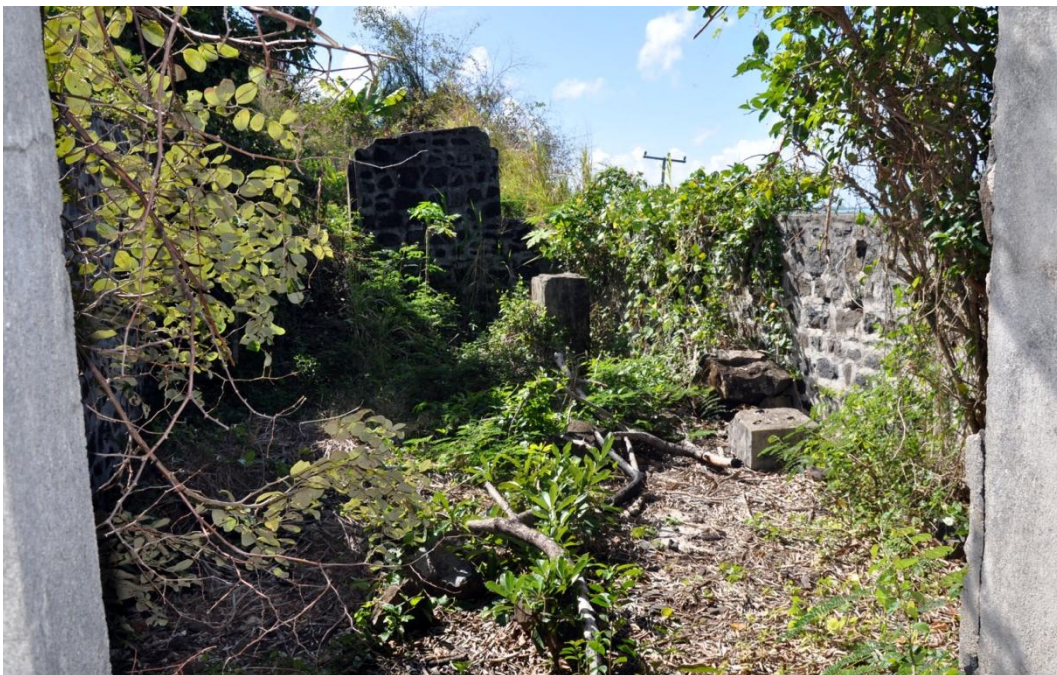
Figure 11. Interior of the northern observation post with doors at either end, low pitch of shed roof seen in far wall and pier to support raised viewing platform. GDS 2012 1013

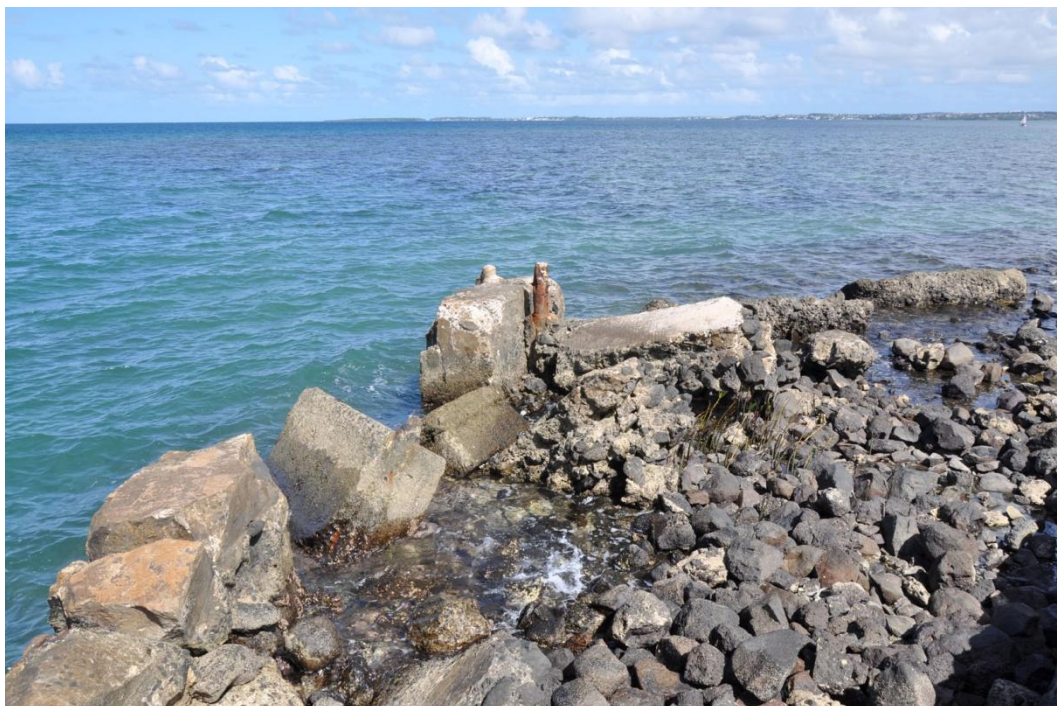
Figure 54. Bois des Amourettes, the collapsed WW II jetty end. GDS 2012 0594

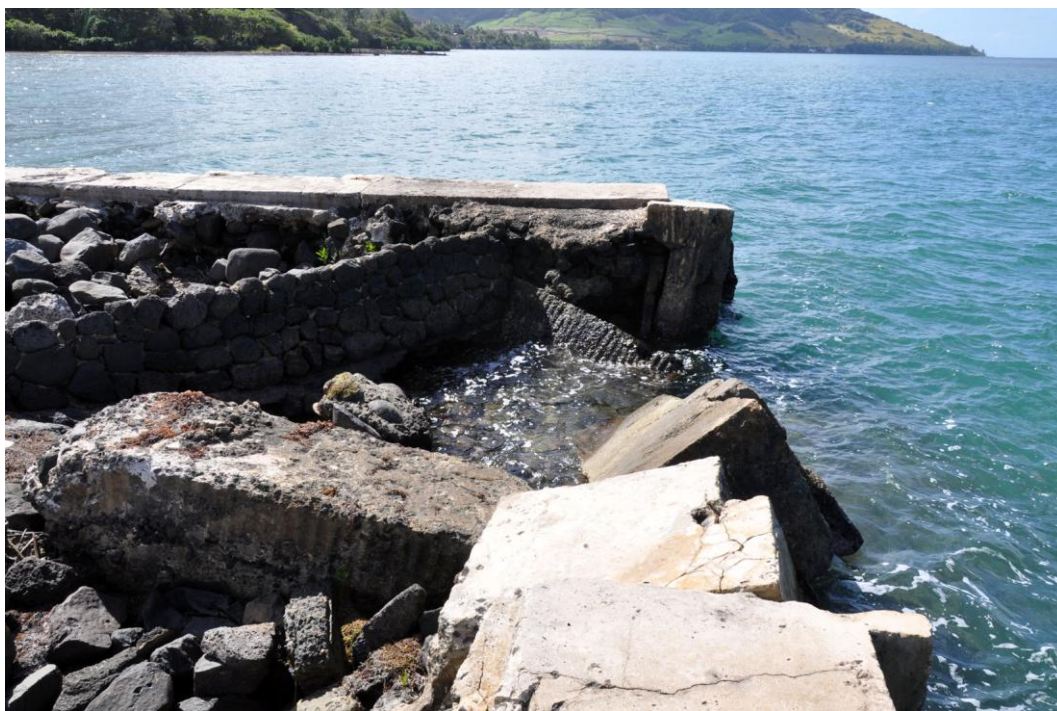
Figure 55. Bois des Amourettes, the collapsed corner of the WW II jetty with the imprints of corrugated metal shuttering and the recent basalt revetment. GDS 2012 0593

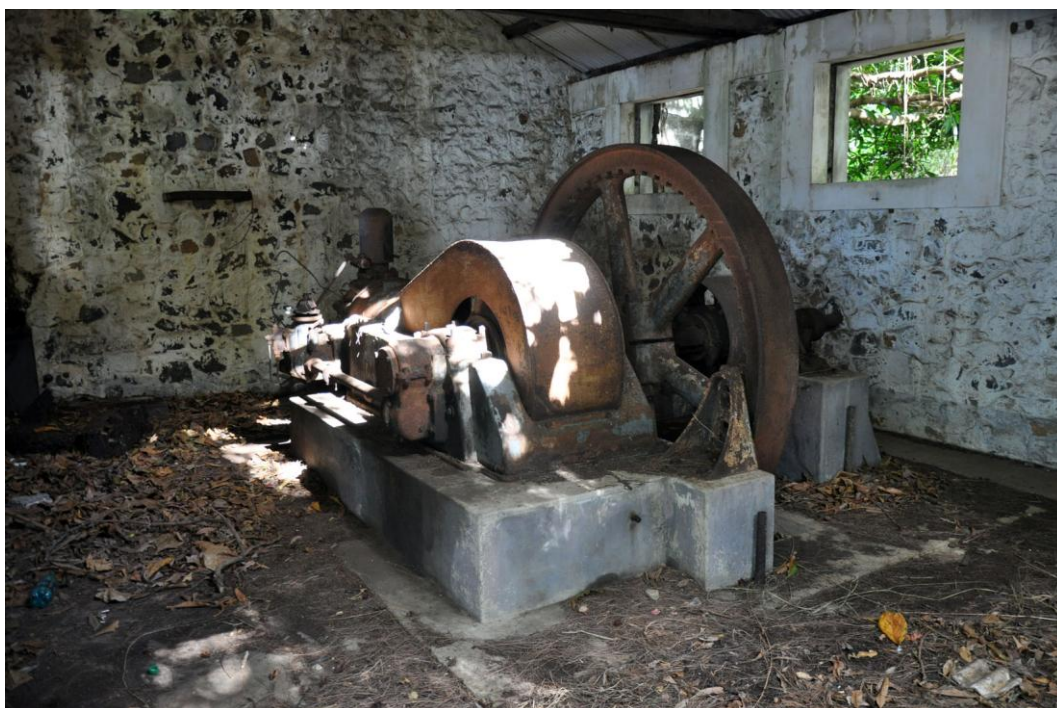
Outside there are various associated features in addition to the extant piping. These include a valve at the south end (Fig. 69) and various valves at the north (Fig. 62 at right). The machinery is rusting and incomplete but, even if it could never be made to work again, it is

certainly not past preservation. The building too, apart from the roof, is sound. There is a stack of pipe sections to the right of the pump house as well as much piping still in place.

Figure 64. The Ruston diesel engine on a concrete bed, rear wall at right. GDS 2012 0754

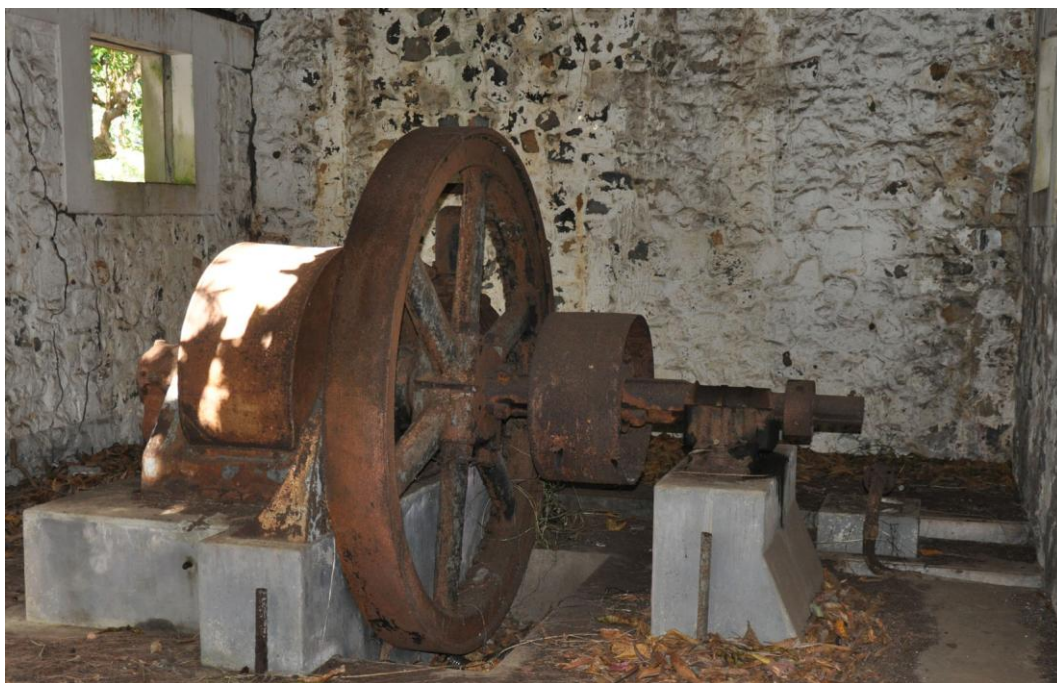
Figure 65. Bois des Amourettes Pump House, Ruston diesel engine on concrete bed, front wall at left. GDS 2012 0758

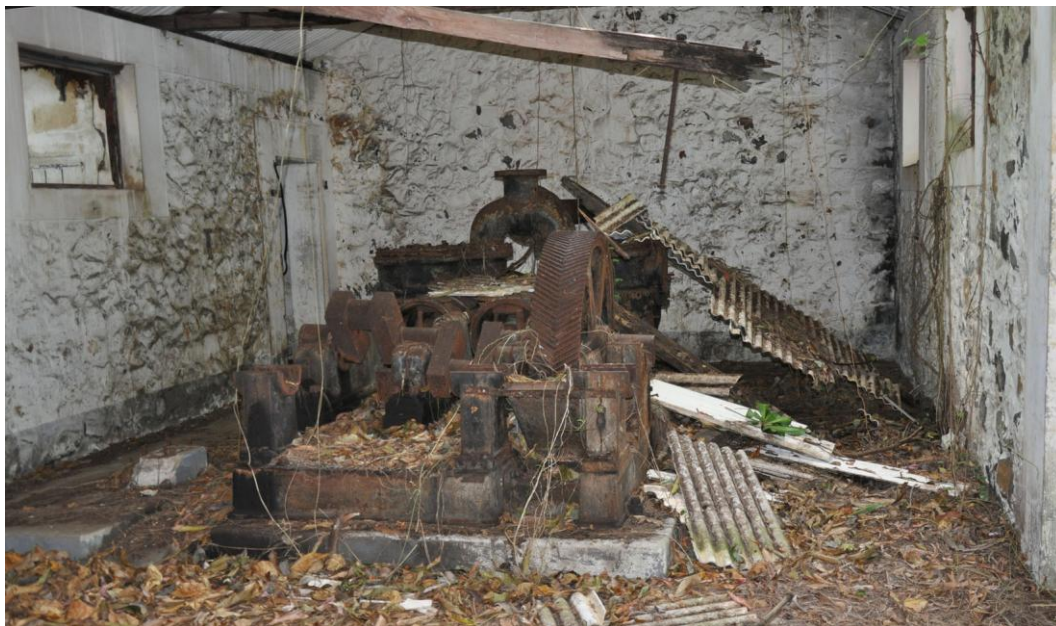
Figure 66. Bois des Amourettes Pump House, the Pump with collapsing roof. The generator room added to the back is accessed via the doorway in the far corner. GDS 2012 0753

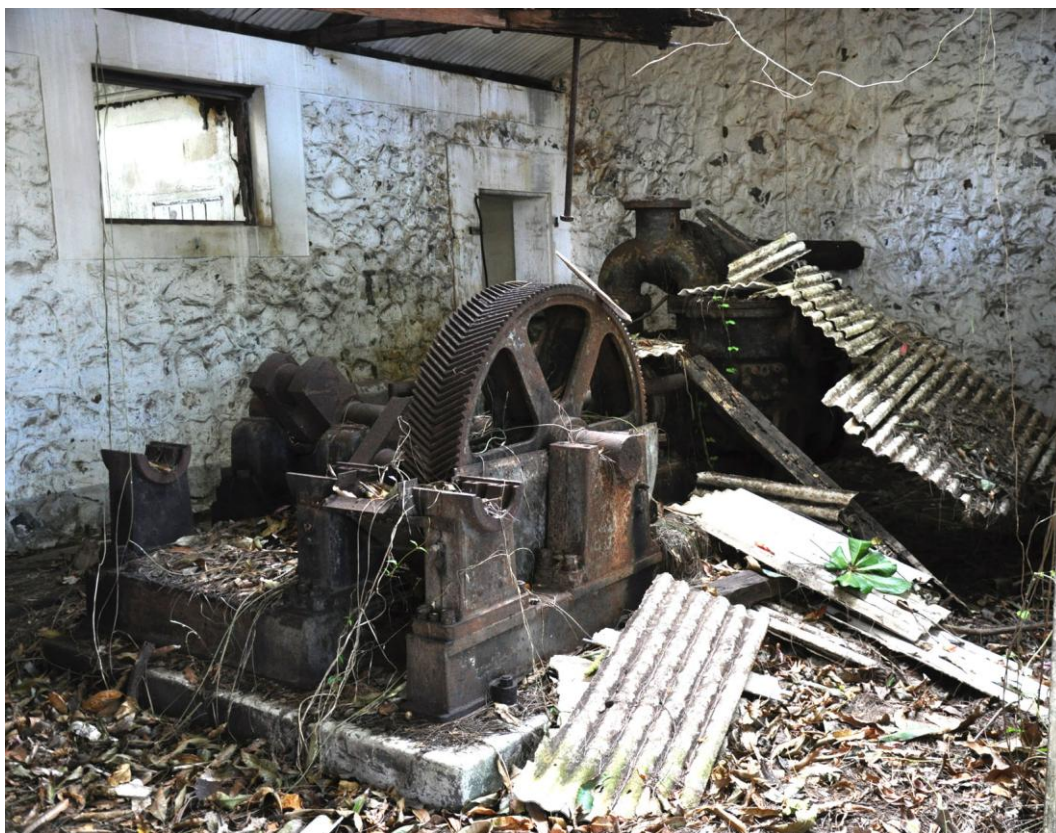
Figure 67. Pump with outlet through end wall at right. Asbestos corrugated sheeting, fallen from the timber framed roof, could be original. GDS 2012 0753

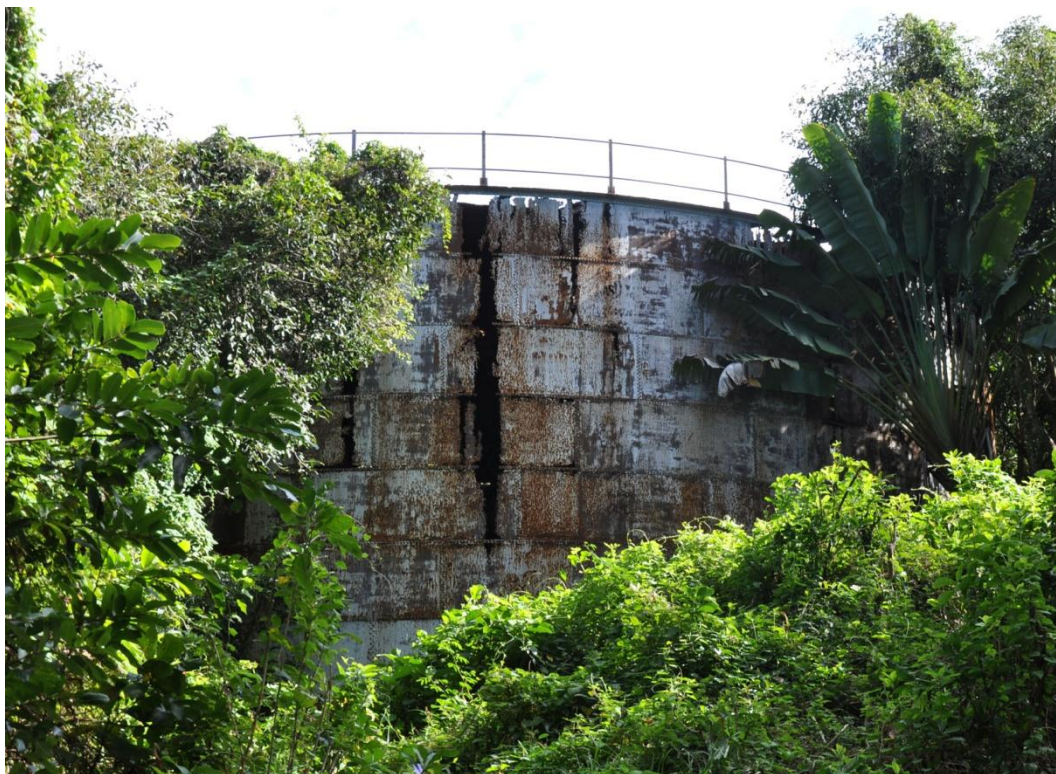
Each tank rests on a concrete base. Today they are rusting and unsafe (Figs 71-73 and 75). Vegetation is sufficiently dense to dissuade the casual visitor, as are the mosquitoes, but there is no fence.

Figure 71. Bois des Amourettes fuel tank. GDS 2012 0750

That there is a need for a full survey, combined with archival work, of the military installations at Bois des Amourettes does not need to be stressed. What to do is more difficult. Fuel storage tanks, long abandoned, are rusting away. They are dangerous and unfenced. The jetty is used and periodically maintained, and has thereby lost much of its WW II authenticity.

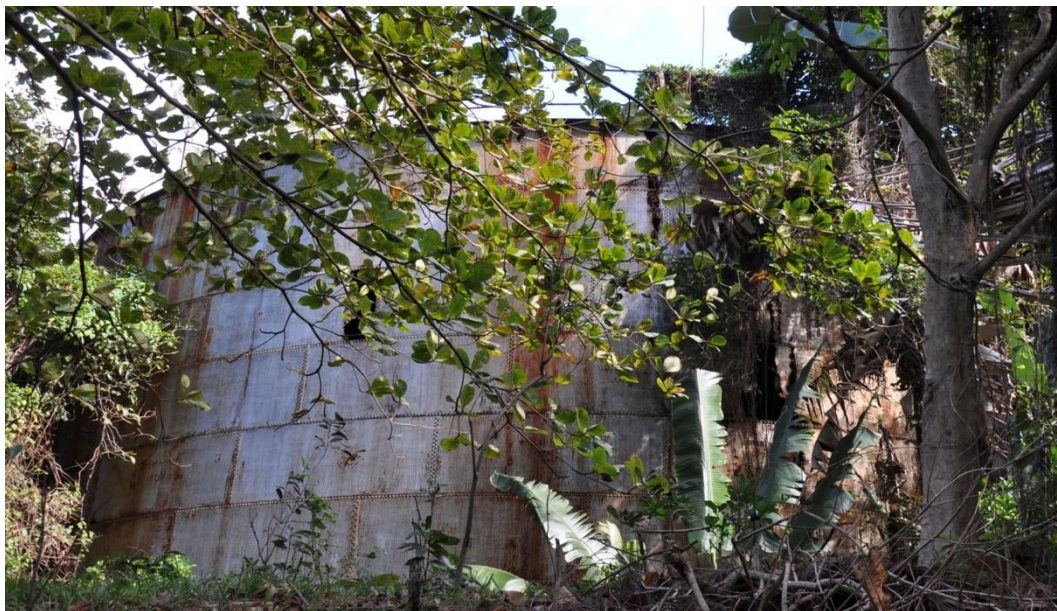
Figure 72. Bois des Amourettes fuel tank. GDS 2012 0774

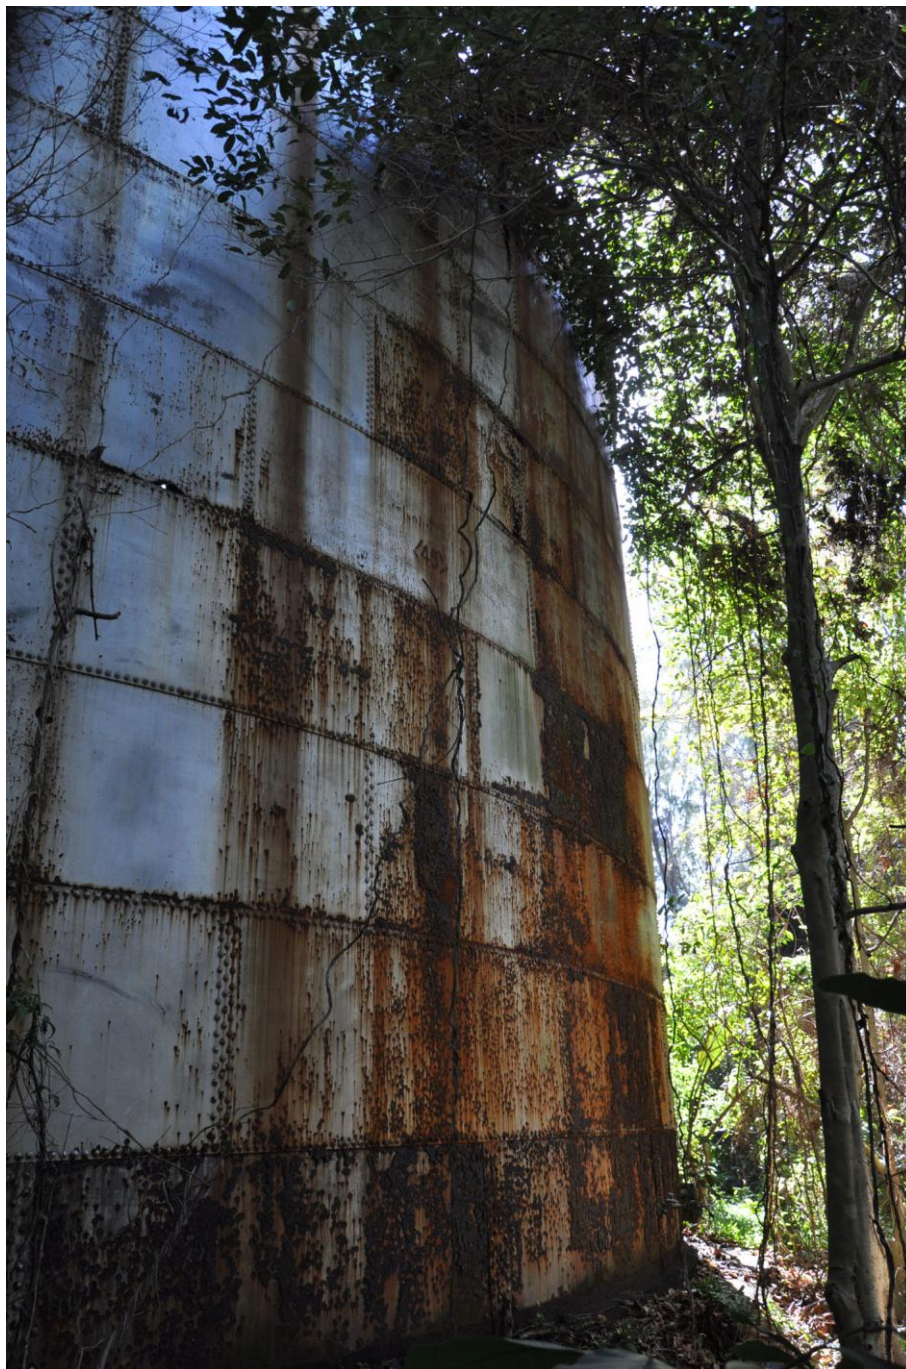
Figure 75. Bois des Amourettes fuel tank. GDS 2012 0767

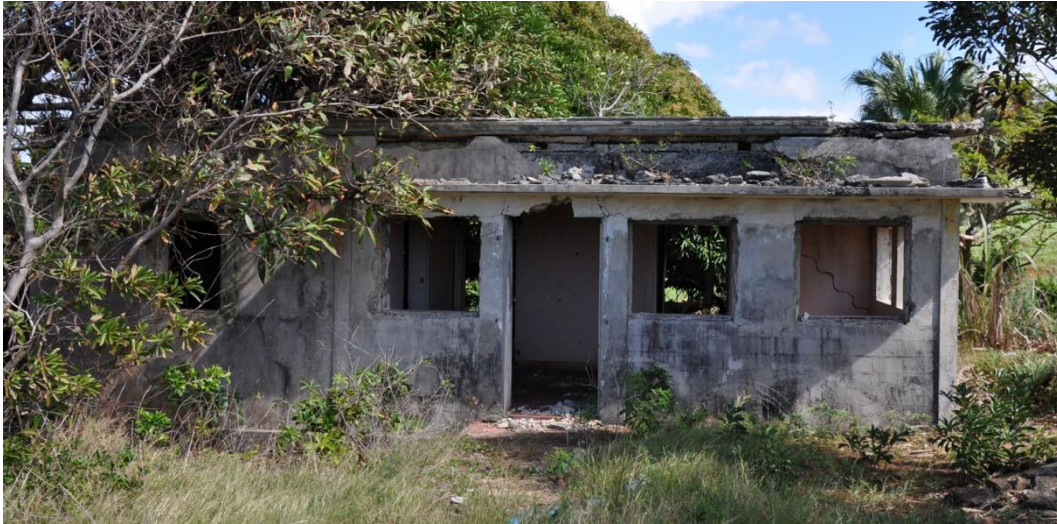
Some little way up the slope to the west of the modern road lies a small temple. Adjacent to it are at least two WW II structures that were later reused and are now in a perilous condition. The first was partially built of reinforced concrete with a slab roof (Fig. 88). It was added to with hollow blocks, in modifications which may have turned an open back into rooms. The second (Fig. 89) is now a double garage, which was very possibly its original function. Here reinforced concrete columns were preferred over the more common precast cement blocks, probable because of the need to support heavy concrete beams and slab roofs. There seem to be several styles of basalt masonry which it was not possible to examine without cutting back vegetation. Safety would be the first consideration in further investigation, and local knowledge would perhaps be helpful in understanding the sequence.

Figure 88. WW II structure reused as a dwelling, now abandoned. GDS 2012 0828
