ARCHITECTURAL AND ARCHAEOLOGICAL STUDIES AT ILE DE LA PASSE

MAURITIUS

REPORT ON THE 2003 SEASON OF FIELDWORK

Submitted to the National Heritage Trust of Mauritius

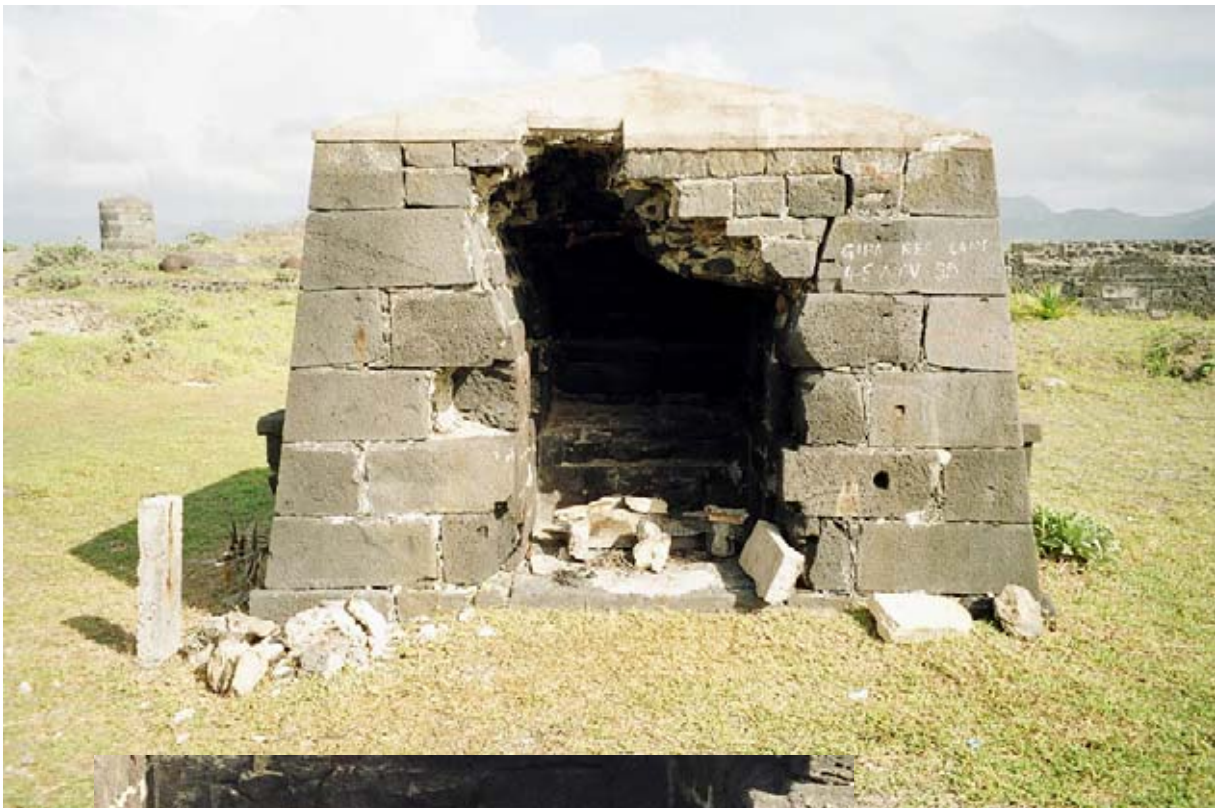
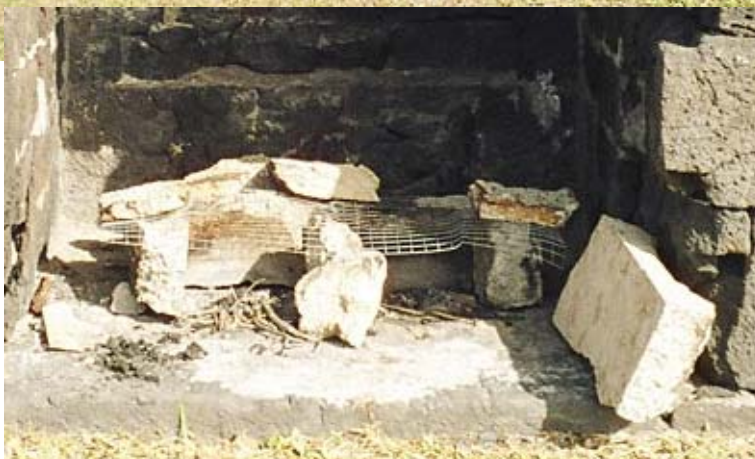
Of particular concern, however, was further damage done to standing structures as a result of cooking-fires having been lit against walls and inside buildings. While the extent of this damage is not in itself disastrous, the accumulative effect is considerable and will soon result in the loss of graffiti, some of which have considerable historical importance for Mauritius. Besides this loss, fire damaged wall faces will be both difficult and expensive to repair.

Figure 9: Barbecues lit inside the hot shot furnace seriously endanger the already damaged structure. (03cn0207)

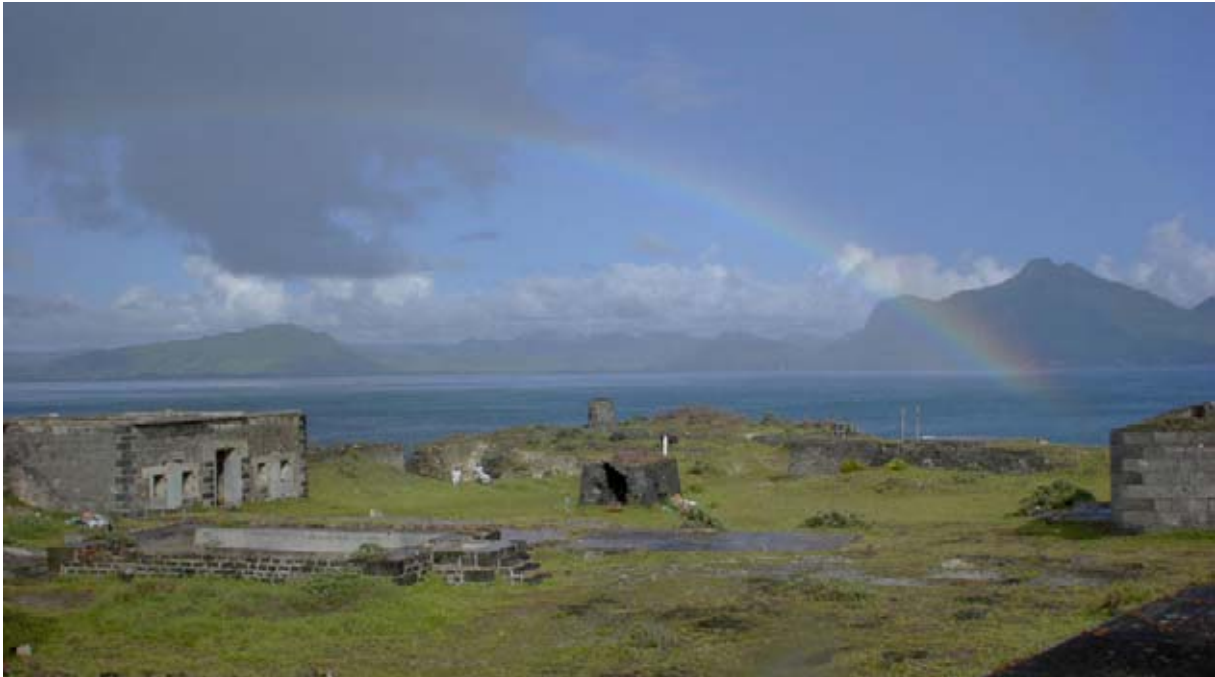
Figure 10: Standing structures are in need of conservation and restoration. (03jv0506)

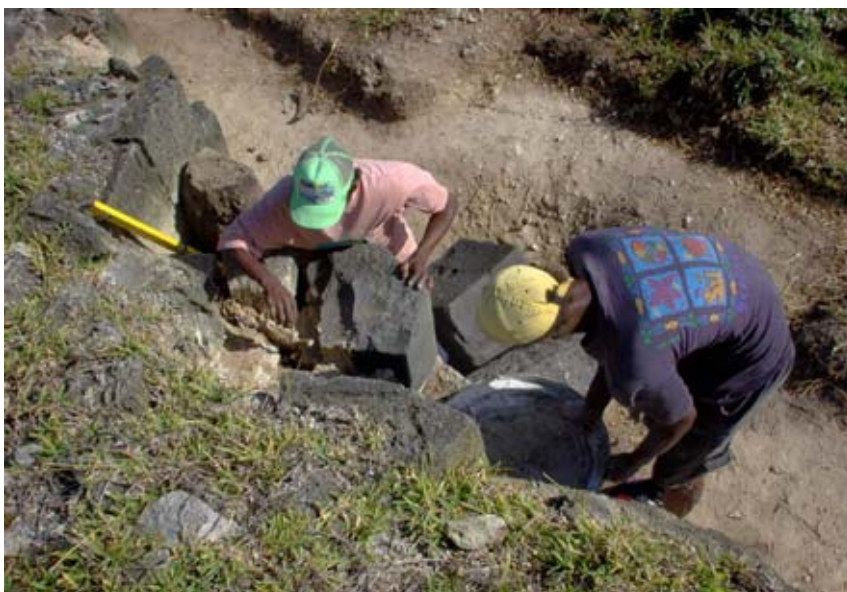
Figure 11: Basalt blocks fallen from the emplacements were set back in their original position. (03jv1610)

In general Emplacements 1 and 2 have been partially restored and consolidated as well as the intervening and adjacent stretches of the parapet wall. Fallen stones have been set back in their original positions in the very few cases where it was obvious from whence they had fallen. Otherwise stones were selected and set in a way that mimicked as nearly as possible the original character of the wall. At the Emplacements new stones had to be cut for the angles, and indeed occasionally to fill gaps. This was done with a simple wood saw. Newly cut stone is, however, gleaming white. Experiments with ways of artificially ageing the newly cut surfaces are in hand and will continue at Ankara. The length of time taken by the natural processes that make the cut coral stone grey is not known but it is of interest that when new the battery walls, and the stone buildings, would have been gleaming white.

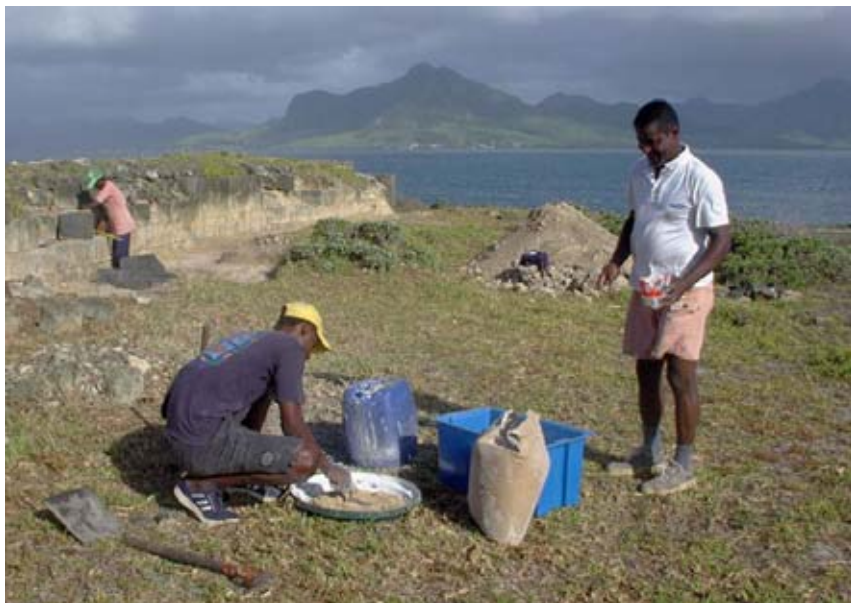
Figure 14: Lime mortar was prepared with 'red earth' brought from the mainland. (03jv1602)

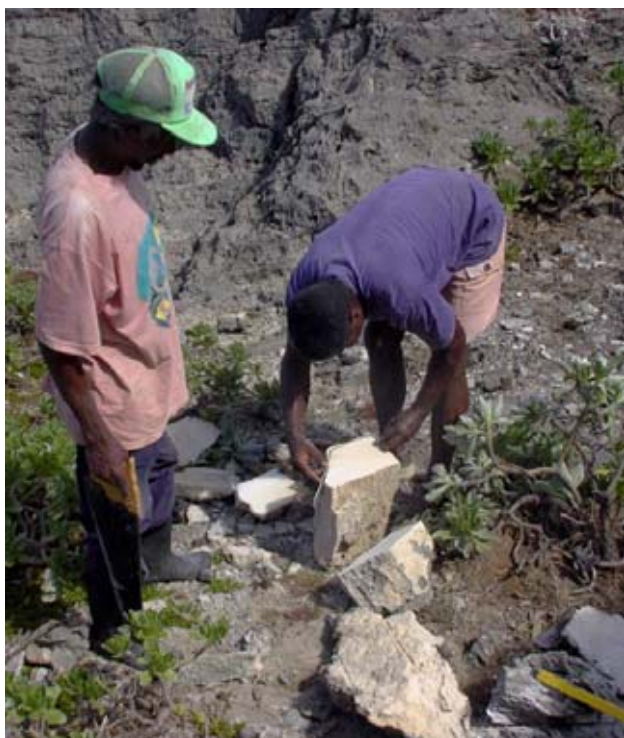
Figure 15: New blocks of coral were cut from the quarry and shaped to replace missing ones. (03jv1716)

Larger scale restoration in future seasons will require new coral blocks. New blocks could be quarried from the islet itself or, preferably but at greater expense, from some source on the mainland. The NHT will have to address this issue in the near future.

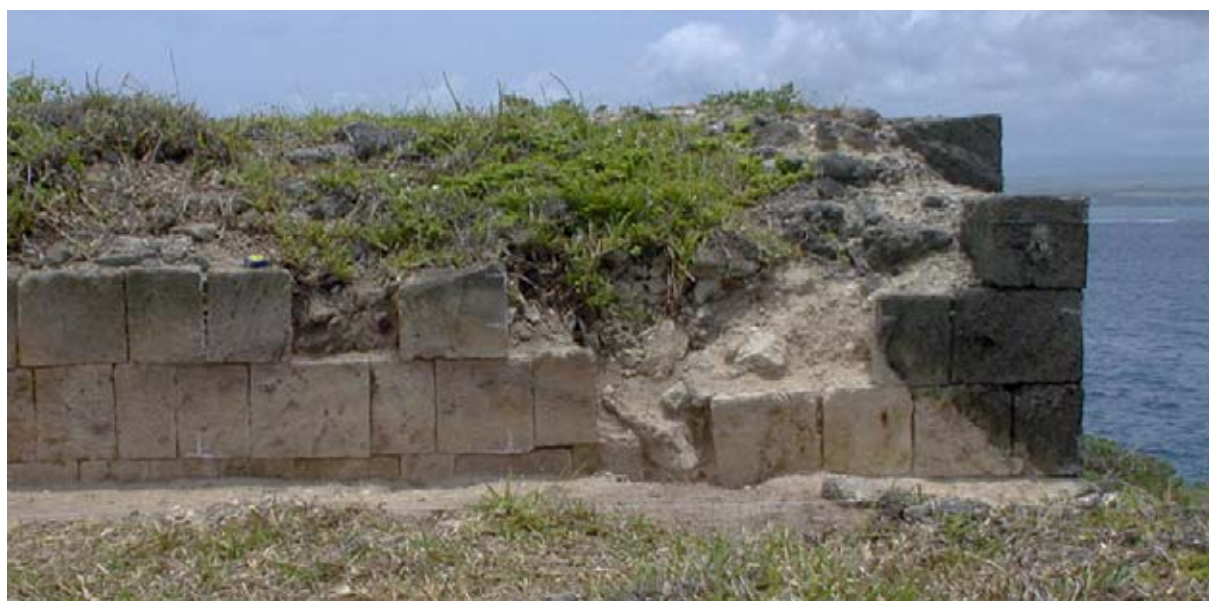
Figure 21: After clearance it was evident that the Parapet Wall of the Upper Battery was not bonded to the North Wall. (03jv1101)

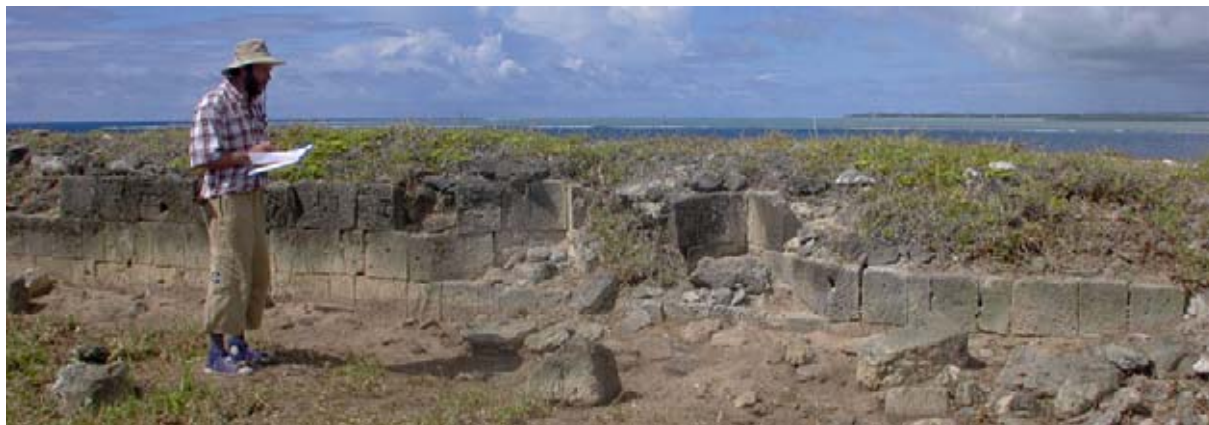
Figure 22: The stretch of Parapet Wall either side of Emplacement 1 has regular courses and staggered vertical jointing, although there is no bonding pattern. (03jv0208)

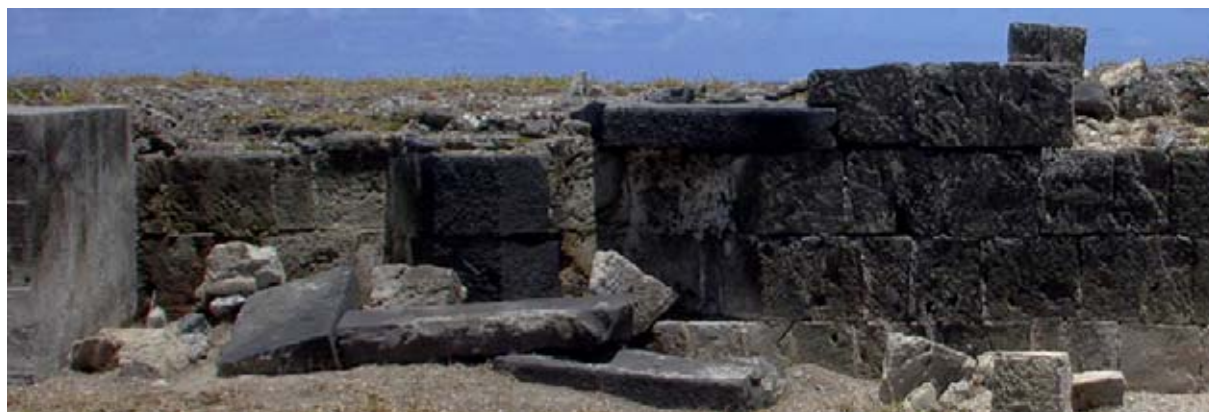
Figure 23: On the right side Emplacement 5 the fifth course comprises basalt lintels locked in place by coral blocks cut to fit. (03jv0603)

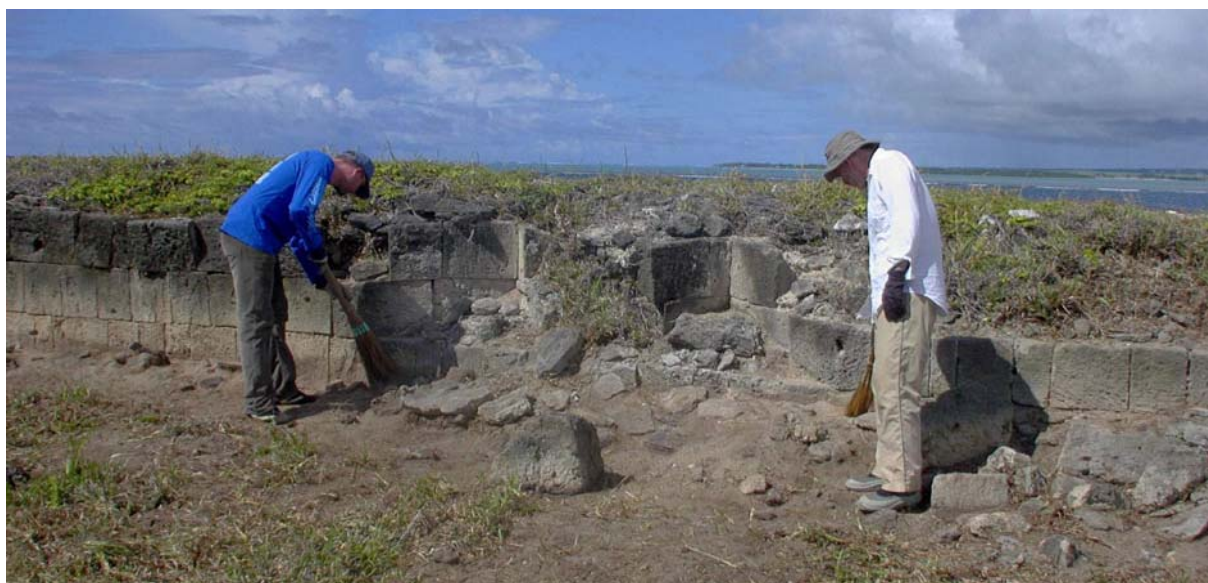
Although no basalt survives at northernmost emplacement, what is almost certainly the lower of the two shaped stones that made up the front of the central pier was uncovered in the shallow scoop on the top of the bank in front. There is no indication as to where the remainder of the original basalt has gone, nor is there any evidence that might indicate the date of its removal. If alterations were made to Emplacement 1 no traces now survive. In this respect it should be noted that there was no indication that blocks were ever set into the top of the layer of clean sand and coral which formed the top of the Platform behind the Parapet Wall.

Figure 24: Emplacement 1 after removal of vegetation and recent debris. (03jv0206)

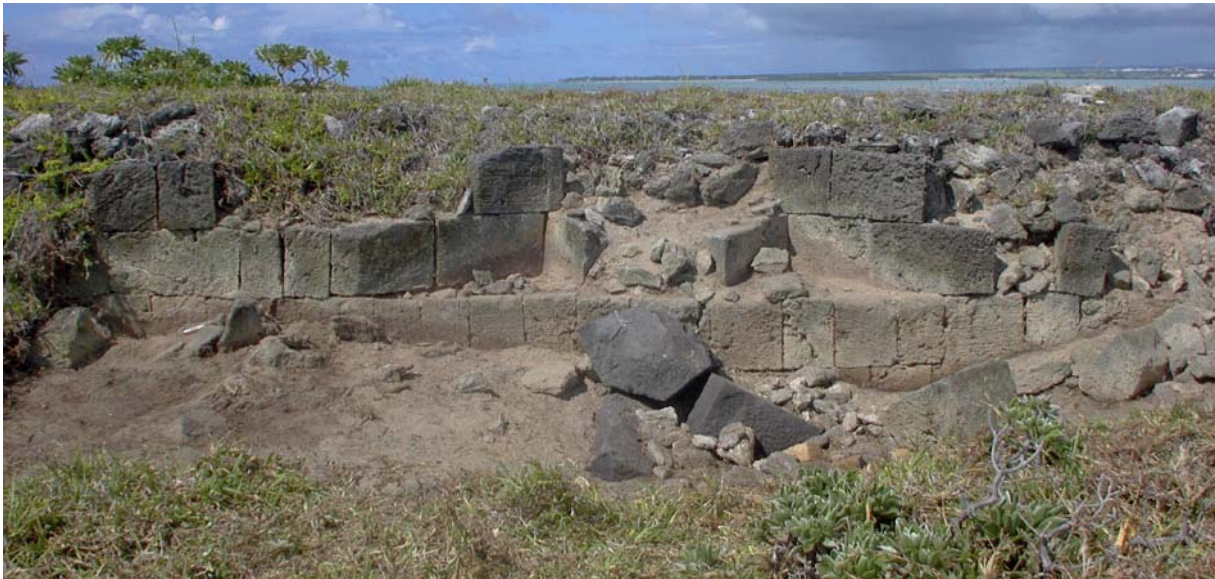
Figure 25: Emplacement 2 after removal of vegetation and before restoration. (03jv0216)

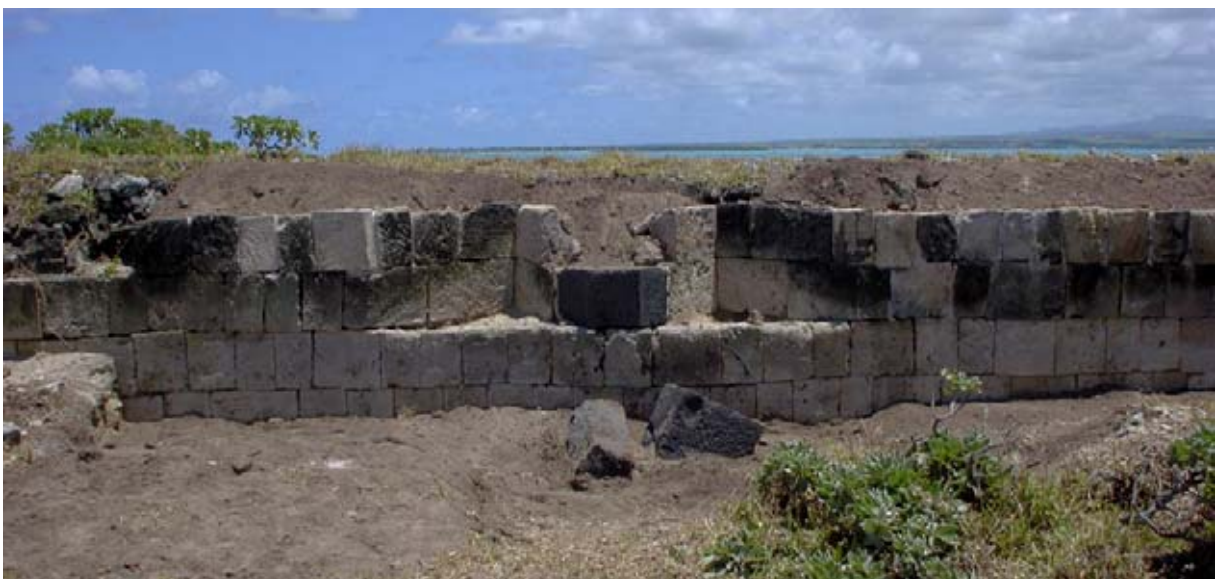
Figure 26: Emplacement 2 after restoration. (03jv2709)

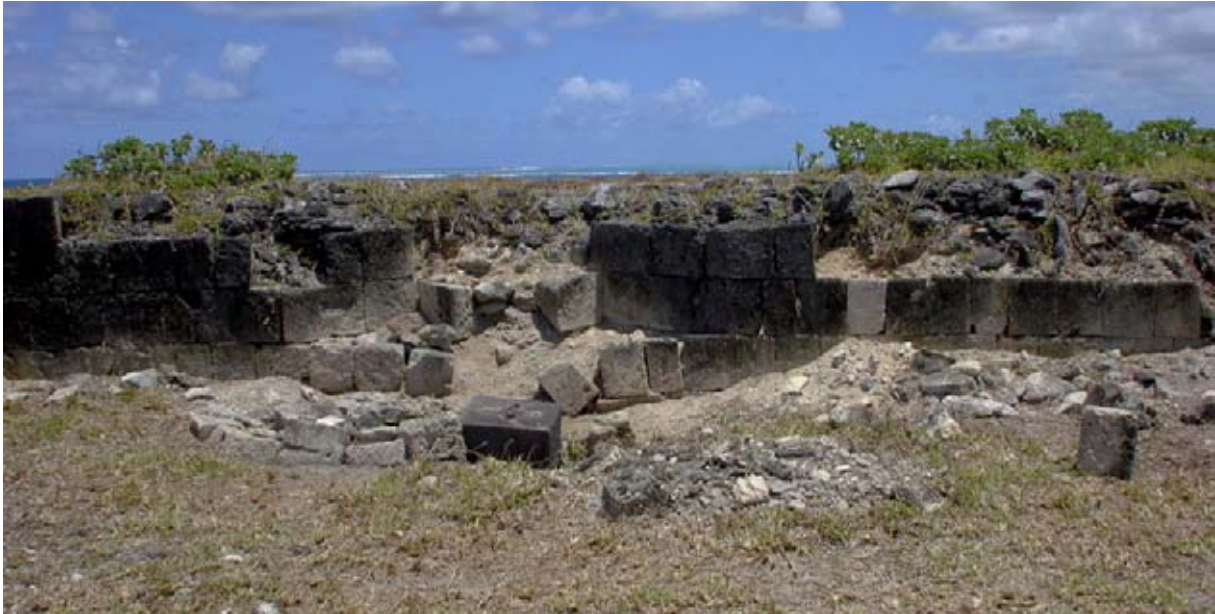
Emplacement 3 was not investigated in detail during the 2003 season, although the grass was cut back to reveal the tops of the basalt stones behind. Here too there is a massive installation was set close behind the central engaged pier between the niches. In this instance, however, the fitting that is set into the top of the squared block is larger, more complex and comprises several elements.

Figure 27: Emplacement 3 as revealed after grass was cut back. (03jv2711)

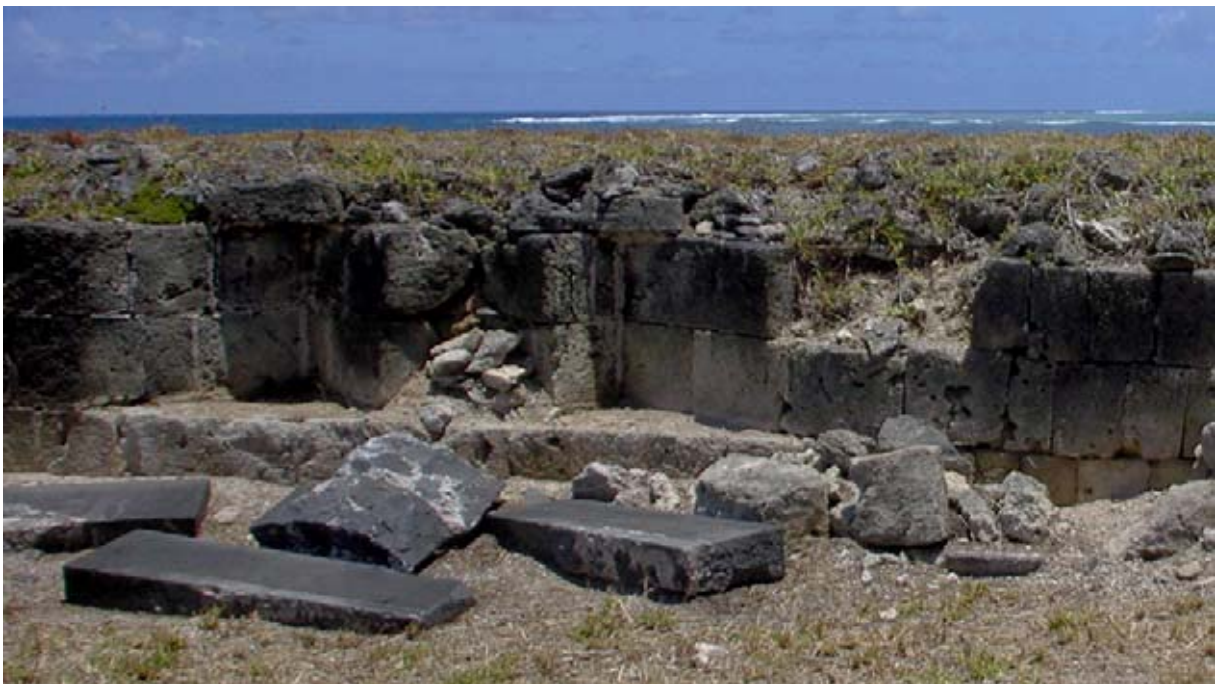
Further vegetation clearance also revealed fallen basalt blocks and lintels behind Emplacement 4.

Figure 28: Fallen basalt blocks and lintels lie in front of Emplacement 4. (03jv2713)

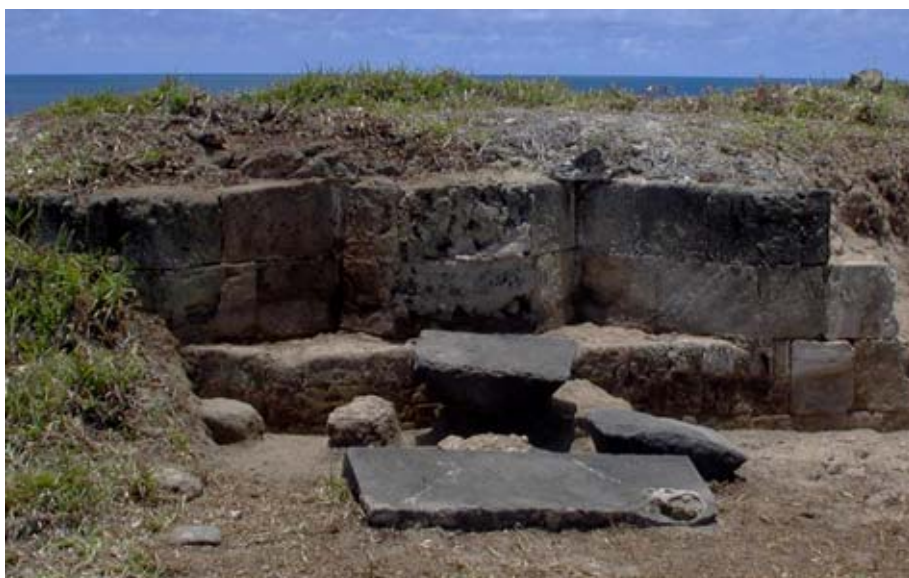
Figure 29: Fallen basalt blocks as found. (03jv0603)

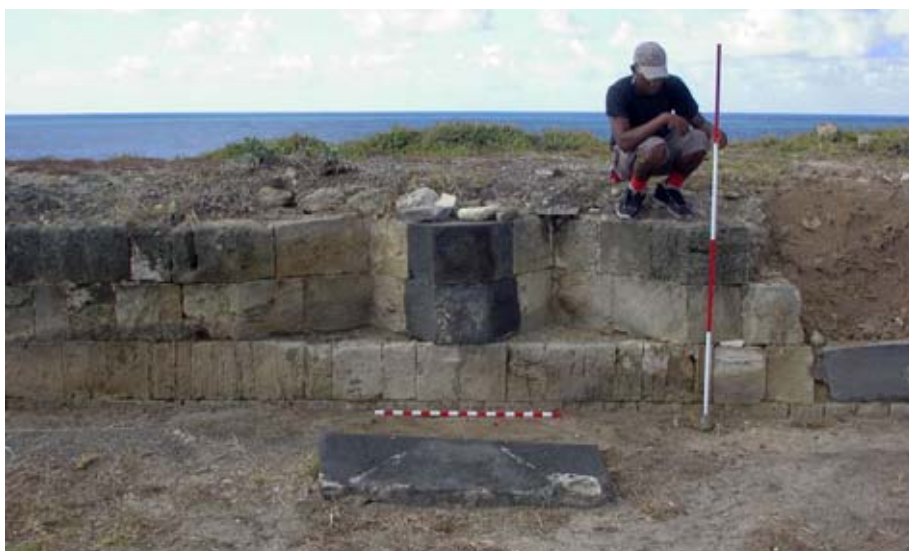
Figure 30: The two central basalt blocks of Emplacement 9 were successfully put back in their original position. (03jv3511)

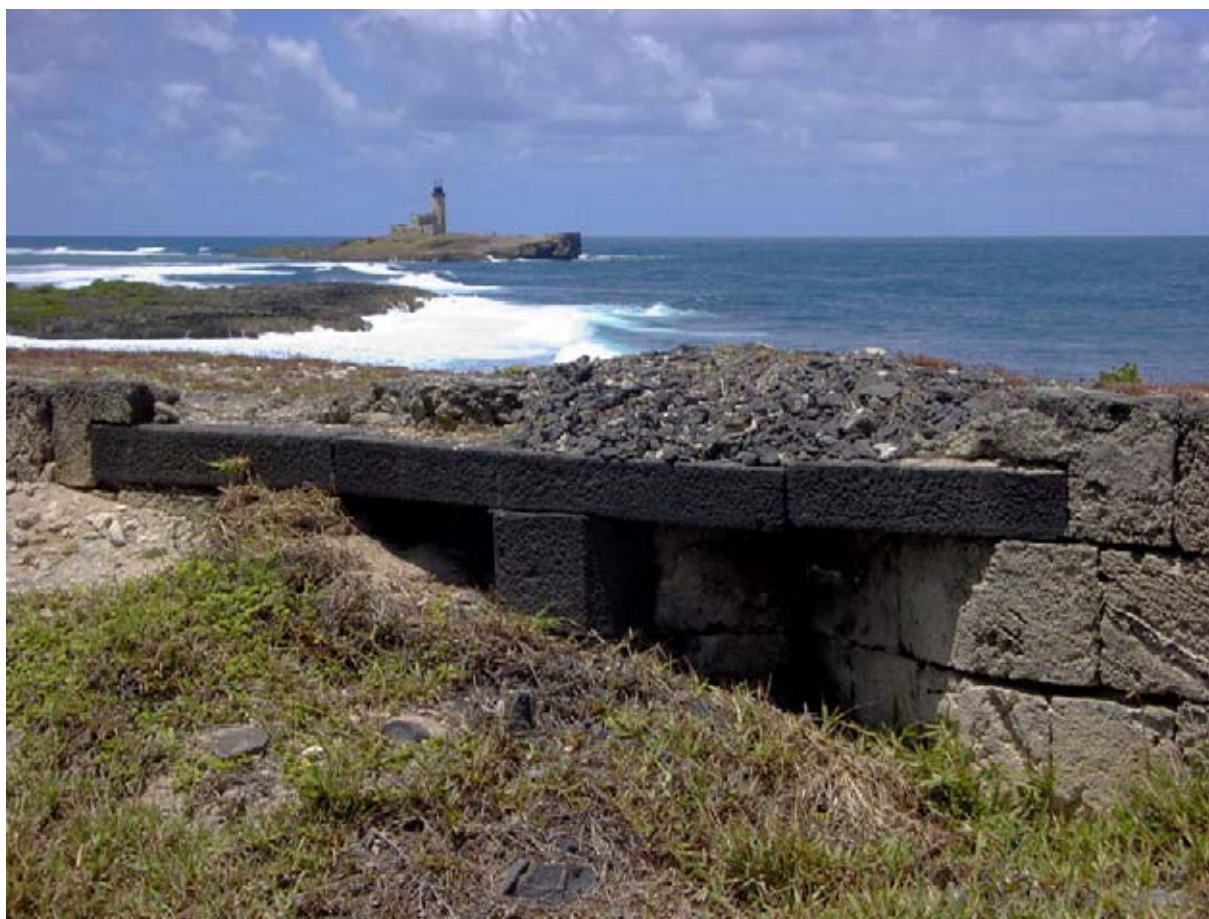
The south-eastern stretch of Parapet Wall contains the most fully preserved Emplacement in which all of the basalt blocks and lintels remain in place. The uppermost course of coral is cut to fit the end of the lintels on each side. Chipped basalt is piled up on top of the lintels. This emplacement is protected by a later bank of coral chips that was thrown up against the face of the Parapet Wall.

Figure 31: Emplacement 11, preserved and partially obscured by a later bank. (03jv2814)

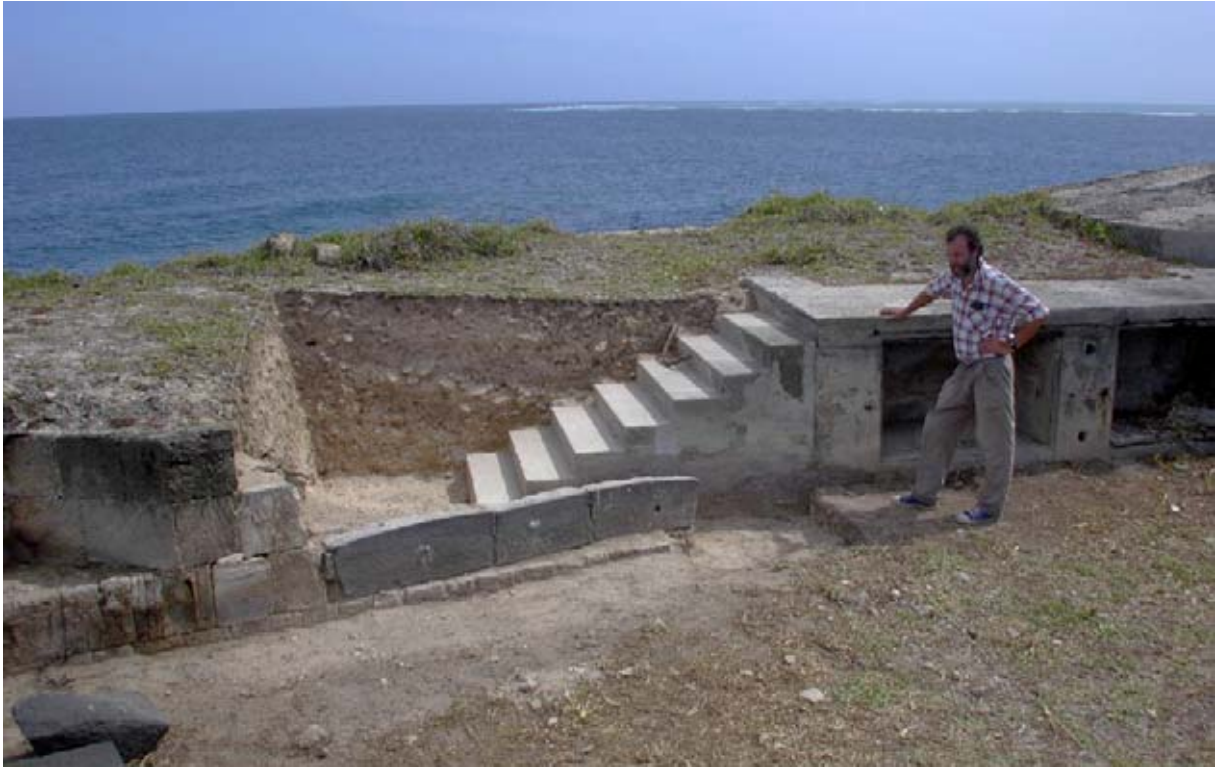
At the southern end of the World War II Battery a flight of seven concrete steps could be seen descending below the top of what appeared to be the Bank (Fig. 32). The steps were cleared but were not found to lead anywhere. It would seem that, whatever purpose these steps were constructed to serve, there was a rapid change of plan and they were buried so as to make the top of the battery level. Perhaps this solution was more practical than building a retaining wall to hold back the bank above them. In any event the filling was retained by three large, reused blocks of shaped and faced basalt, each with a central iron fitting set in led, set on edge. It seems possible that these blocks once formed the horizontal edge of a curvilinear installation of which no other trace has been recognised.

Figure 32: The WWII concrete steps with the basalt feature. (03jv1201)

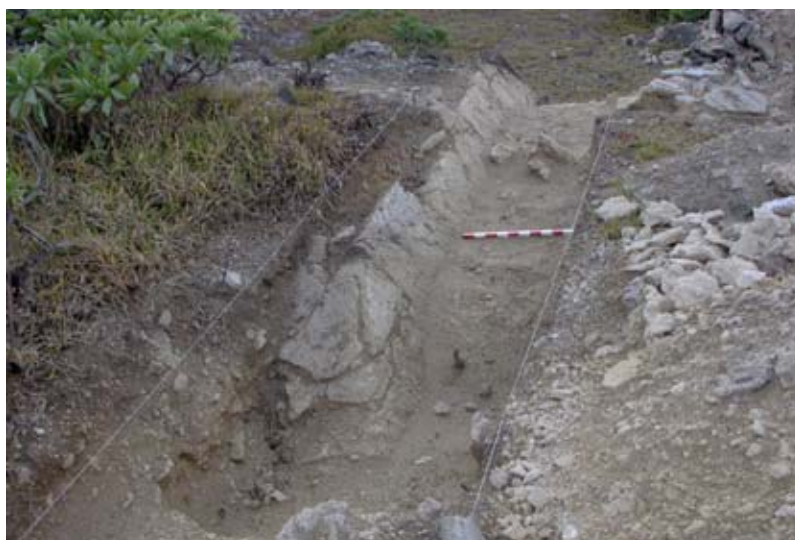
Figure 37: This angled face of coral blocks could prove to be the base for the flagpole depicted on an early French map. (03jv2502)

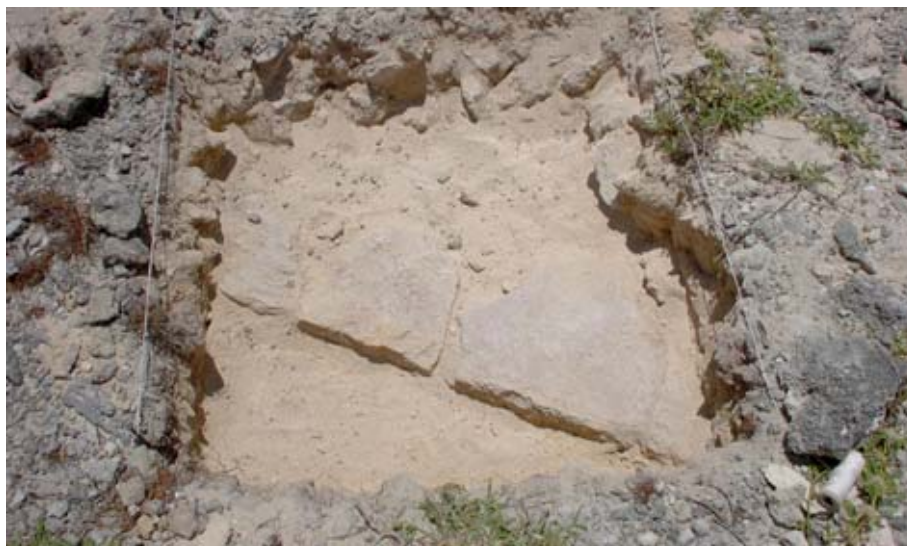
Figure 38: Edge of platform or ramp revealed in Trench 5.

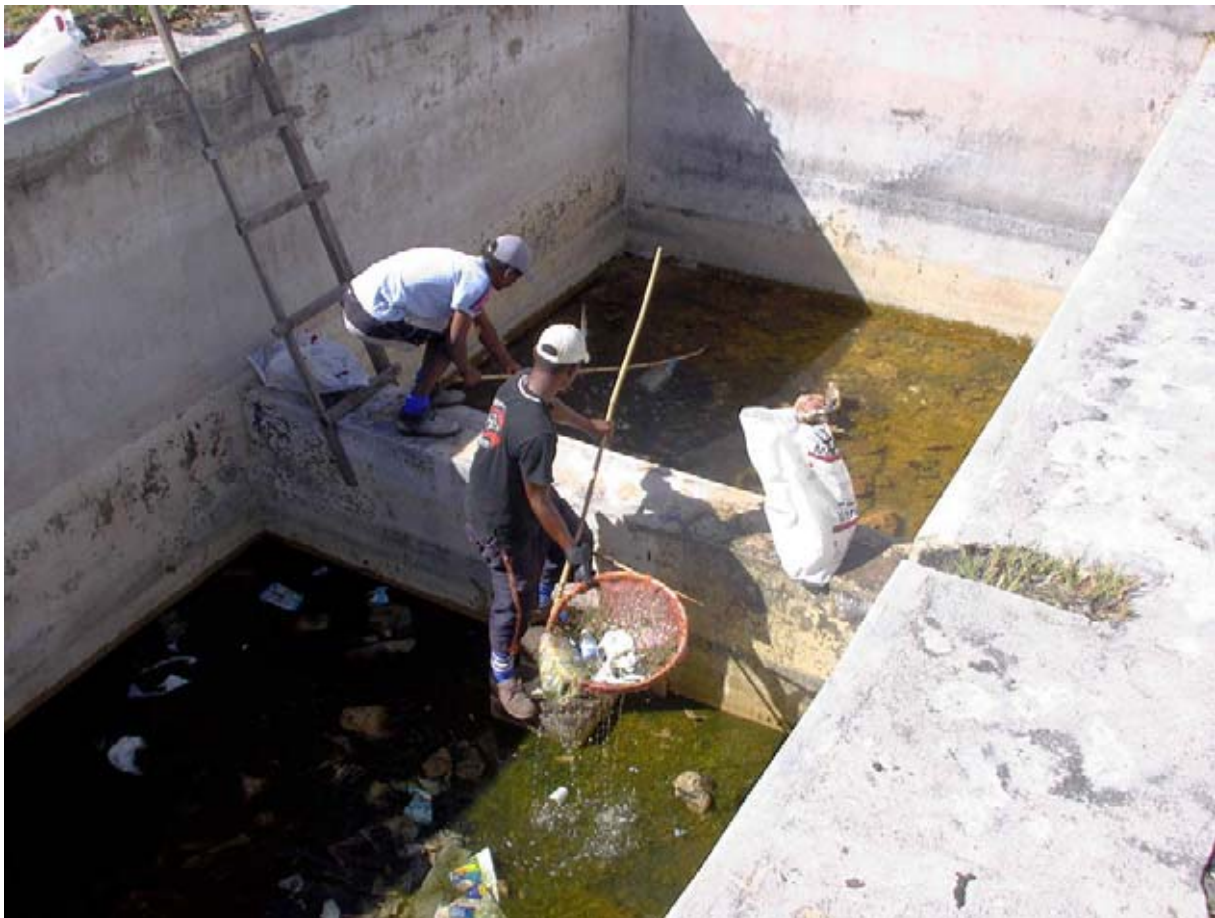
Similar cleaning and gardening operations were undertaken in this area of the islet, including the removal of much really foul material from the cistern for which we particularly thank the workmen. The extent of recent damage, particularly to the cistern, has been made clearer.

Figure 39: Rubbish being removed from the cistern. (03jv1615)

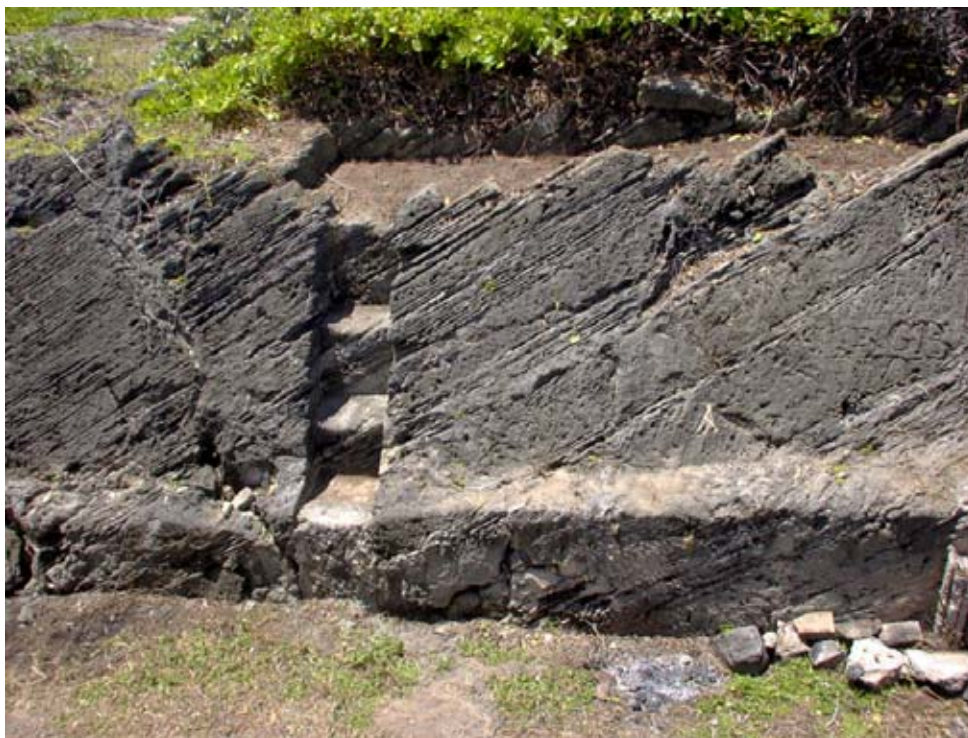
It has become apparent that the large channel which was cut around some two thirds of the top of the Ditch, the north-western end of which terminates in opposed stepped slots, possesses three additional pairs of stepped slots that were regularly spaced. When the Generator Halls were constructed these slots were utilised for the dividing walls between each hall and for the front wall. These observations explain the lengths of the halls.

Figure 42: Rock-cut channel and stepped slot, possibly associated with a pre World War II roof. (03jv2903)

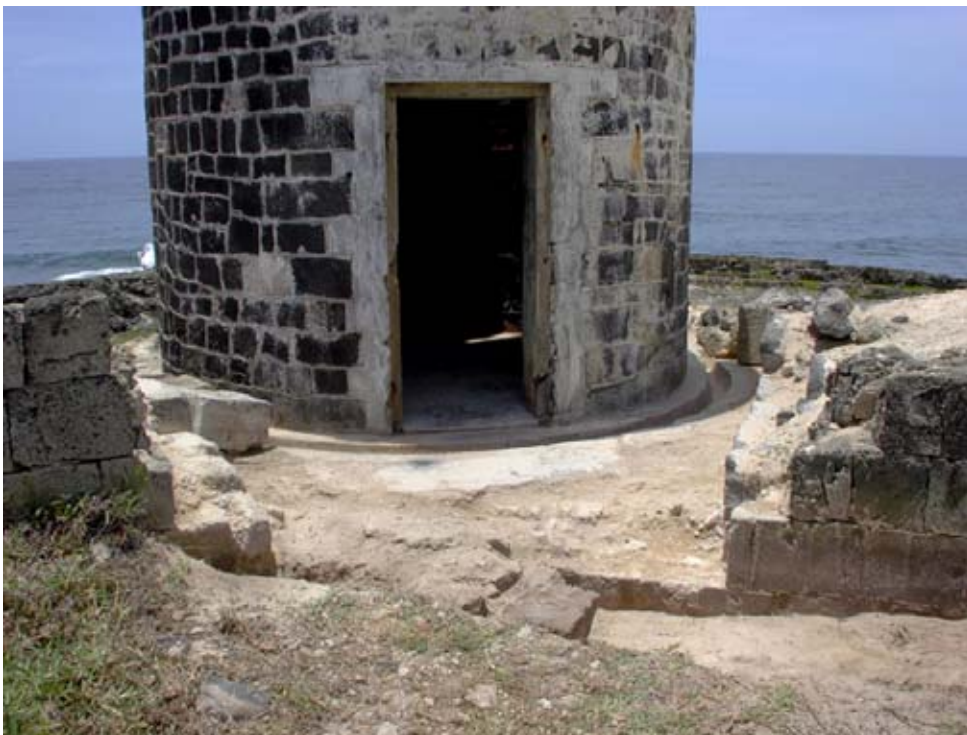
Figure A: Features at the base of the Observation Tower. (03jv1009)

1. The World War II cement screed surface and surrounding drain (Figs A & B, and the "water channel" on Fig. 16) should be retained if this can be made compatible with other constraints. We see no reason why the existing surface need be removed and the existing cement appears to be in excellent condition. If there are to be large-scale building works it might be very advisable to cover the surround and drain with sand or some other suitable material to protect it from scaffolding feet and falling concrete.

2. The edging or surround at the back (south-east) and the rear sections of the sides of the original (lime and basalt chip) concrete should be repaired. The original surface, on which the Tower is founded, ought to be preserved.

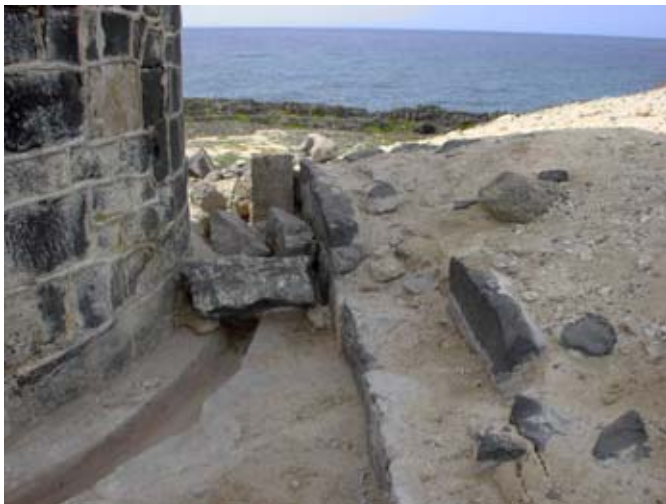
Figure B: Displaced basalt blocks, the basalt retaining wall and the eroded bank on the north-west side of the Observation Tower. (03jv0915)

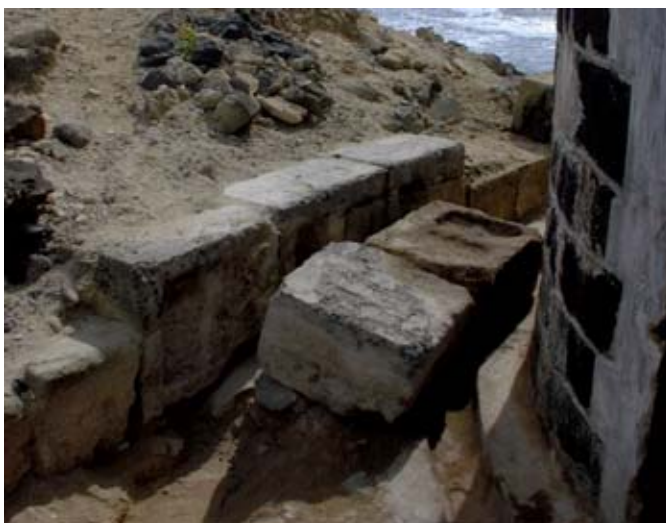
Figure C: World War II precast hollow concrete blocks were used to retain the bank on the north-east side of the Observation Tower. The two fallen blocks seen here, together with others now lying at the foot of the bank, could be put back on the retaining wall. (03jv0913)
