# ARCHITECTURAL AND ARCHAEOLOGICAL STUDIES AT ILE DE LA PASSE

## MAURITIUS

### REPORT ON THE 2004 SEASON OF FIELDWORK

**The Archaeology, Architecture and Conservation of an Historic Islet.**

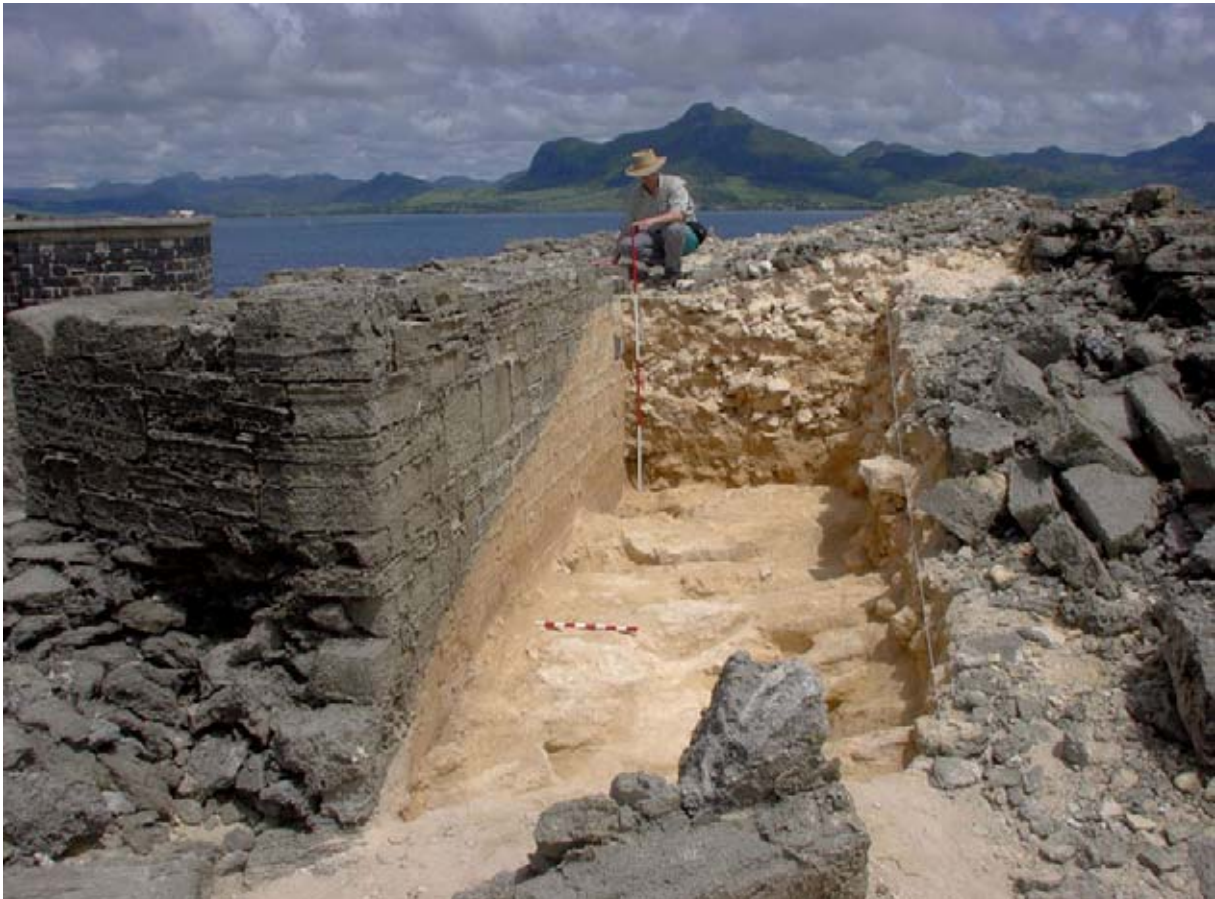
*Figure 1. Excavation of Trench TR09 at the Lower Battery. (04jv1103)*

Excavation of trench TR9 at the northern end of the Lower Battery (Figs 1, 5 and 13) revealed the inner face of the original battery wall (A3) and precisely half of the south-eastern blocked gun emplacement. It was unrewarding that no significant discoveries were made.

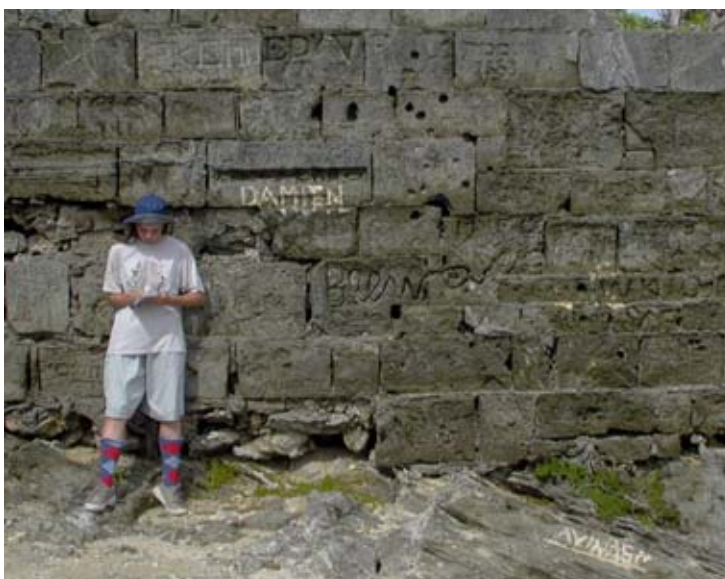
*Figure 7. Freshly scrawled graffiti by the Landing Place stand out as bright white scars on the darkened coral. (04jv0414)*

Of particular concern, however, was that yet more damage had been done to standing structures as a result of cooking-fires having been lit against walls and inside buildings. While the extent of this damage is not in itself disastrous, with the possible exception of the very important Hot Shot Furnace which continues to be used for fires, the accumulative effect is substantial and will soon result in the loss of graffiti, some of which have not inconsiderable historical importance for Mauritius. Besides this loss, fire damaged wall faces will be both difficult and expensive to repair. New graffiti (Fig. 7) standing out as bright white scars on the darkened coral is also to be deplored.

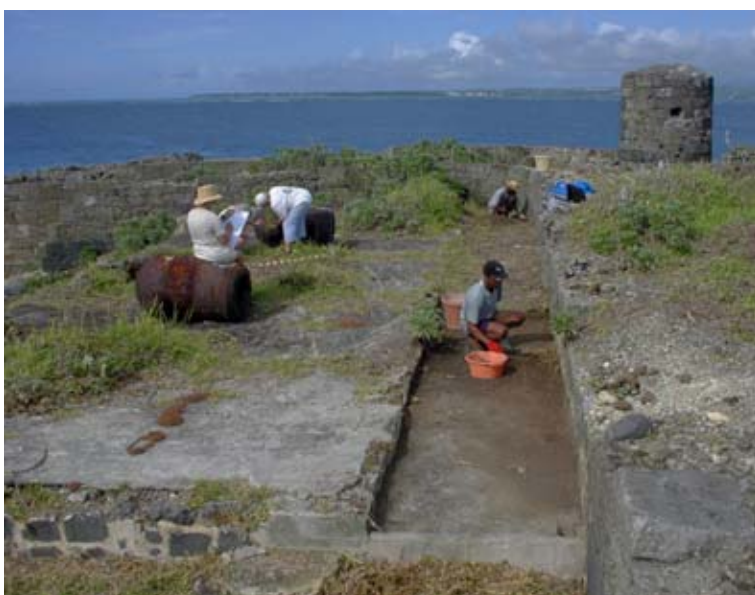
*Figure 12. Clearing between Wall G of the NW Battery and WW II Structure 23 revealed a corridor with post holes, indicating covered access to the rooms. The iron mortars, recently placed on the floor, were measured and drawn. (04jv1201)*

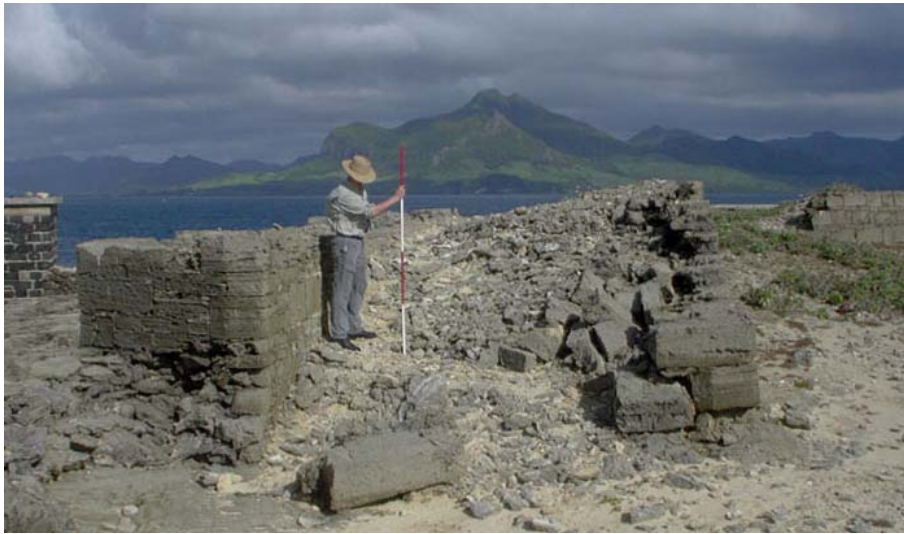
*Figure 13. Brad at the northern end of the Lower Battery showing the ramp before excavation of trench TR9. (04jv0102)*

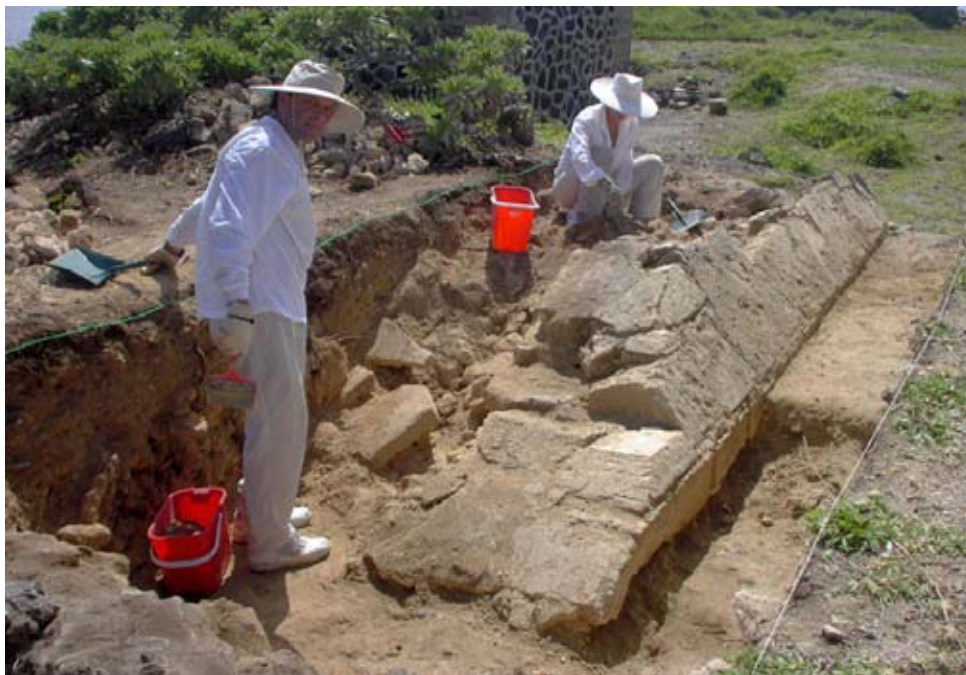
*Figure 14. Mark and Rosanne excavating in trench TR3. (04jv1808)*

At the Central Platform (Structure 13 also shown on Fig. 10) the extension of trench TR3 (Fig. 14), begun in 2003, together with excavation of trench TR7 confirmed that there were a minimum of two phases to this built feature. This result added very considerable weight to the interpretation that we are here dealing with carefully constructed platform that supported flagpoles or masts for signalling.

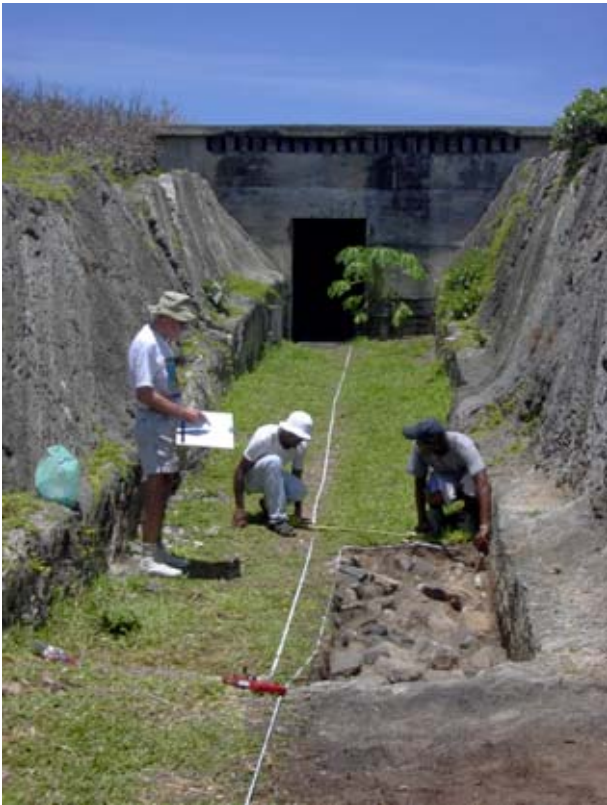
*Figure 17. Rudy and Vickram, helped by a workman, drawing the top of the stone fill of trench TR12 in the enigmatic Ditch. The entrance to the Generator Hall can be seen in the background. (04jv2021)*

Trench TR12 (Fig. 17), in the base of the ditch, showed that the feature was never completed but also, somewhat disappointingly, that it had been completely cleaned out in World War II.

Trenches TR13 and TR14 confirmed the dimensions of the channel around the top of the Ditch and provided some support for the idea that this was a secondary feature associated with a roof. It is likely that this channel belongs with the Observation Tower and associated structures, and should therefore be dated to late 19<sup>th</sup> or early 20<sup>th</sup> century.

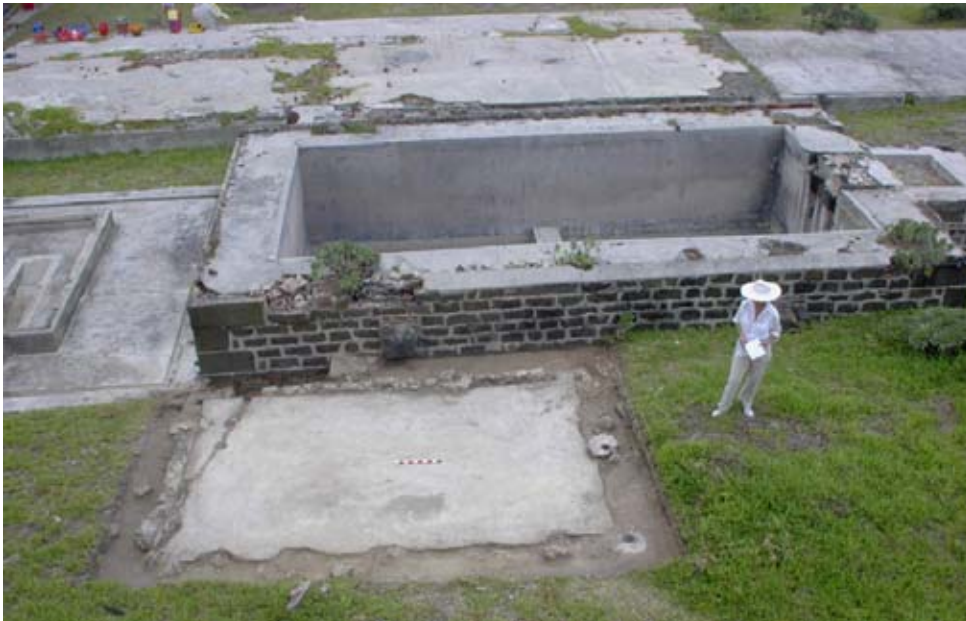
Structure 32 (Fig. 19), adjacent to the Cistern, appears to have a cement floor laid over an earlier structure. Once completely exposed in trench TR10, the remains were photographed and planned.

*Figure 19. Structure 32 uncovered in trench TR10. (04jv2415)*

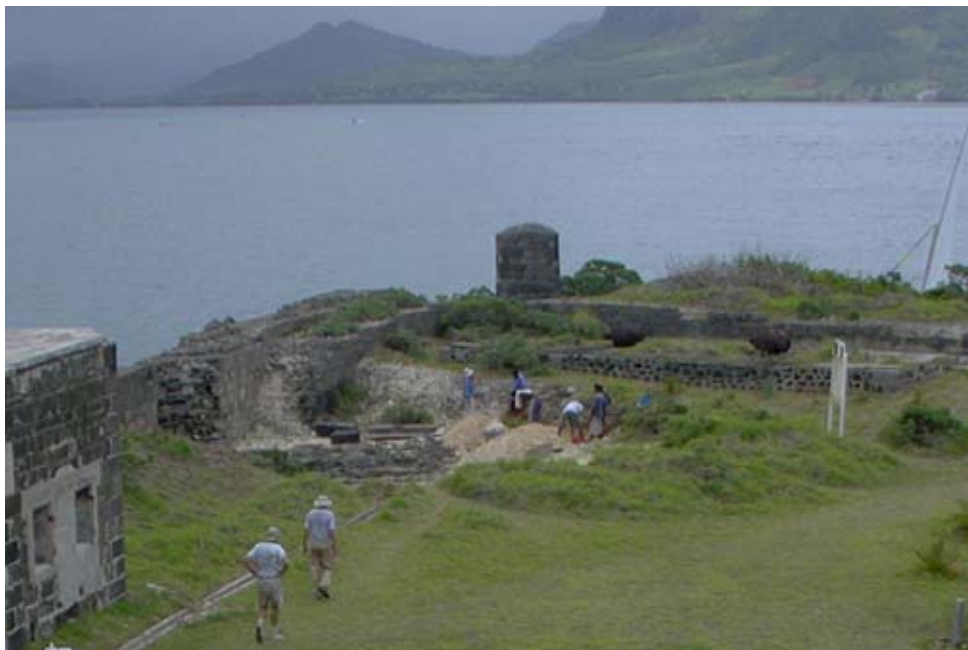
Trench TR11, in the north-western sector of the islet (Fig. 20), was begun because traces of walling could be seen emerging from the eroding scarp. Very limited excavation revealed some evidence of stratigraphy in which burnt features can be seen. Charcoal and bone is also well preserved, although very fragmentary. This area will be a focus of research in 2005.

*Figure 20. Trench TR11 investigated stratigraphy associated with Structure 33 seen in an eroding scarp. (04jv2417)*

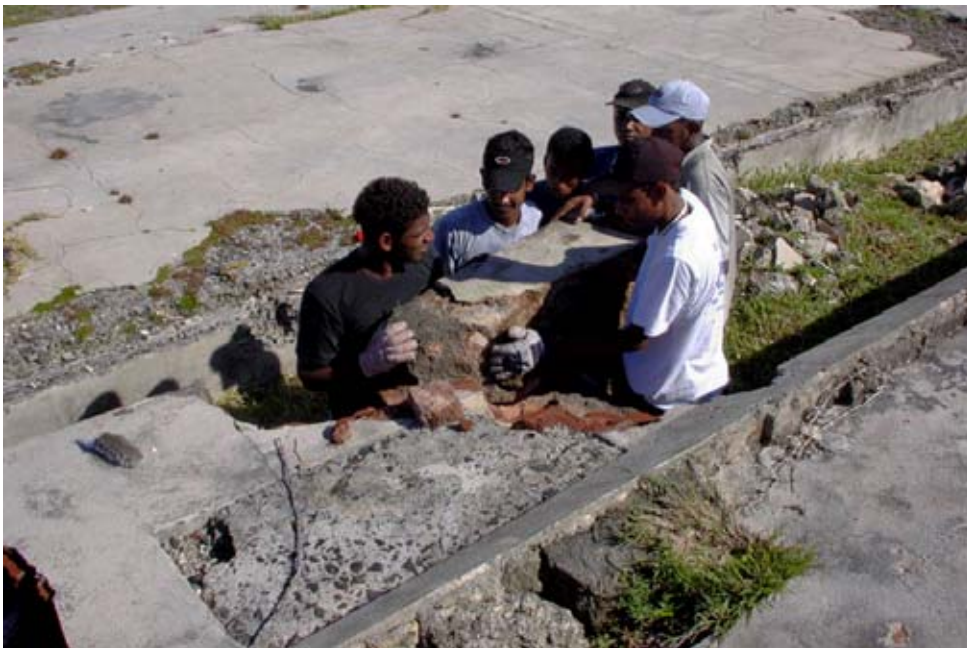
*Figure 21. The workmen uniting efforts to put back a large basalt block dislodged from the settling tank of the Cistern. (04jv0905)*

Essential conservation work (Fig. 21) to prevent further degradation and deterioration was also carried out. The islet attracts many visitors and it is essential that campers are deterred from dislodging stones to use for anchoring temporary shelters.

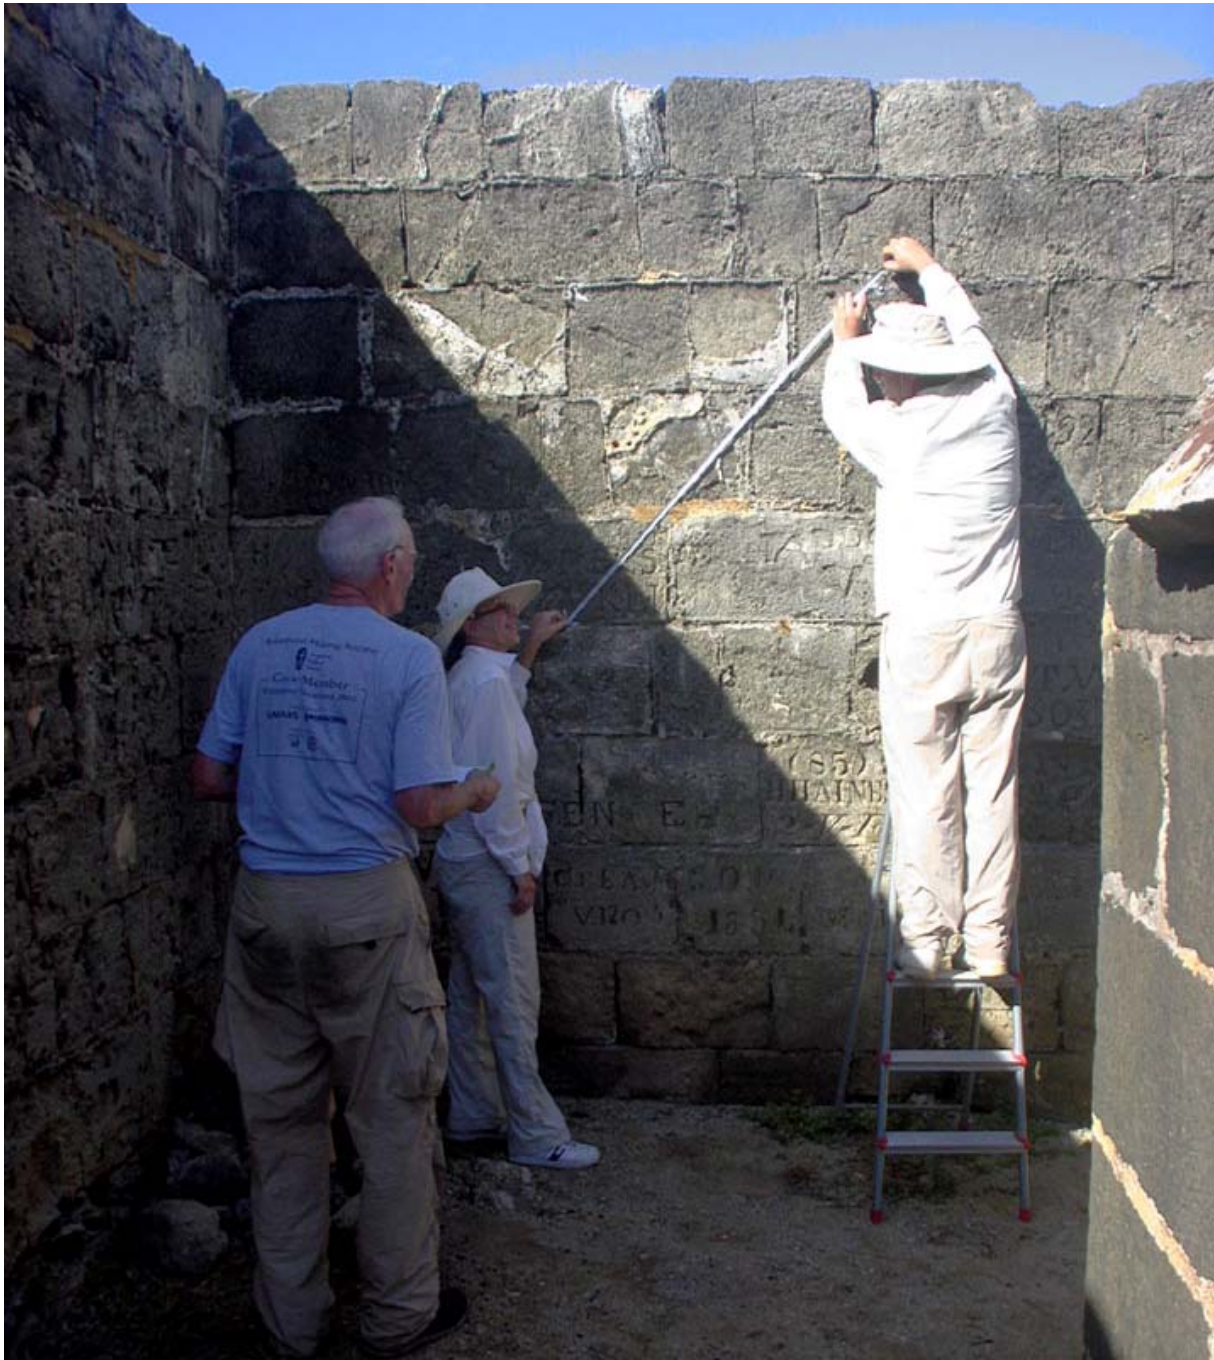
*Figure 23. Rod, Rosanne and Mark measuring control points needed for the rectification of digital photos. Graffiti on the enclosure wall of the Powder House is being recorded and drawn using this technique. (04jv2111)*

Systematic recording of graffiti (Fig. 23) continued at the Powder House. This represents the greatest challenge because of the restricted distance between the inner faces of the Enclosing Wall and the Powder House itself. A good start was made, but it is clear that systematic coverage will require several stepladders and planks, a number of individuals and not inconsiderable patience and dedication!

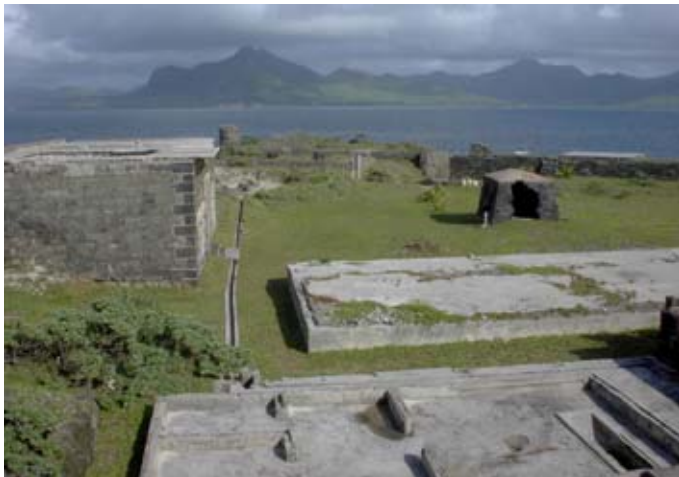
*Figure 26. The northern area of the islet after the grass was cut. The WW II drain running from the Cook House, (Structure 6), was emptied and cleaned. (04jv1401)*

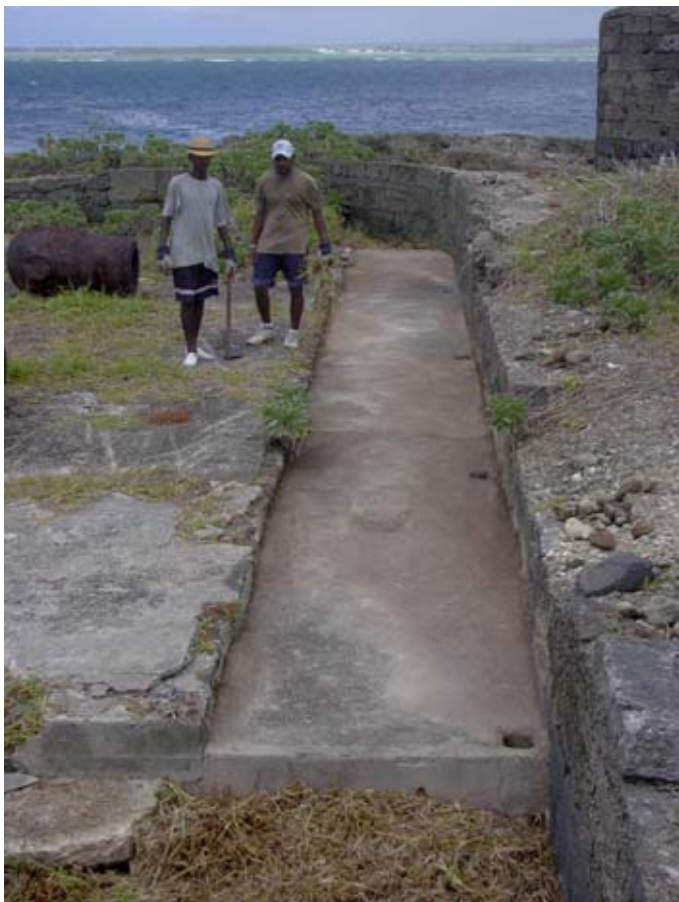
*Figure 27. The corridor at the front of Structure 31 built against the earlier Battery wall. Post holes indicate that it was roofed. (04jv1220)*

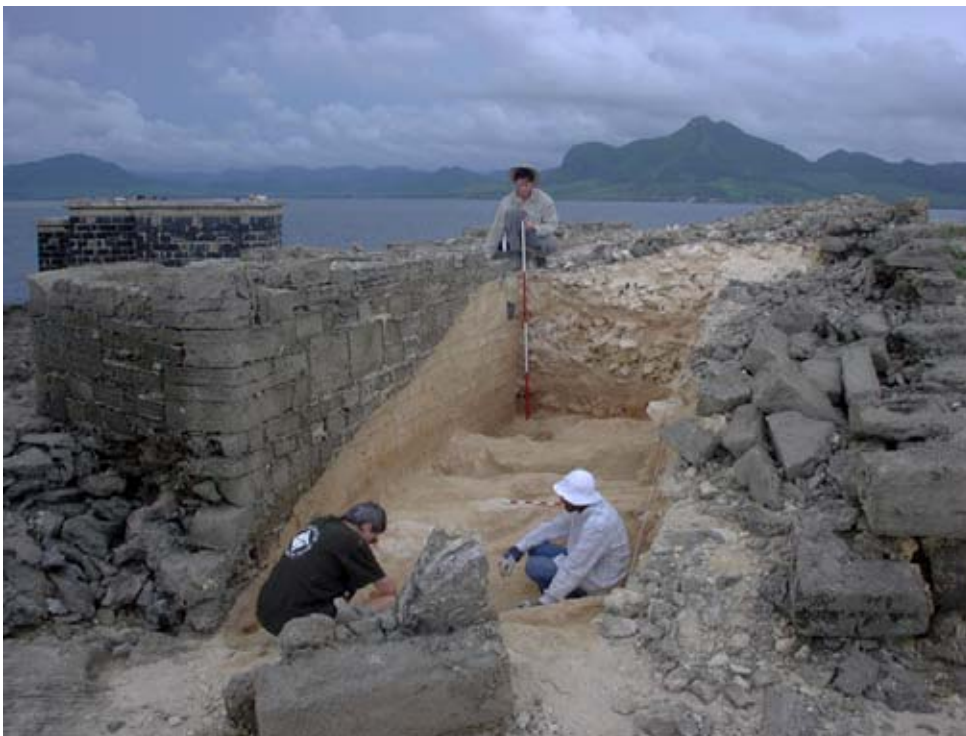
*Figure 32. Trench TR9 at the end of the excavation. At front left is the one extant side of the embrasure at the south-east end of Lower Battery Wall A2. Brad, holding the scale, has his right hand on the top of the blocking of the next embrasure which is bisected by the section. (04jv0803)*

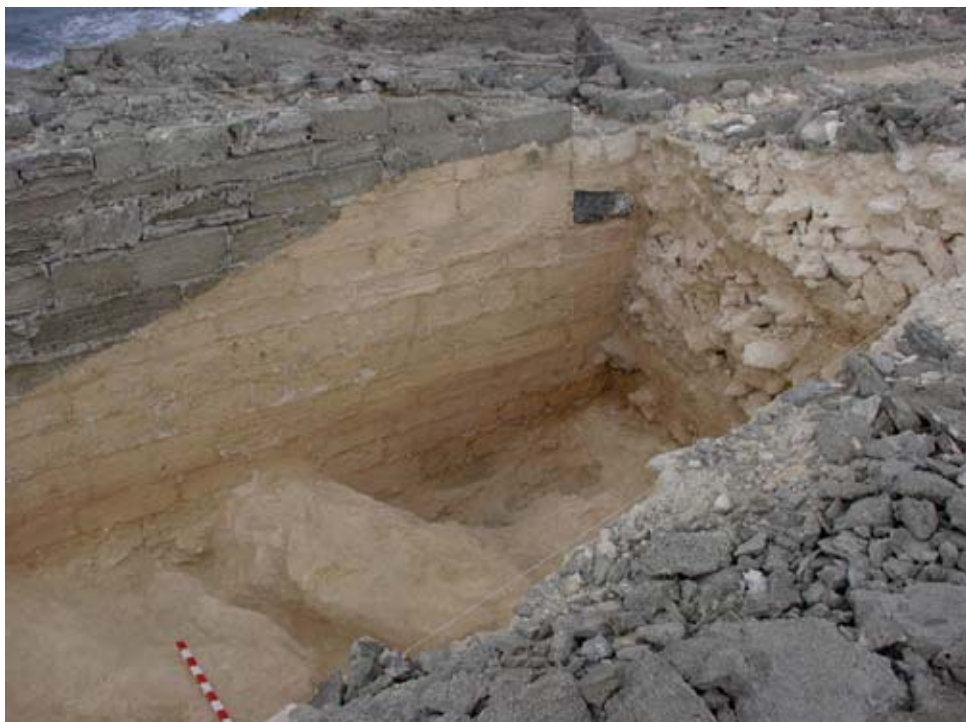
The basalt block in the wall face in Figure 33 is in the bottom left-hand corner of the blocking. Wall D3, constructed from spolia robbed out from Lower Battery wall A3 and including a large portion the missing side of the embrasure opposite, is partially seen at left in Figure 32 and more clearly in Figures 5 and 13. The surface on which the guns would have stood can be seen in the section (Fig. 34), but no trace could be found of wooden decking.

*Figure 33. TR 9 after excavation showing the blocking of the embrasure. (04jv0810)*

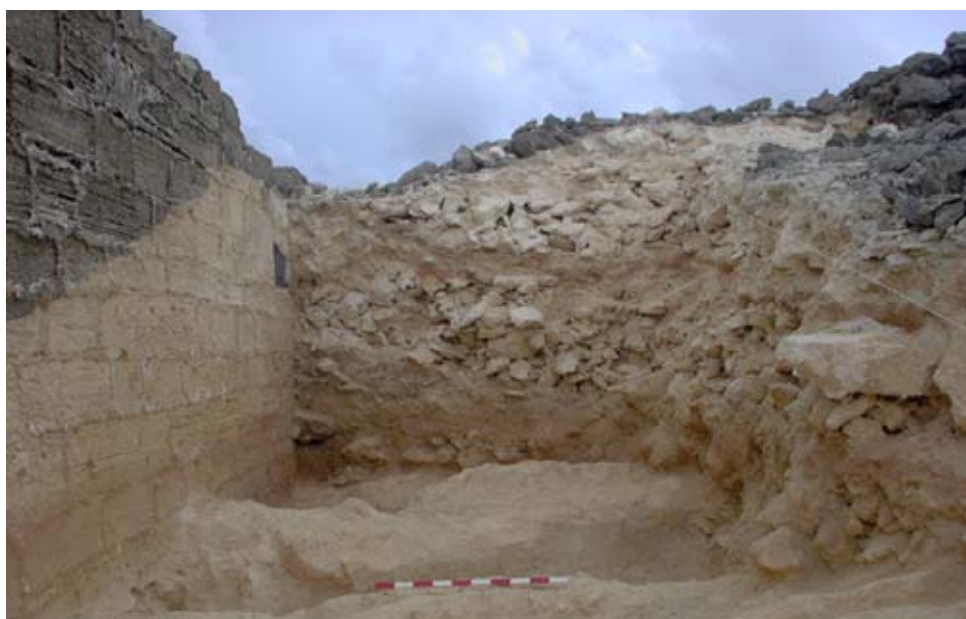
*Figure 34. The trench section clearly shows the different surfaces and layers. (04jv0808)*

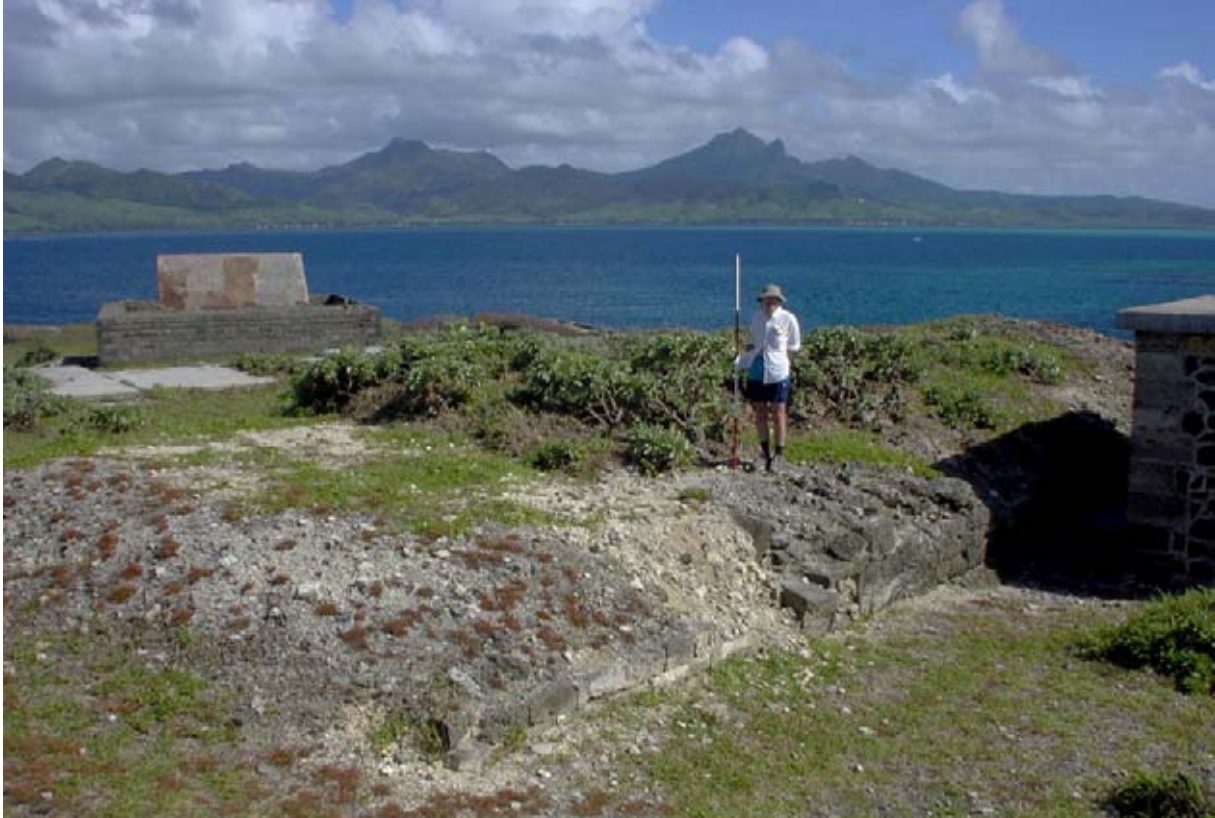
*Figure 35. George standing on the Central Platform with a 2m scale before the re-excavation of trench TR3. (04jv0115)*

Excavation started at the Central Platform (Structure 13) began by emptying out and extending TR3, which had been backfilled at the end of the 2003 season. A 1m wide trench, TR7, 1m wide, was positioned 5m to the north of TR3 in an attempt to locate a flagpole installation shown on the earliest map (Fig. 31).

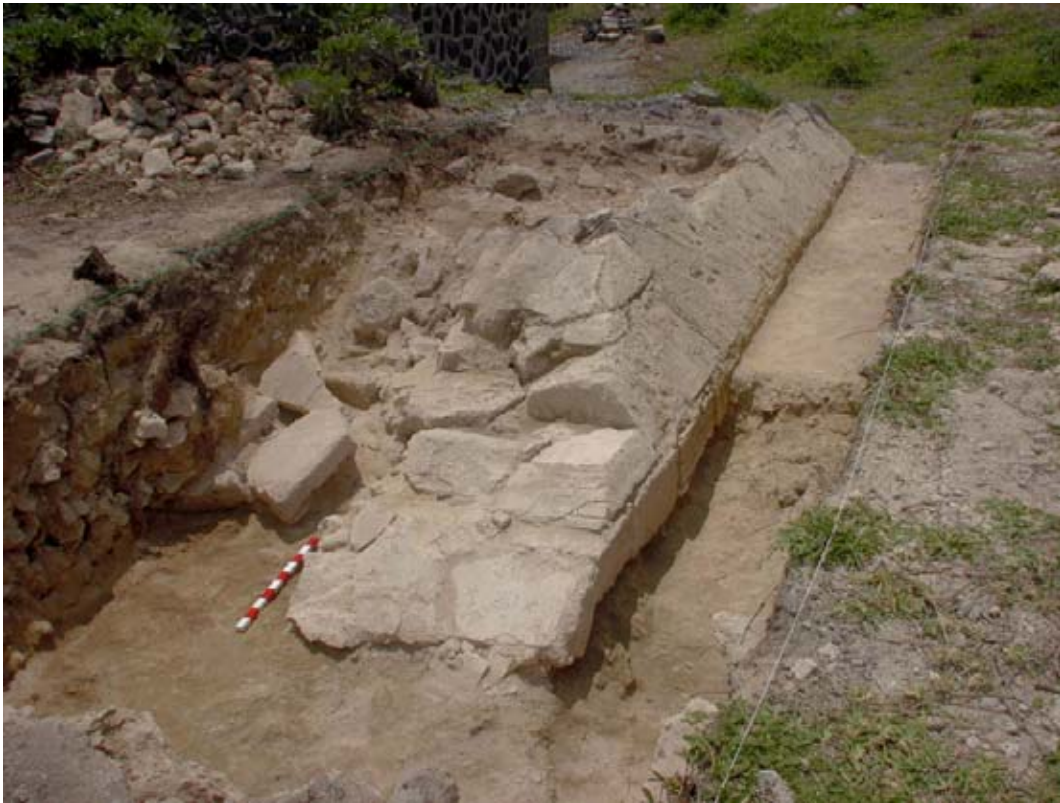
*Figure 36. Trench TR3 looking north showing the angled masonry of the earlier phase of the Central Platform. (04jv2314)*

It was found that only the upper course of the south-west side was bevelled while the entire north-west side was inclined at a shallower angle. There is no ready explanation for these bevelled sides. The extension was found to be of inferior workmanship, the north-western face being constructed of uncut stones (Fig. 38) while the south-eastern face was of poorer workmanship, using smaller stones, than that of the earlier phase (either side of trench TR3 on Figs 35 and 37). The south-western face of the extension no longer exists, perhaps having been cut away when the Upper Battery was constructed or modified.

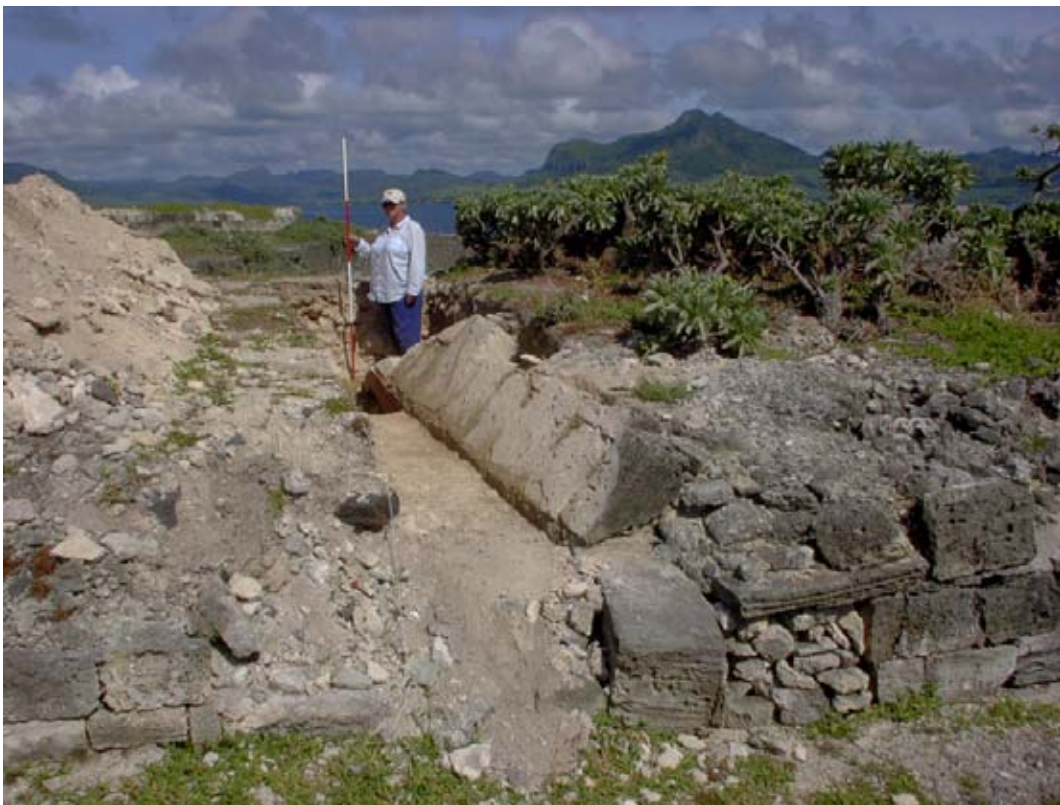
*Figure 37. Mary holding the 2m scale in trench TR3. (04jv0701)*

The results confirmed that there were a minimum of two structural phases, the earlier platform being extended to both the north-west and the south-west. The extension had covered and preserved the carefully cut and fitted coral blocks that formed sloping north-western and south-western sides (Figs 36 and 37).

The excellent quality of the lime-mortared masonry indicates French work, a conclusion completely in accord with the archival evidence as seen, for instance, on the map reproduced as Figure 10. The uppermost edge of the topmost surviving stone on the north-west face is at an angle (Figs 36 and 37), giving reason to think that the platform was originally at least one course higher. No trace remains of the original surface and there is no indication of the original height. The date of the extension is uncertain, and there is no indication as to how the extension relates to the phases revealed in trenches TR4 and TR5 dug in 2003.

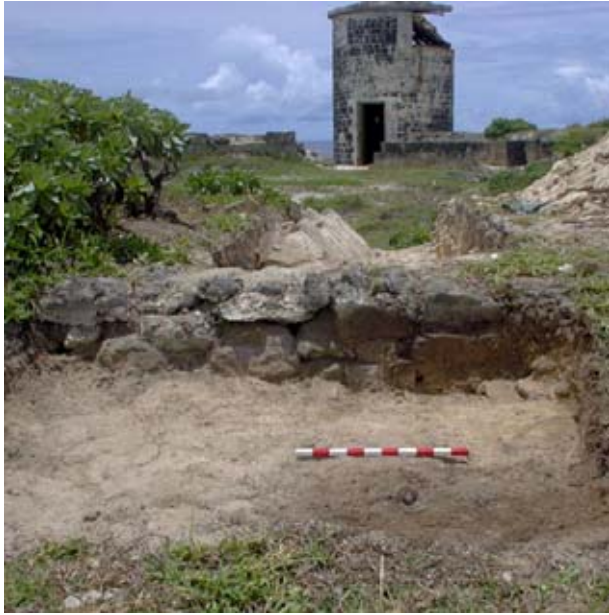
*Figure 38. Trench TR3 showing the outer face of the north-western extension to the Central Platform. An iron shot can be seen in front of the 1m scale. (04jv0607)*

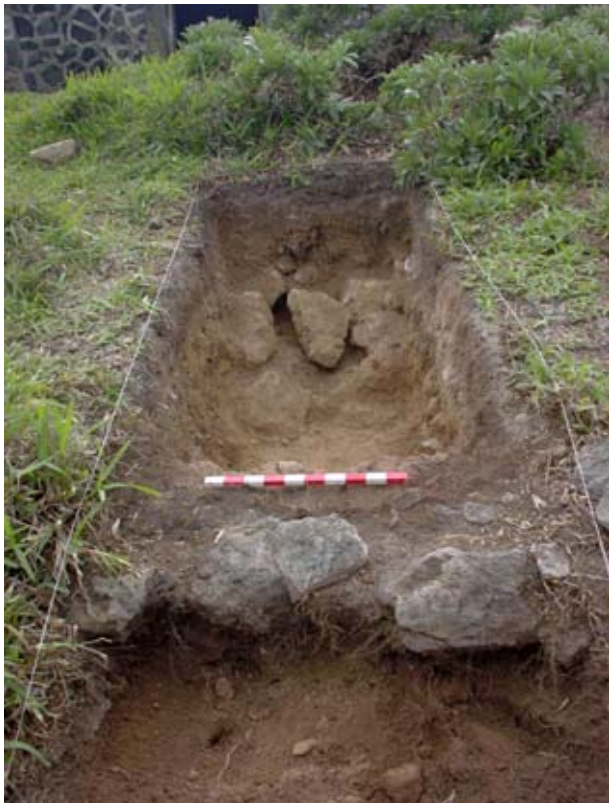
In trench TR7 it was found that the structure was completely ruinous (Fig. 39). No trace was found of the flagpole installation shown on the first maps of the French period.

*Figure 39. In trench TR7 the Central Platform was found to be ruinous. (04jv0714)*

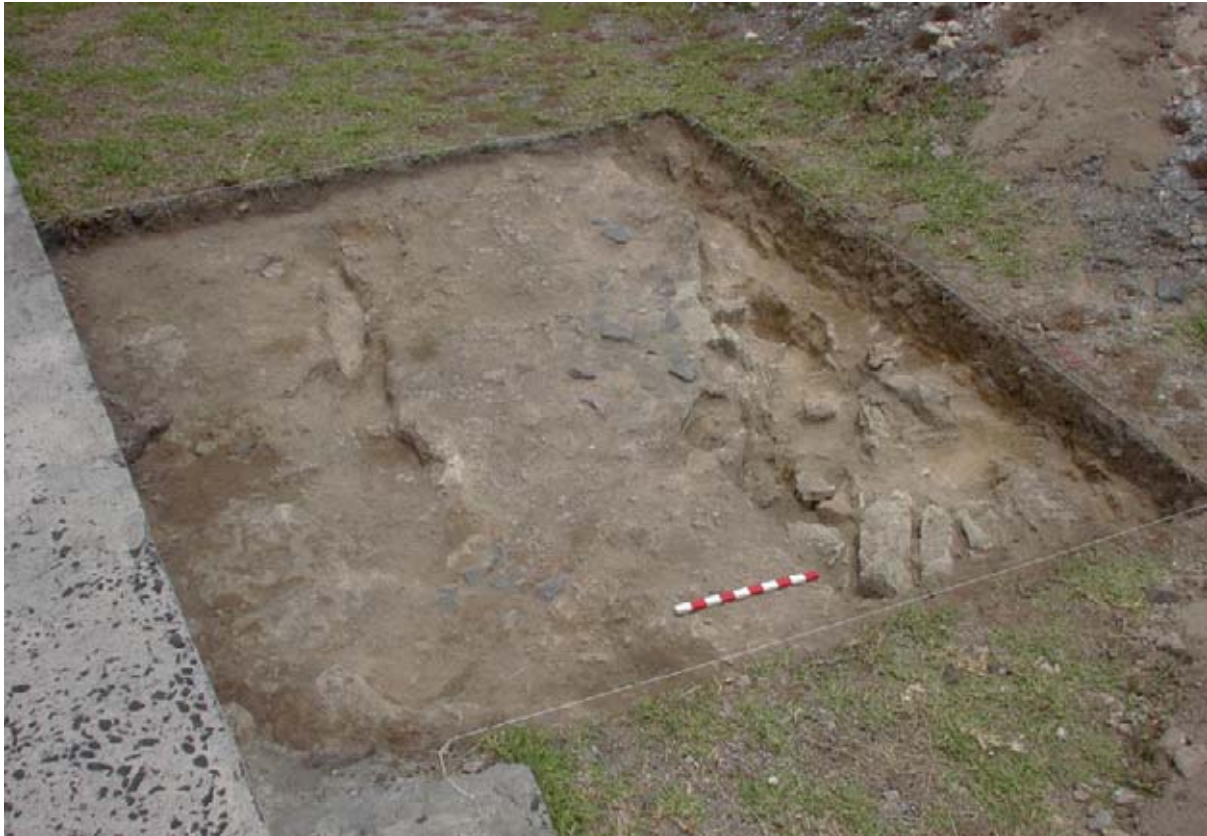
*Figure 42. Trench TR8. The scale is 1m long. (04jv2324)*

For this purpose trench TR8 was laid out behind Emplacement 7 (Fig. 31). There was found to be very little deposit behind the parapet wall, the coral bedrock being reached very quickly. Evidence came in the form of a curved depression with a radius of 7m, the centre of which is at the centre of Emplacement 7 (Fig. 42). The basalt sill of this Emplacement is extant behind the WW II concrete battery (Fig. 31). This arc, of which the eastern half was excavated up to the point where it is covered by WW II concrete, forms an edge to, or a depression in, a bed of basalt chips and lime mortar and the soft coral bedrock.

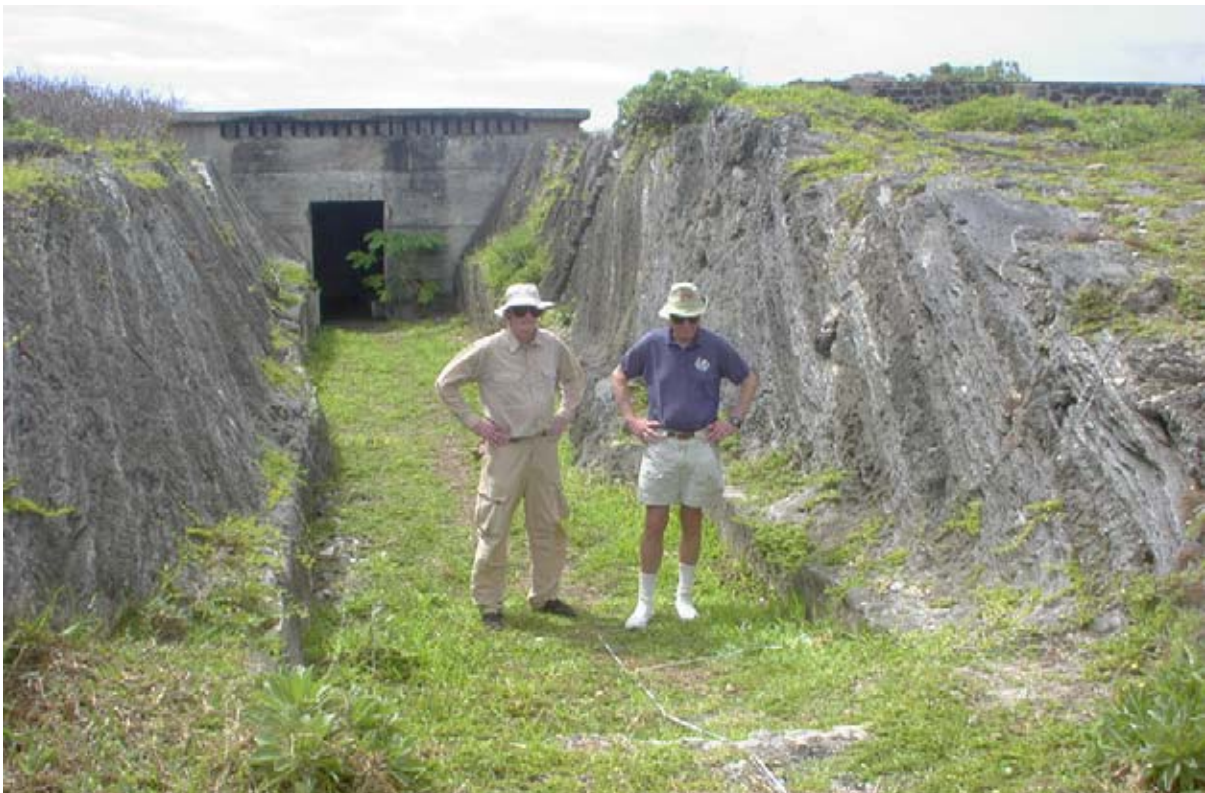
*Figure 43. Rod and Rudy laying out trench TR12 in the ditch with the Underground Generator Halls behind. The trench was positioned to investigate the step in the base of the Ditch and excavation was made on the south-eastern side because there was evidence than a WW II cable had been laid on the other. (04jv1410)*

Excavation in trench TR12 (Figs 43, 44, 45, 46, 47 and 48) confirmed that the cutting of the ditch was abandoned before the scheme was complete. This is demonstrated not only by the different elevation of the flat base of the Ditch, but also by the observation that a portion of the exposed vertical side was also left undressed. Disappointingly, it was revealed that the part which was selected for excavation had been completely cleaned out in the 20<sup>th</sup> century, presumably when the generator halls were constructed within it. There is every reason to suppose that the entire ditch was cleaned at this time, with the result that no early deposits would be found by extending the trench. Pieces of WW II corrugated sheets were found laying directly on the base of the ditch. Most of the fill comprised stone rubble which perhaps came from demolition of some earlier covered structure associated with the channel and, as has been argued in earlier reports, might very possibly belong the scheme of construction that included the original phase of the Observation Tower, the Central Building and the Searchlight Building. Evidence to directly support this interpretation was not, however, forthcoming.

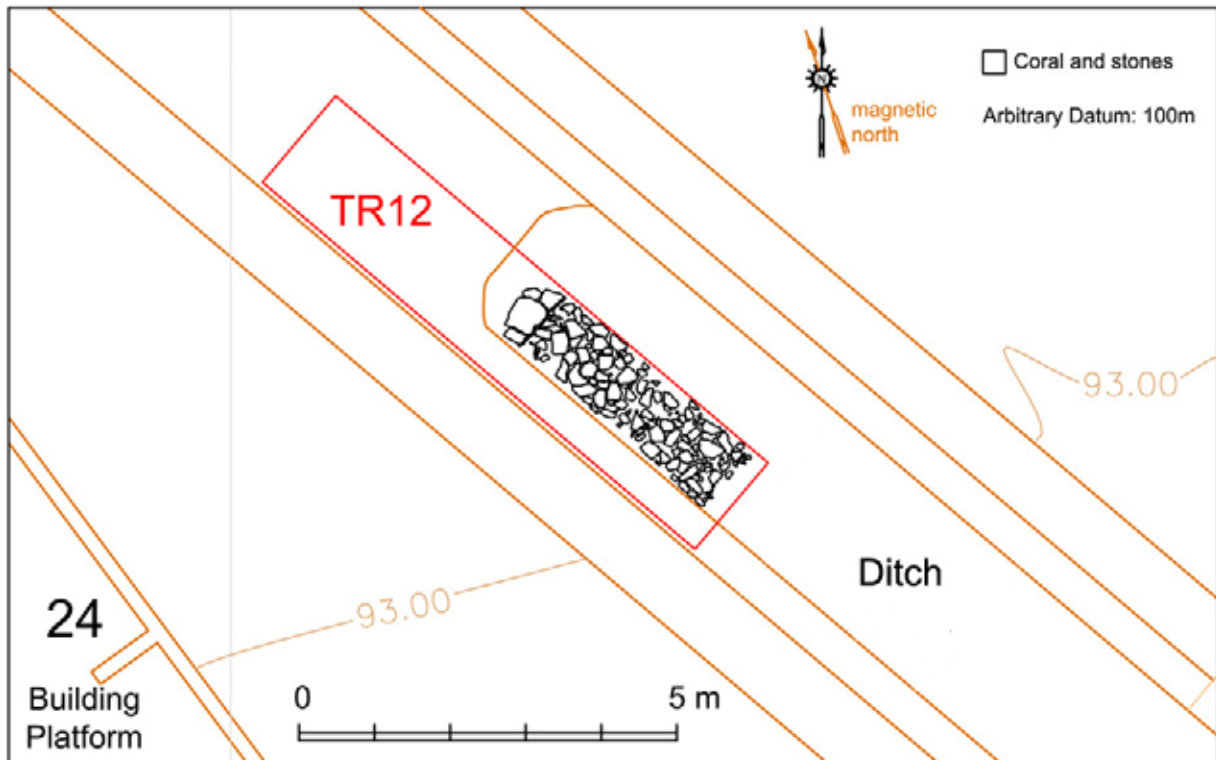
Figure 44. Plan of the of the rubble fill in trench TR12 with a crude step at the north-west end.

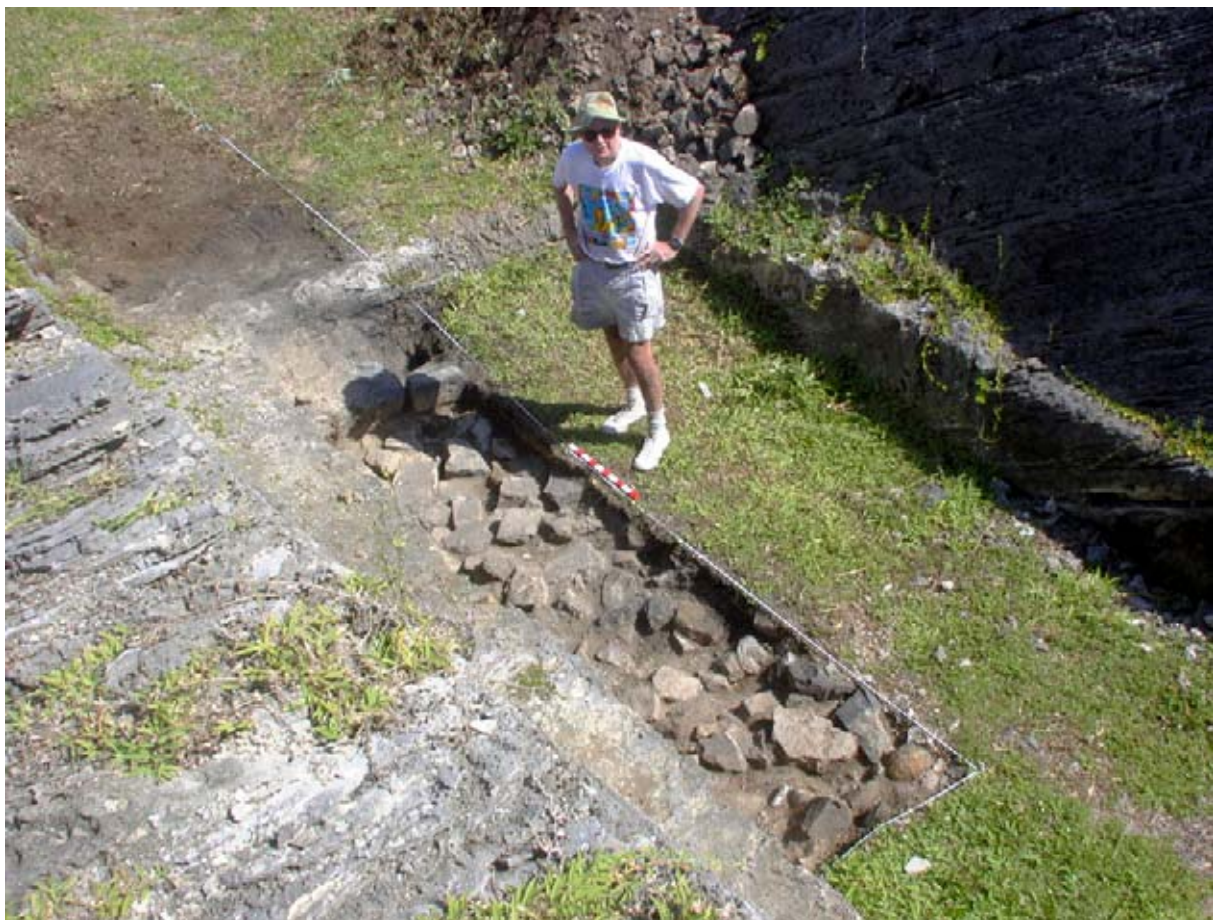
Figure 45. The top of the rubble fill in trench TR12. (04jv1701)

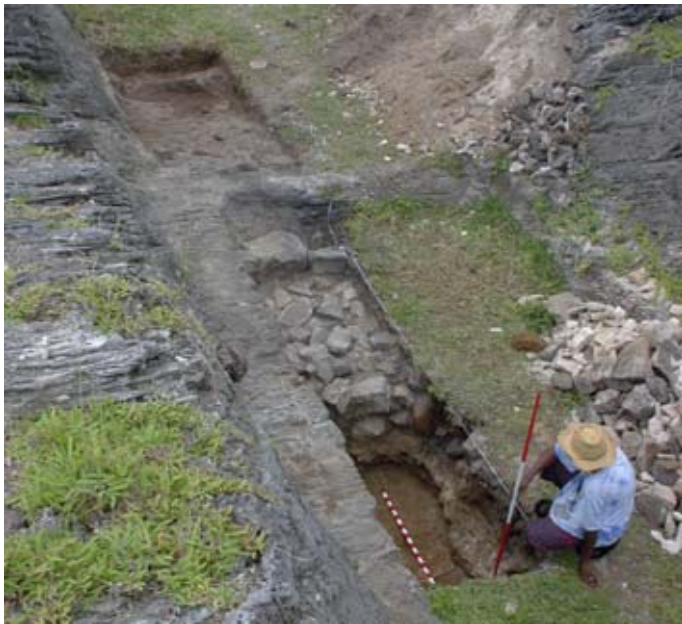
*Figure 46. Once it was discovered that there was WW II corrugated sheeting in the bottommost fill of trench TR12, it was decided not to continue further. (04jv2007)*

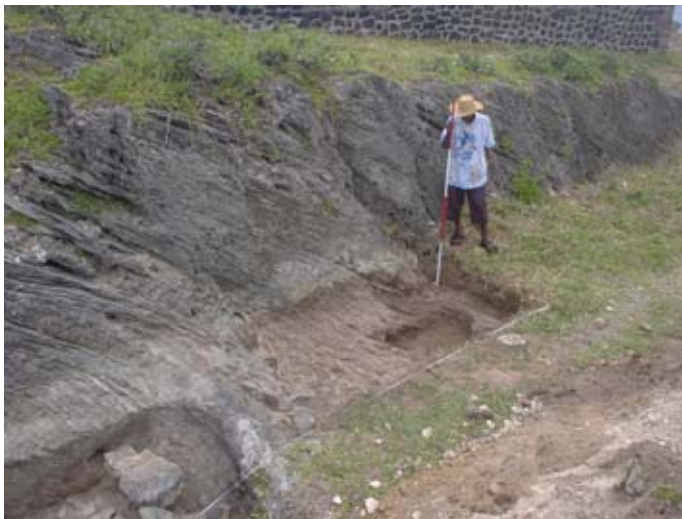
*Figure 47. The base of the ditch stepped down, the higher part at the north-western end being unfinished. (04jv2009)*

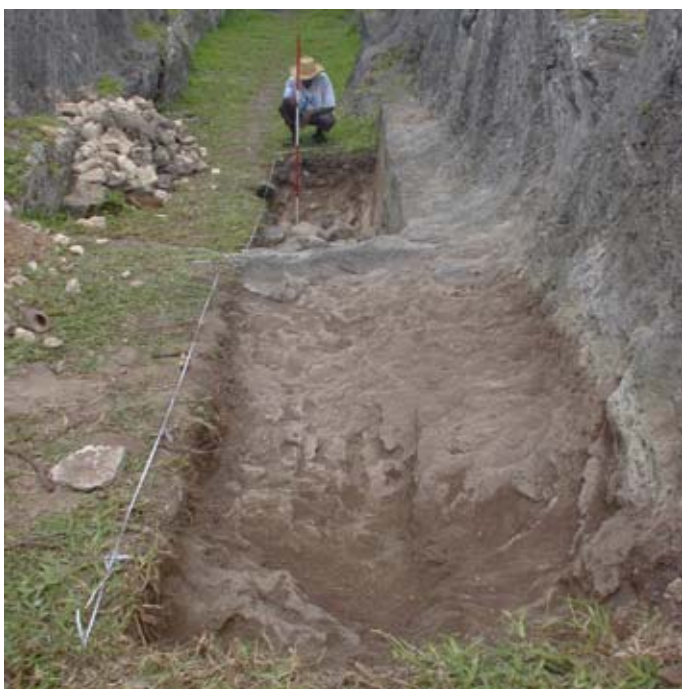
*Figure 48. The line of the unfinished ledge at the end of the trench can be clearly seen from this angle. (04jv2011)*

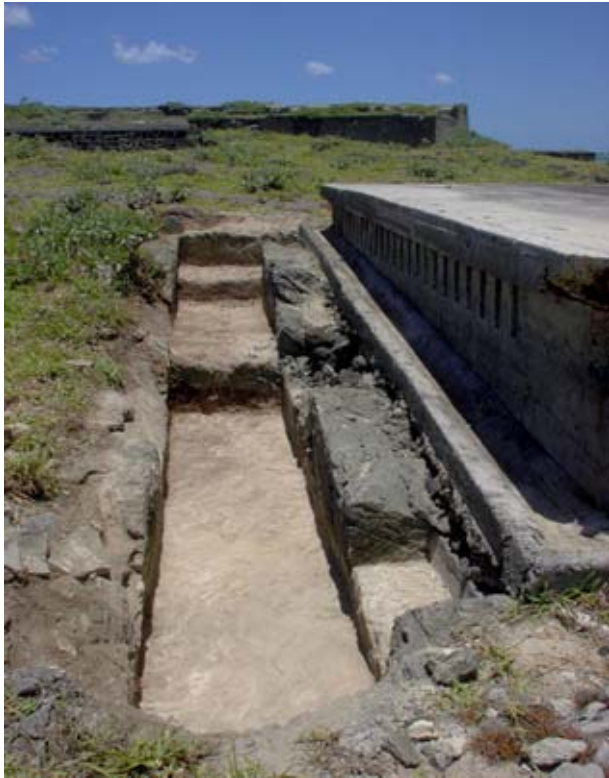
*Figure 49. Trench TR13 showing the channel at the top of the Ditch with the roof and ventilation slots of the Generator Hall at right. (04jv1717)*

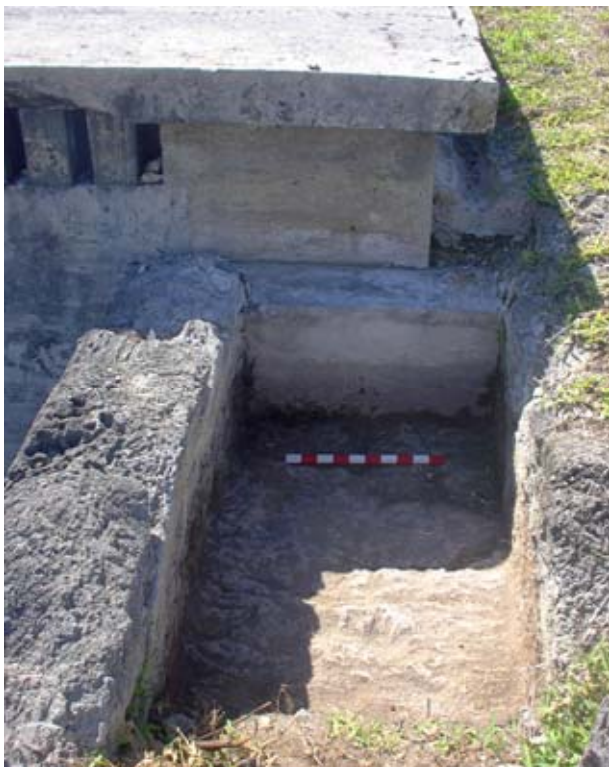
*Figure 50. Trench TR14 showing the channel blocked by the front wall of the WW II Generator Hall. (04jv1517)*
