# ARCHITECTURAL AND ARCHAEOLOGICAL STUDIES AT ILE DE LA PASSE

## MAURITIUS

### REPORT ON THE 2004 SEASON OF FIELDWORK

**The Archaeology, Architecture and Conservation of an Historic Islet.**

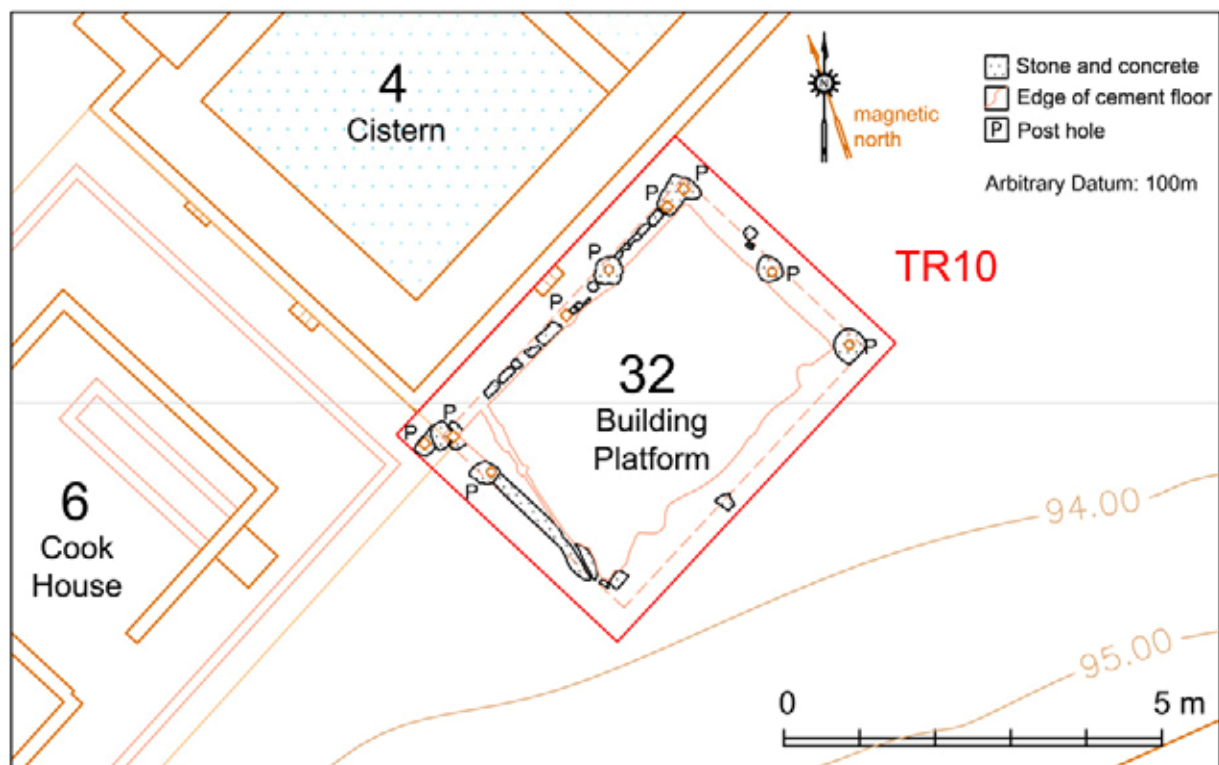
Figure 51. Plan of trench TR10 and remains of Structure 32 revealed in 2004.

Clearance of the western corner further revealed that there were traces of an earlier structure the walls of which were composed of cut coral bonded with lime mortar. These are stippled on the plan (Fig. 51). It was therefore decided to clear the entire WW II floor which was found to be covered with nothing other than vegetation and a little sand.

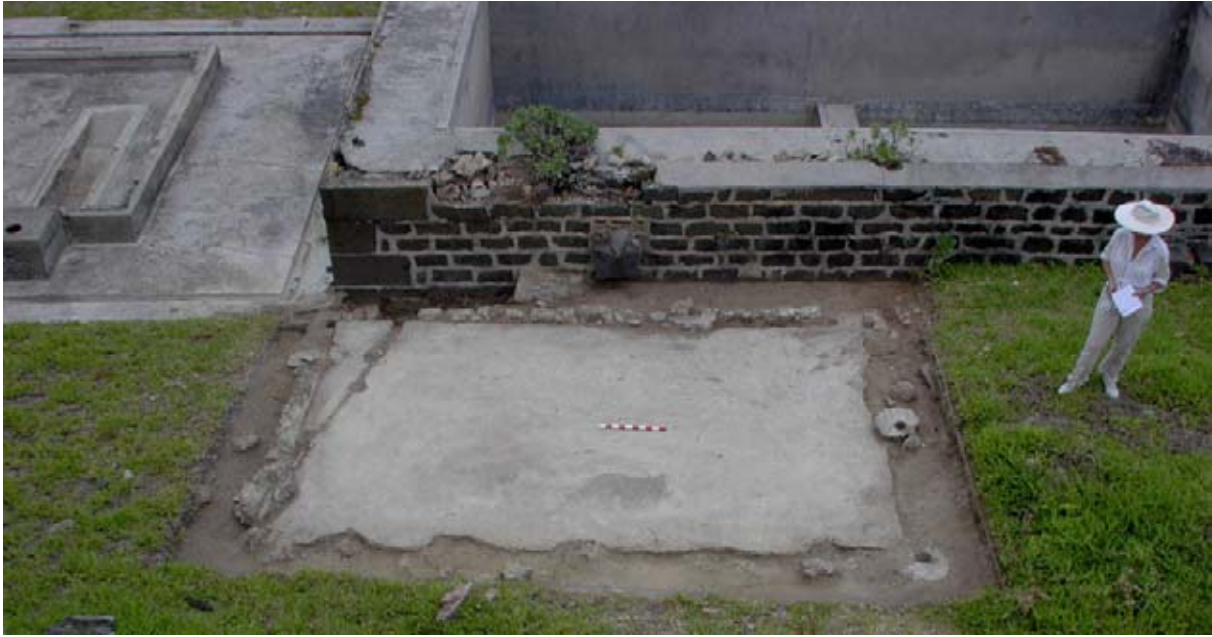
*Figure 52. Structure 32 south of the Cistern. The entire floor was exposed by trench TR10. (04jv2416)*

Of the earlier structure only a few stones of the north-west and south-west walls were found. The presence of a structure in this position is not recorded on any known plan, and it need not be assumed that the remains belong to a building. Use of cut coral and lime mortar probably indicates a French date.

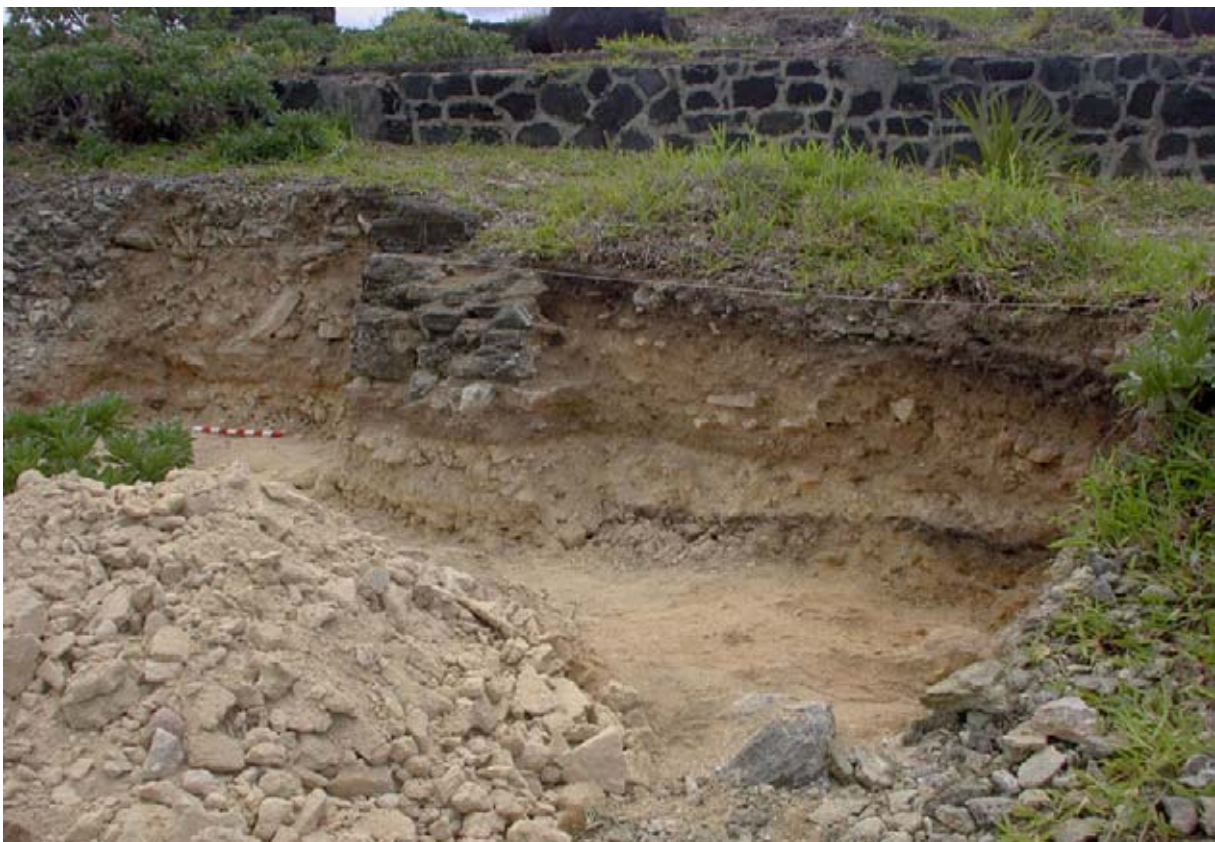
This operation (Fig. 54) revealed an unexpected depth of stratigraphy that comprises a layer containing cultural material above the bedrock and beneath a surface which has patches of burning, apparently associated with clay features. The wall is above, and thus postdates, this surface. The material against the outer face of the wall (at left in Fig. 54) represents yet later activity.

Figure 54. Trench TR11 with the wall of Structure 33 at centre and the sections to either side. Structure 23 lies behind.

Finds from this operation include a number of iron nails from the burning as well as a few bones, shells and fragments of charcoal. There were no diagnostic objects or sherds, so that the precise date of these layers is open to speculation.

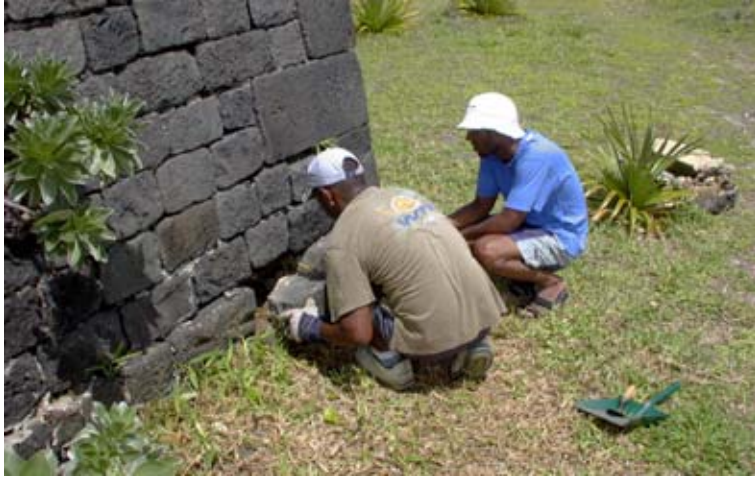
*Figure 55. A stone that slipped from the base of the Hot Shot Furnace was put back in its place. (04jv1213)*

Emergency conservation work was carried out at the Cistern and Hot Shot Furnace where stones which had slipped or been pushed out were put back in place, thus preventing further deterioration of these structures.

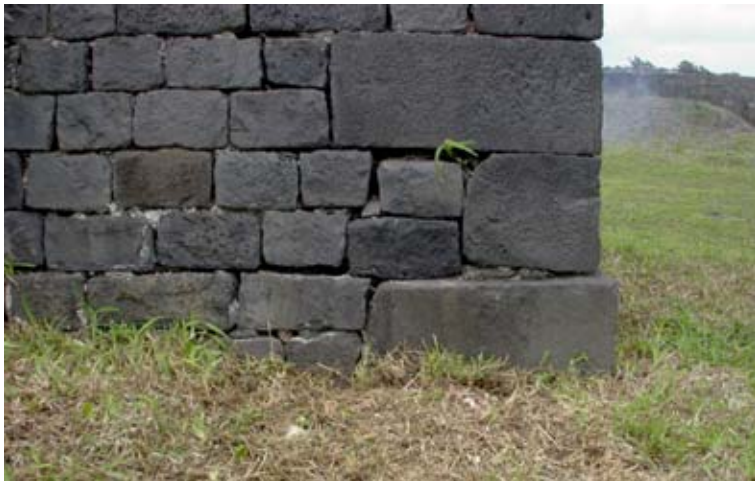
*Figure 56. Replacement of the stone has restored the stability of the bottom course of masonry. (04jv1216)*

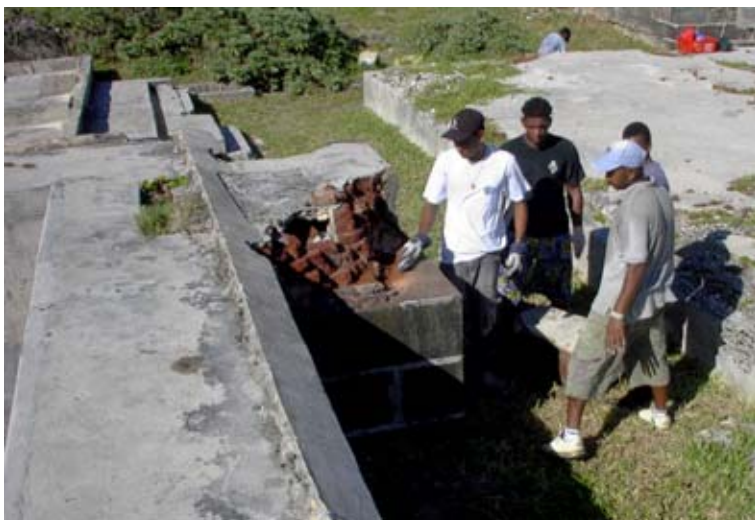
*Figure 57. A large basalt corner block was put back on the settling tank of the Cistern. (04jv0903)*

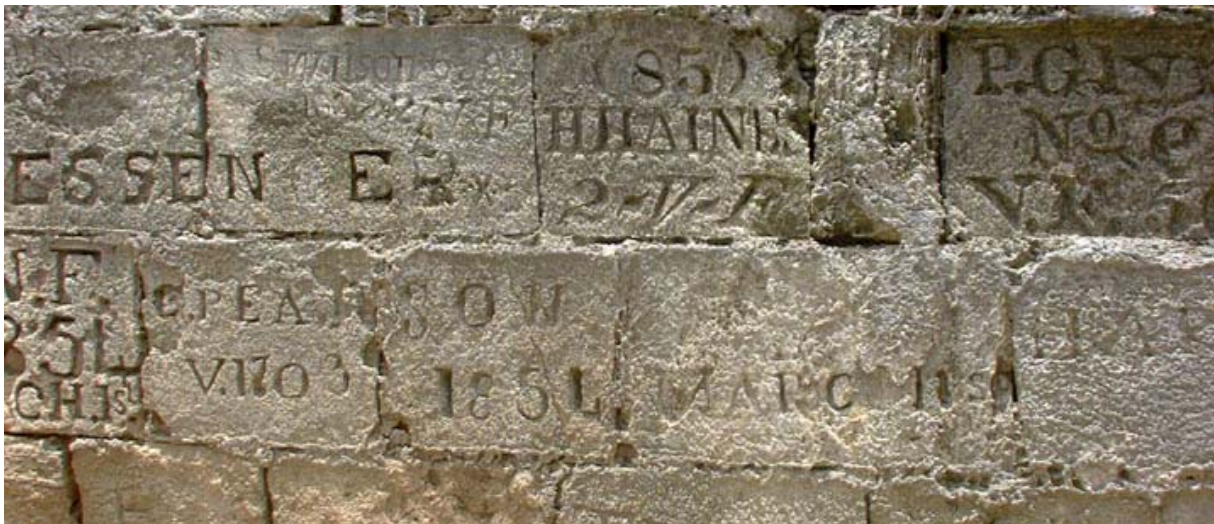
*Figure 58. Digital photography produces clear images of graffiti. A scale drawing can be produced from a rectified photo. (04jv0538)*

In 2004, the efforts to record graffiti focused on the Powder House. Complete photographic coverage of a wall is followed by the measuring and plotting of control points. A sufficient number of control points are needed for the rectification of each photo. If space is so restricted that only close up can be taken progress is both slow and tedious. Post-fieldwork consists of using appropriate software to plot the points and rectify the photos. The precise position of each graffiti is also recorded in this way. When resources become available it will be possible to assign these tasks to a student. The graffiti can then be transcribed and the transcriptions collated back in the field and accurate drawings could be made from the rectified photographs. Transcription, collation and drawing are, however, time consuming tasks that require practise and dedication.

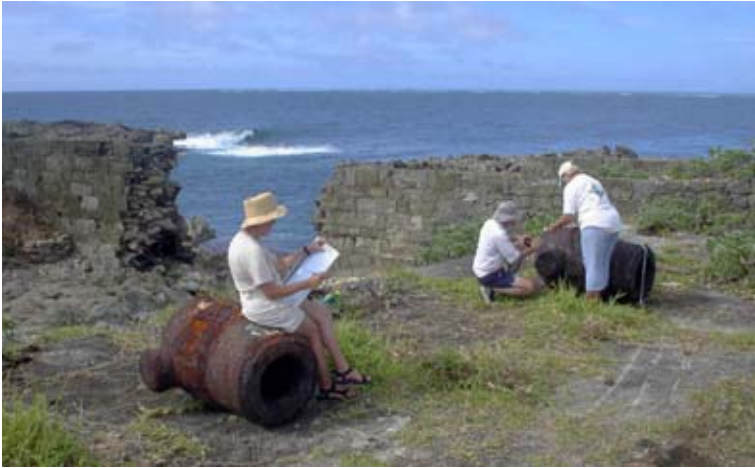
*Figure 59. Lise, Mary and George documenting the iron mortars. (04jv1205)*

Although most of the artillery has been taken to the main land, three guns remain on the islet. Two iron Gribeauval mortars with cylindrical inner chambers that are now on the WW II Building Platform 23 were photographed, measured and drawn (Fig. 59). These weapons are corroding rapidly. An identical mortar, in an excellent state of preservation, can be seen outside the National Naval Museum in Mahébourg. One side of an iron bed for one of these mortars has been dragged to the Landing point where it is now washed by the waves (Fig. 60). This rare and important piece was also drawn. These large mortars and their iron beds, which were made for coastal defence, were manufactured in France. The effort of shipping them from Europe would only have been surpassed by the difficulty of unloading them and moving them into position on Ile de la Passe.

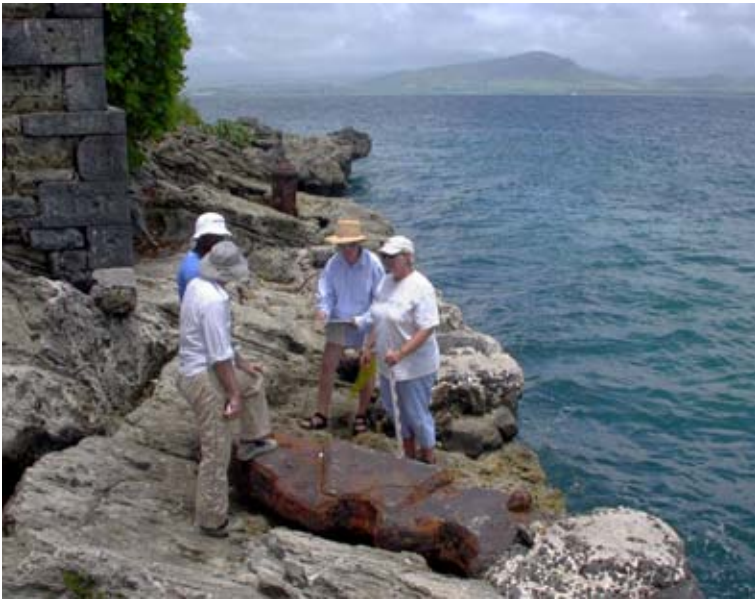
*Figure 60. Lise, Mary, George and Vickram measuring the iron mortar bed which would have supported a mortar. The piece was dragged to the Landing Place but was obviously too heavy to be put on a boat. (04jv1309)*

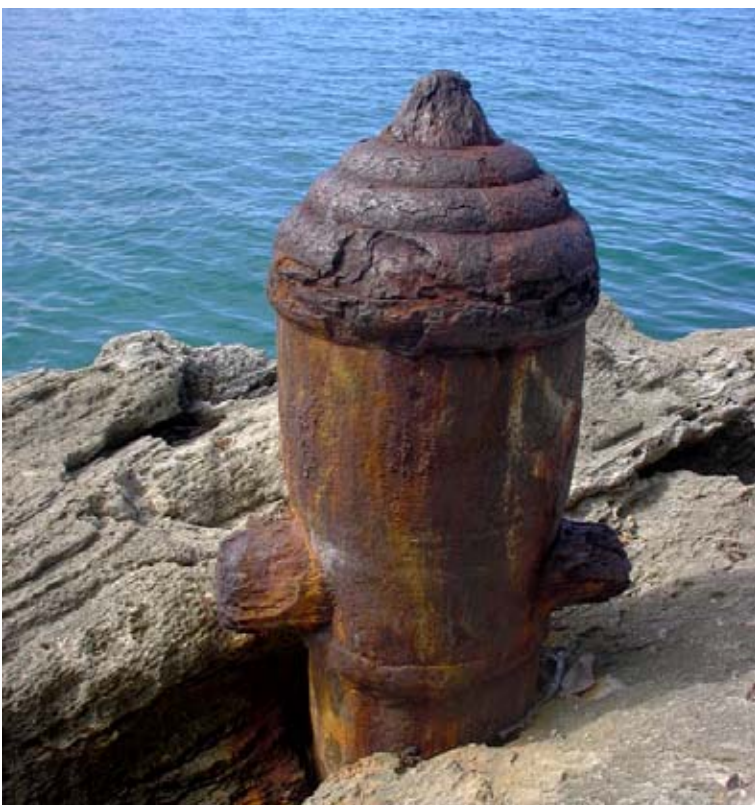
*Figure 61. The carronade by the Landing Place. 04jv3522)*

Yann von Arnim pointed out that the iron cannon set vertically in the rock on the west side of the Landing Point is in fact a carronade (Fig. 61) i.e. a gun with a short barrel and wide bore generally used on ships for combat at close range. This too was documented.

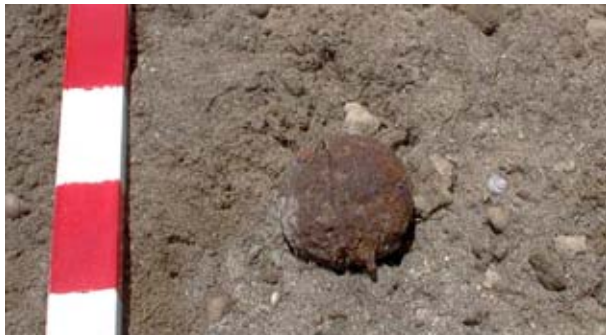
*Figure 62. Iron shot from trench TR3 on the Central Platform. (04jv)*

- Ceramics (see Fig. 61 for an example of porcelain)
- Glass
- Metal Objects (see Fig. 62 for an example of iron shot)
- Organics (see Fig. 63 for a selection of bones)
