THE LIMEKILNS AND ASSOCIATED STRUCTURES ON ÎLE AUX AIGRETTES, MAURITIUS

THE 2003 STUDY

Geoffrey and Françoise Summers

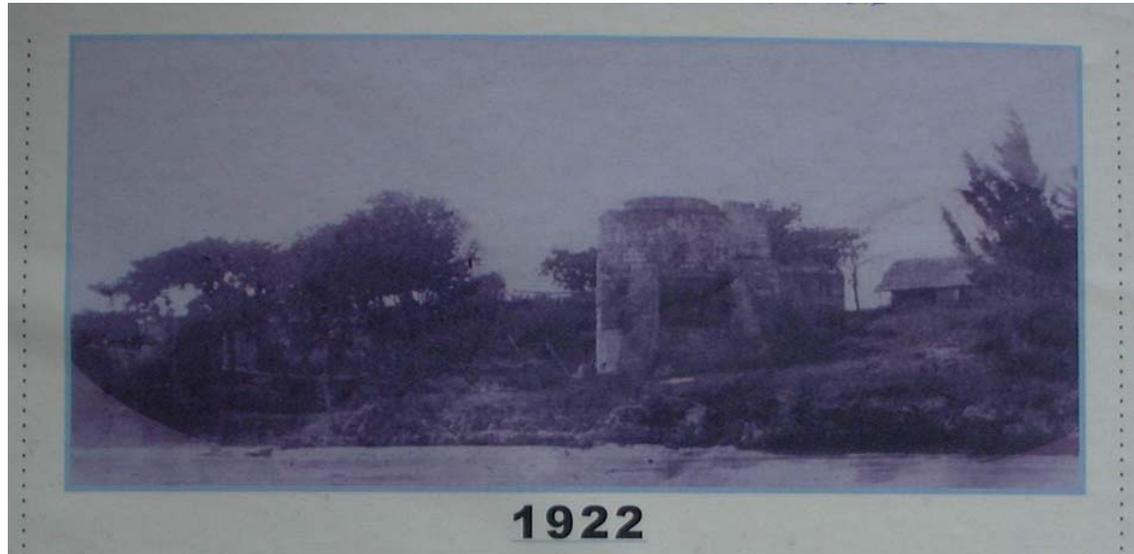
This picture of the kilns, the earliest known, is on a display panel at the site. Structure 2, which now serves as quarters for the Wildlife Foundation, can be seen to the right and the ghost of Structure 3 is visible at left. This picture provides evidence for the two large dark features on the seaward side. (ma03jv0220)

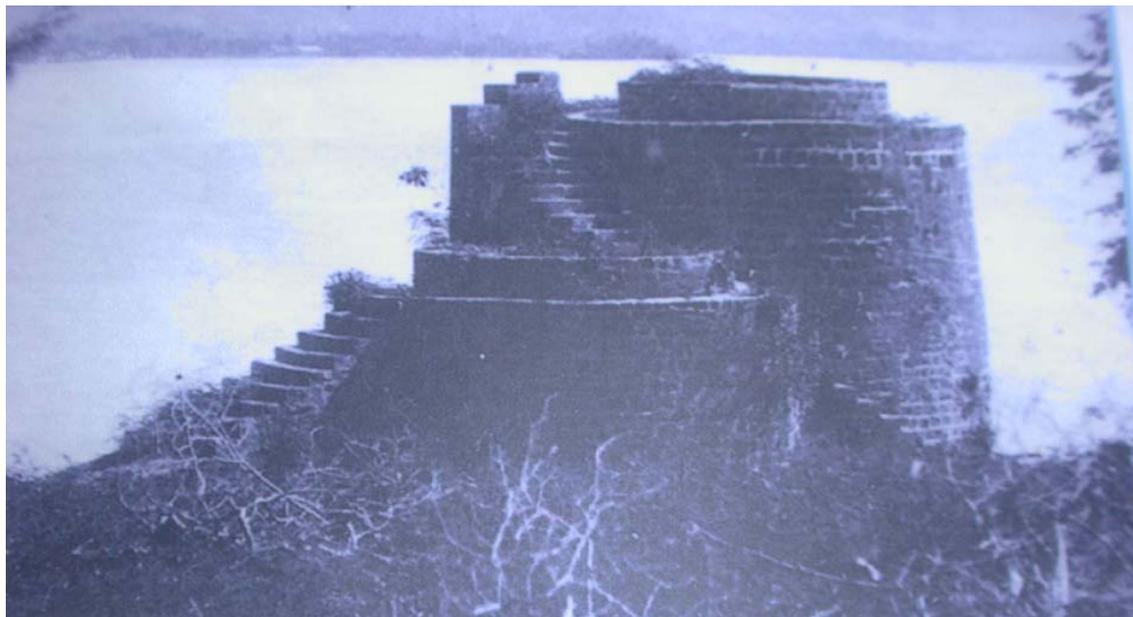
This photograph of the Limekilns in 1941 is displayed on the information board at the site. The earlier Kiln I has a spiral stair. (ma03jv0223)
