# **ILE DE LA PASSE**

## **REPORT 1**

### **ARCHEOLOGICAL AND ARCHITECTURAL SURVEY**

**Geoffrey and Françoise Summers**

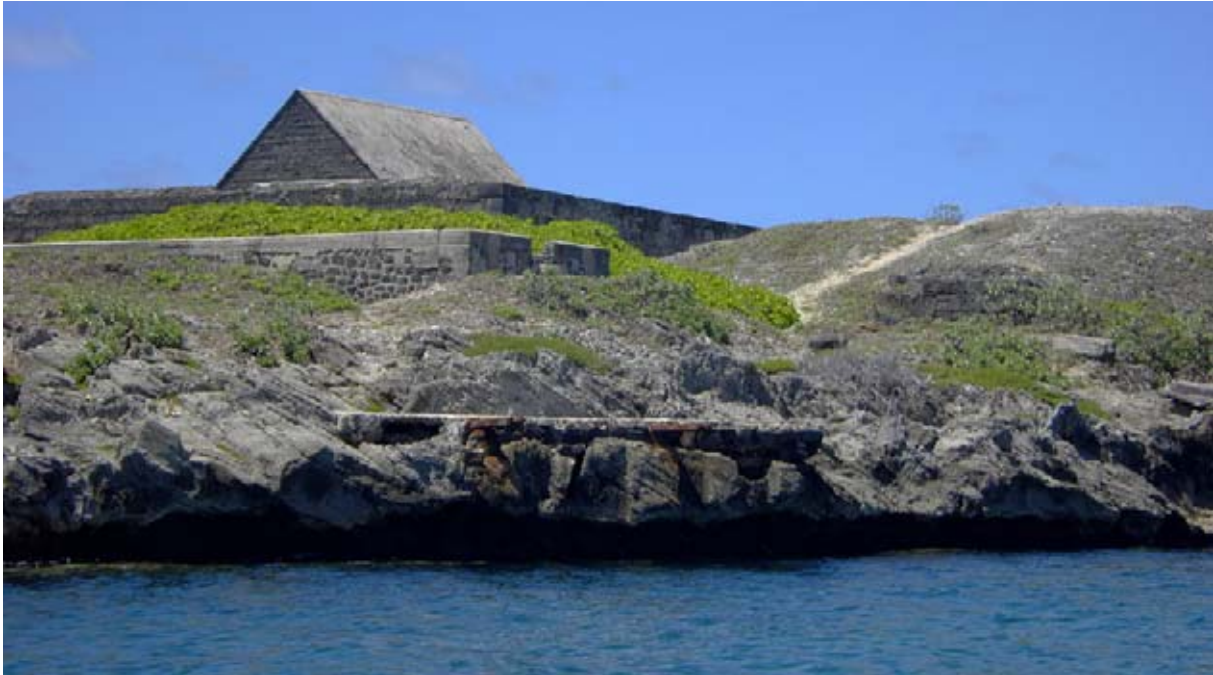
*The cuttings in the rock below the World War II toilets (Structure 30) taken from the sea at low tide. The concrete platform and iron rails rest on an earlier rock-cut platform. (02jv1515)*

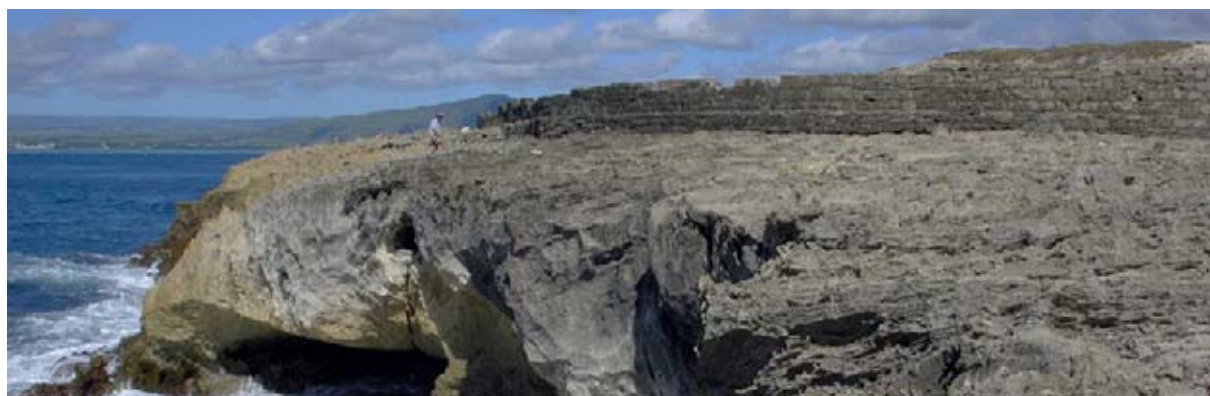
*The main sweep of the Lower Battery (Wall A) from the south-eastern spur of the island. The top of the battery wall was originally higher, but it was demolished to the base of the cannon emplacements when the Upper Battery was constructed. (02jv1806)*

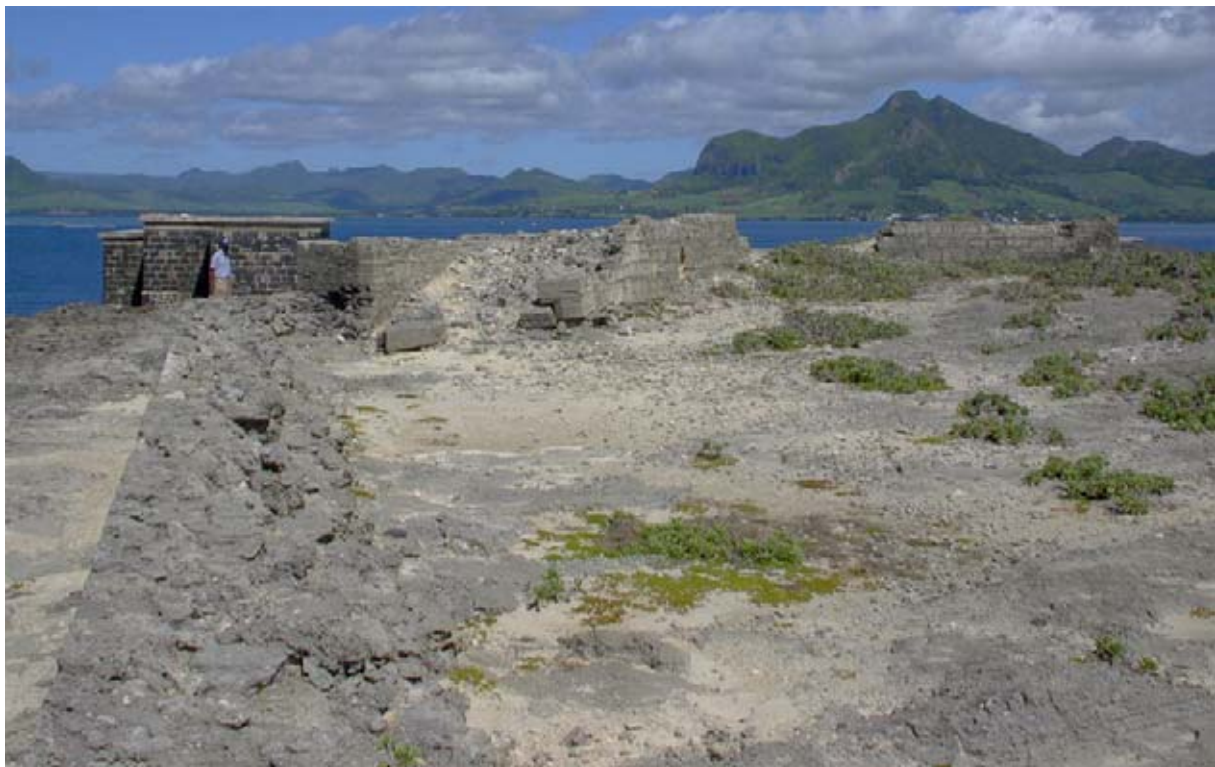
*The junction Wall A2 and A3 showing how the upper part and inside face of A3 was demolished up to the now the ruinous ramp and platform supported by Wall D. The roughly levelled area behind the Lower Battery can also be seen. (02jv1904)*

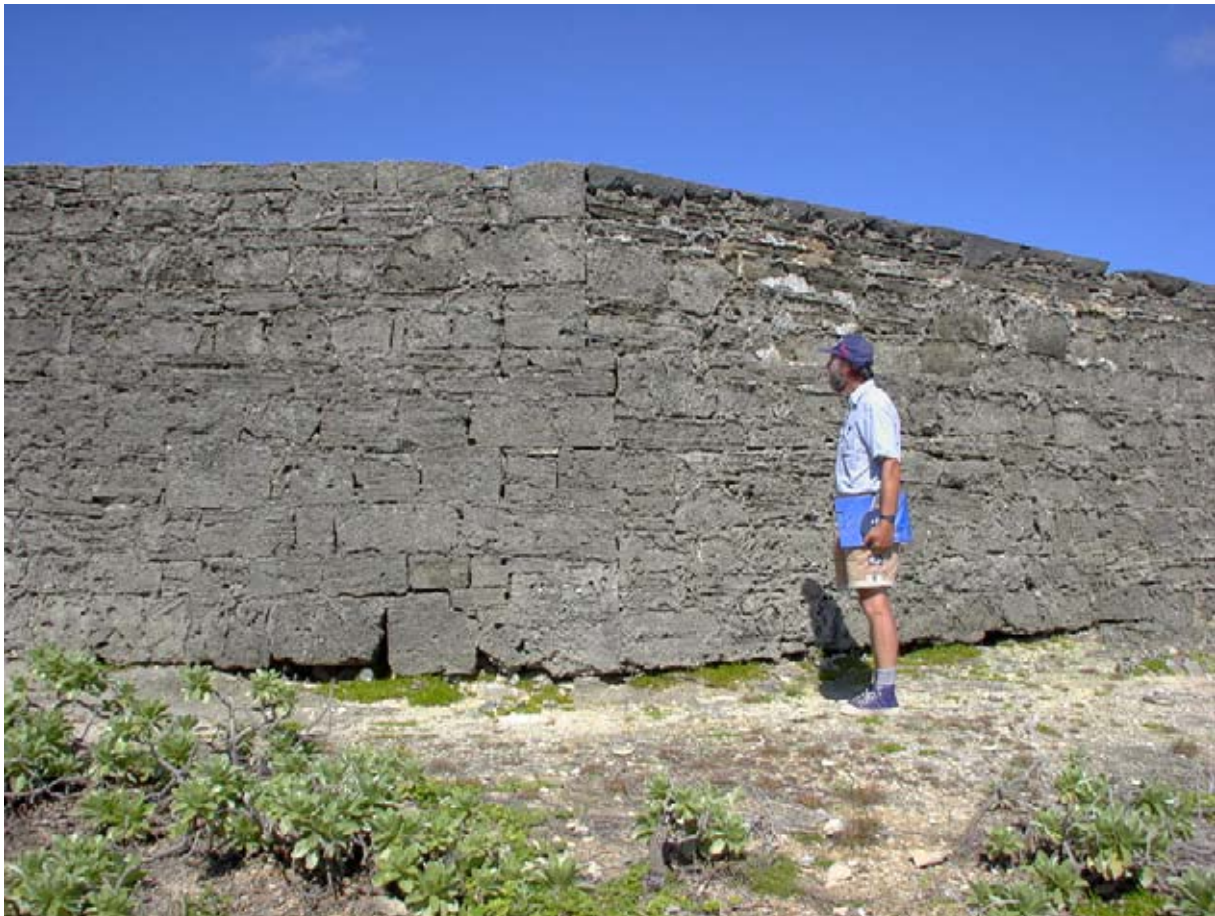
*The junction of the main wall of the Lower Battery, Wall A at left, and Wall B showing the butt joint, broken by the insertion of the fourth stone from the bottom, and the offsets. (02jv1807)*

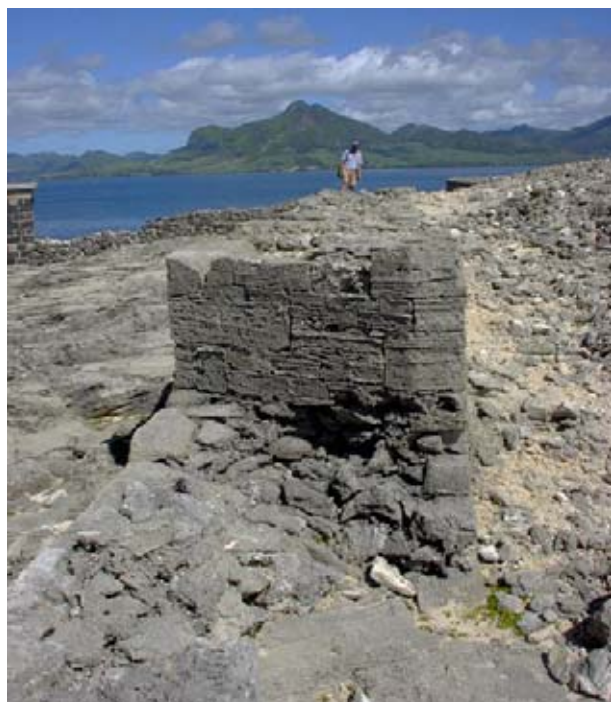
*The surviving half of the emplacement in Wall A2 and the rubble fill of the platform. (02jv1905)*

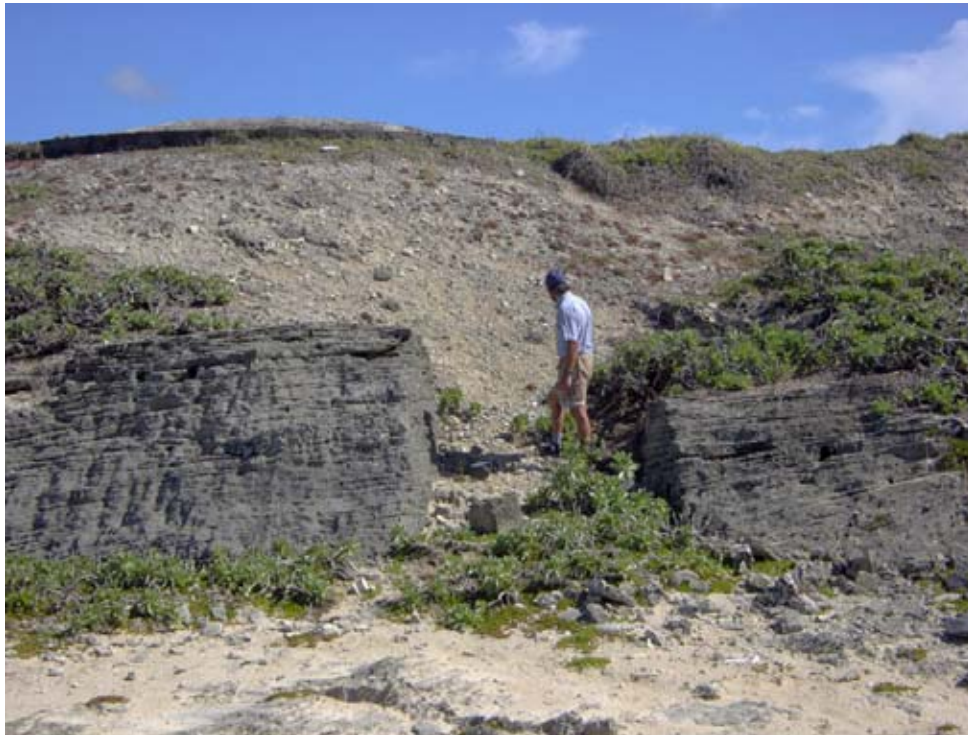
*The cutting, now partially filled by the rampart of the Upper Battery that may perhaps be the end of the passage shown on Map 1. (02jv1901)*

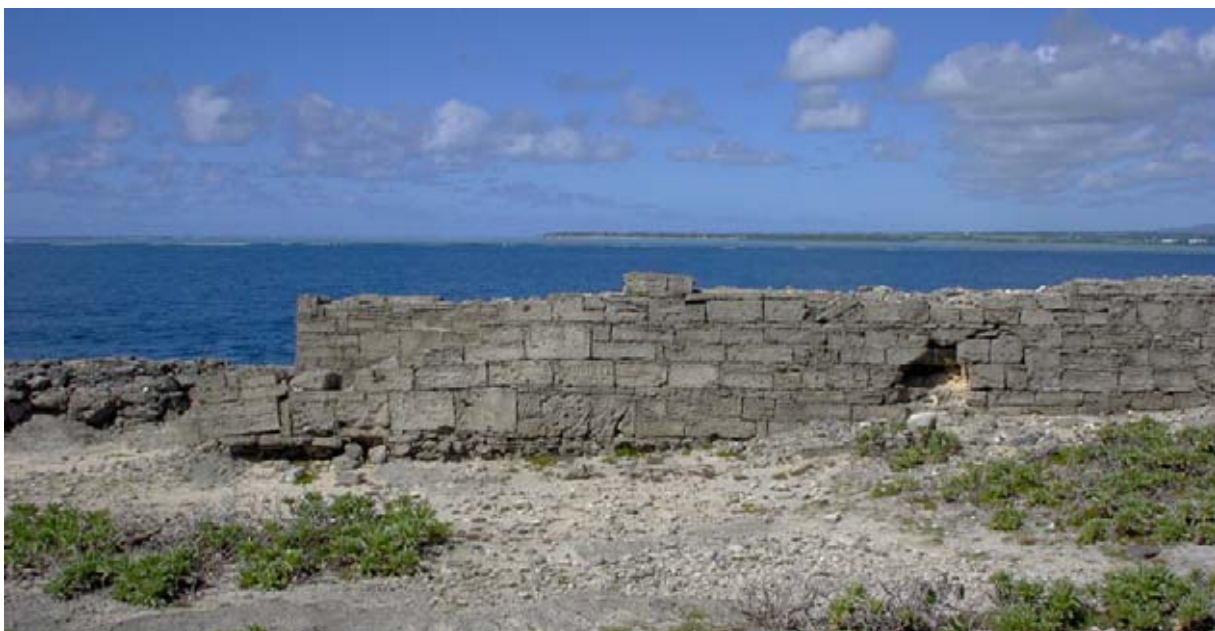
*Wall D3, with Wall A behind. The large block at the base of the southern end of Wall D3 has been reused from an earlier cannon emplacement. (02jv1906)*

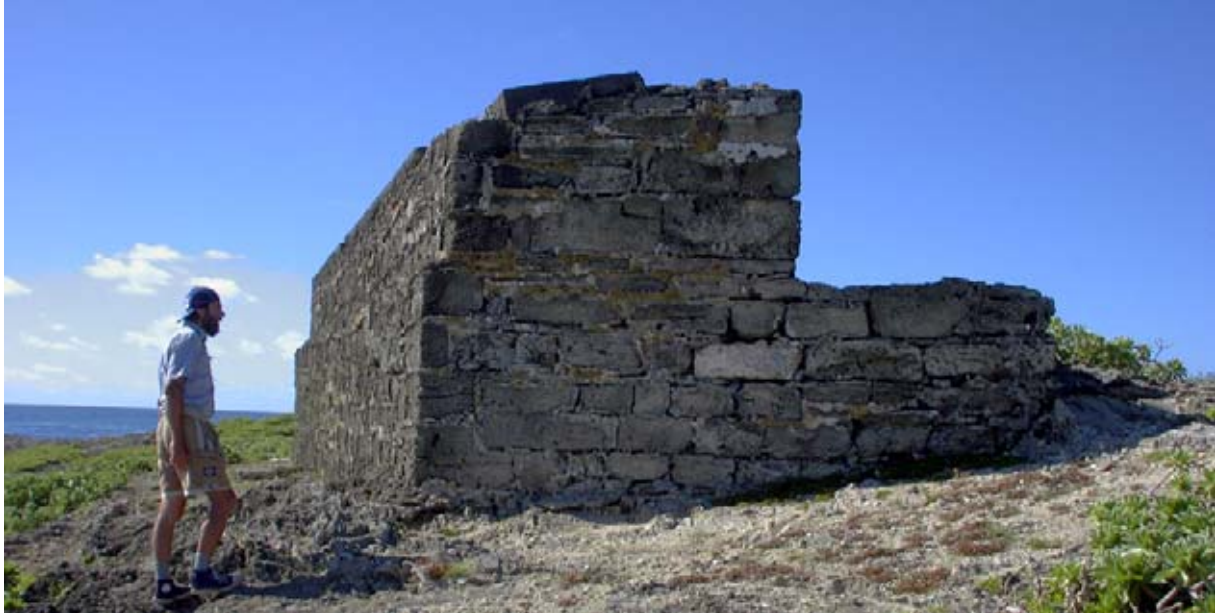
*The end of Wall B showing the sloping top edged with basalt coping-stones, the offset and the low return terrace wall. (02jv1618)*

A small number of stones have become dislodged from the lowest course at the front. More seriously, much of the basalt from the top is missing. We were informed that some basalt slabs had been taken from here in the recent past. Urgent remedial action is needed. The low return at the south end is very ruinous and would derive some benefit from cleaning and consolidation.

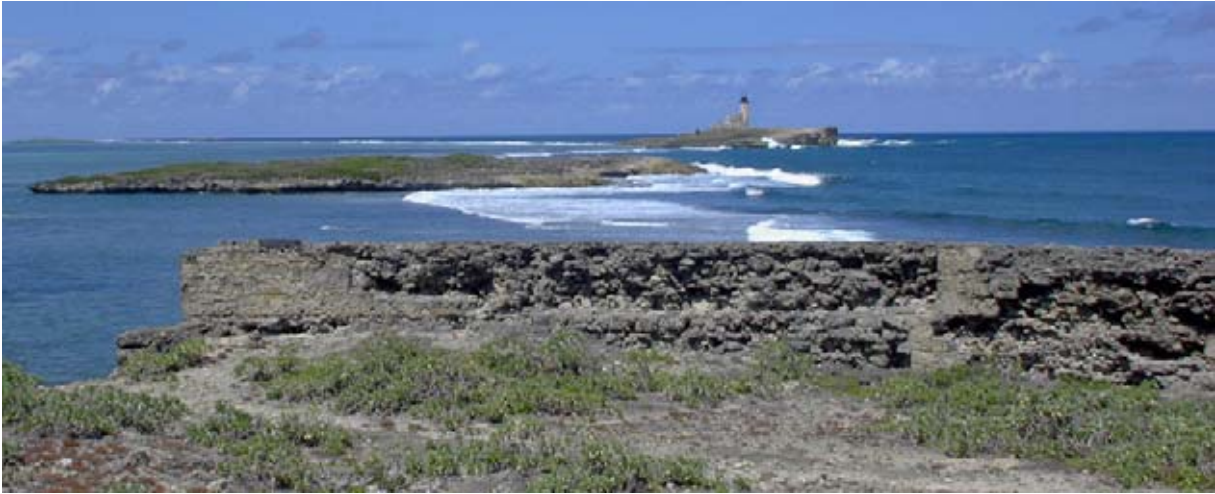
*The inner face of Wall B and its junction with Wall A. (m02jv0914)*

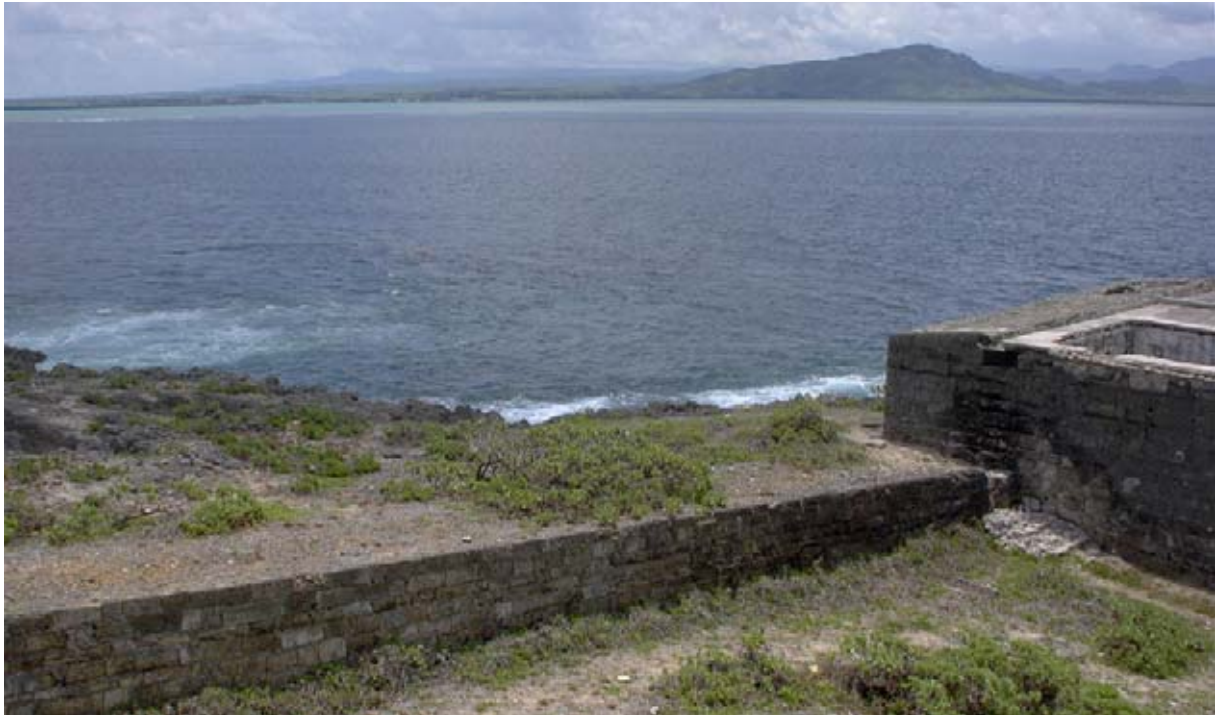
In need of slight repair, most essentially at the junction with the Storehouse (Structure 2) where a modern track is causing rapid erosion. When the WW II reinforced concrete roof of the Storehouse was recently demolished some of the debris was sensibly piled up in the corner to retard further damage and erosion where the footpath traverses the wall.

*Wall E with the berm and bank beyond. (02jv0312)*

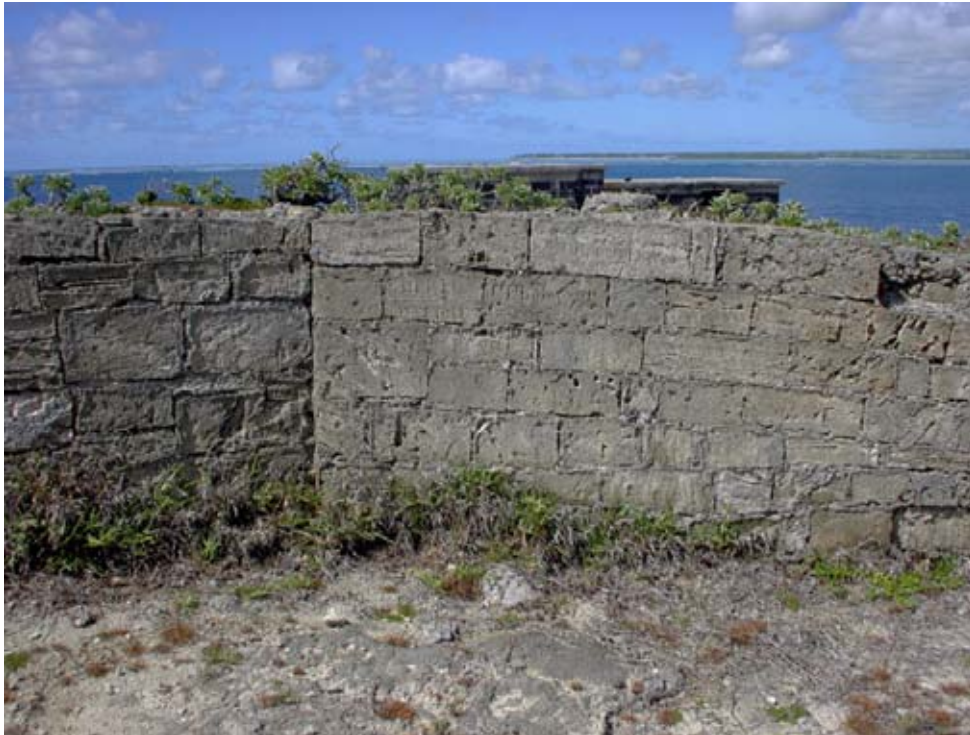
*The vertical joint between Walls D1 and E. Note the difference in masonry styles and the change in the horizontal angle of the upper courses of Wall E. (02jv1911)*

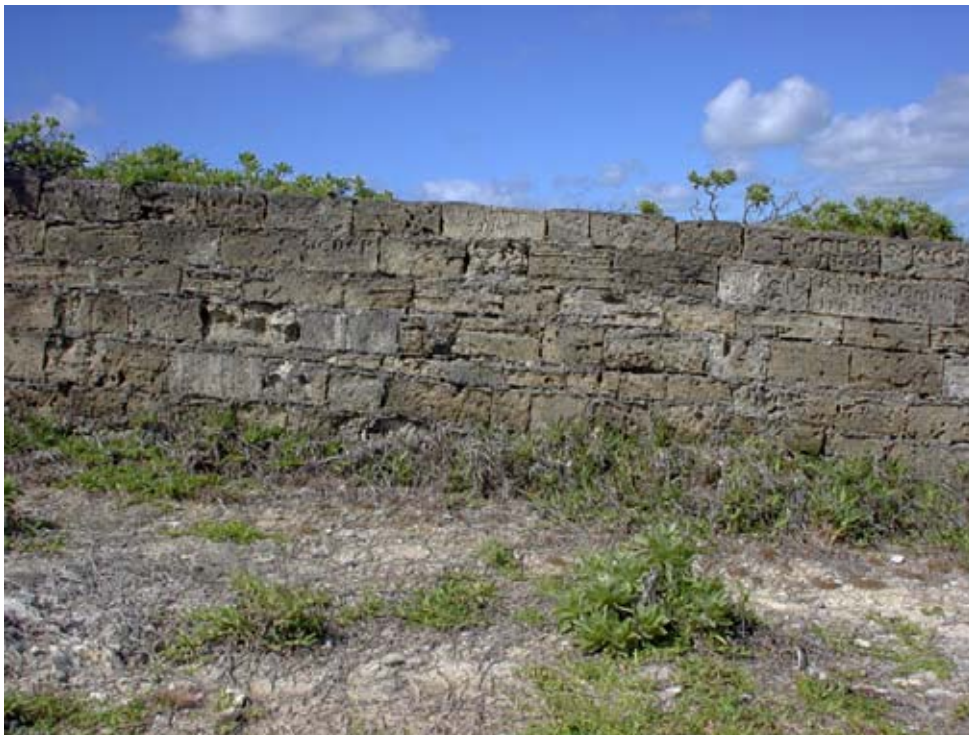
*The inner face of part of Wall E showing how the courses of stone run parallel to the slope of the ground. Some of the graffiti from the 1840s are visible. (02jv1916)*

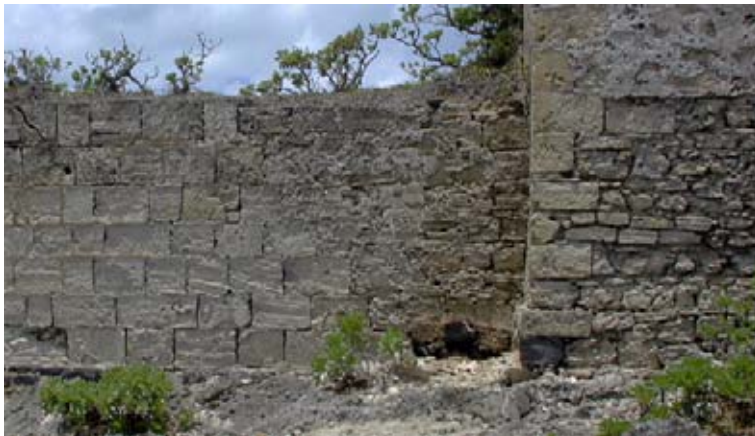
*Wall F5 at left showing the rebuilding and extension, with a drain at the base, in a very different style. The upper part of the rear wall of the Storehouse, at right, shows how the face was rendered with lime mortar above the top of the now vanished bank which once protected the lower part. (02jv0201)*

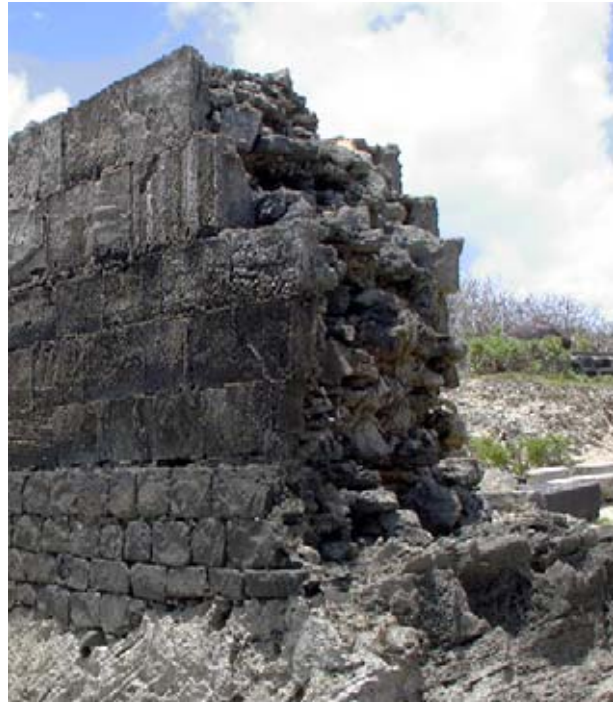
*Wall F showing the external basalt footings founded directly on the irregular bedrock and the layered rubble construction of the wall core. (02jv0208)*

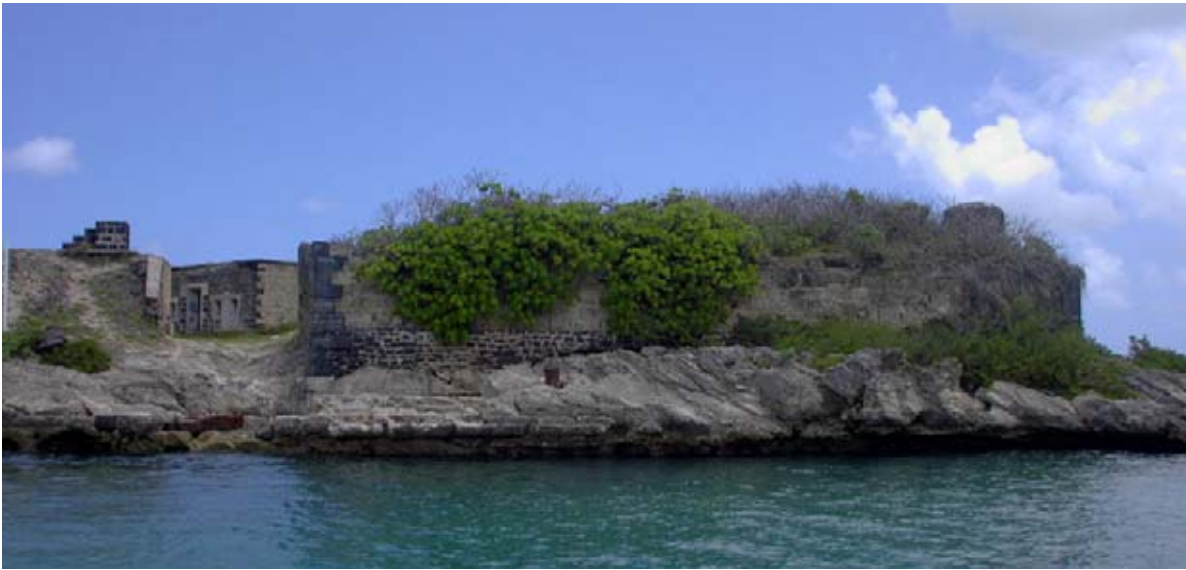
*The Landing Point and the North-Western Defences showing the ashlar basalt quoins of Wall F1 and F2, the basalt footings and the overhanging vegetation. At centre foreground is a cannon set upright as a mooring post. The stepped Structure 31 at top left was a British flagpole base. The top of the North-West Sentry Post is at top right. The Storehouse is in the middle distance. (02jv0701)*

There are a few other places where repair to the outer foundation would be prudent. Especially important is the need to underpin the corner by the Landing Point.

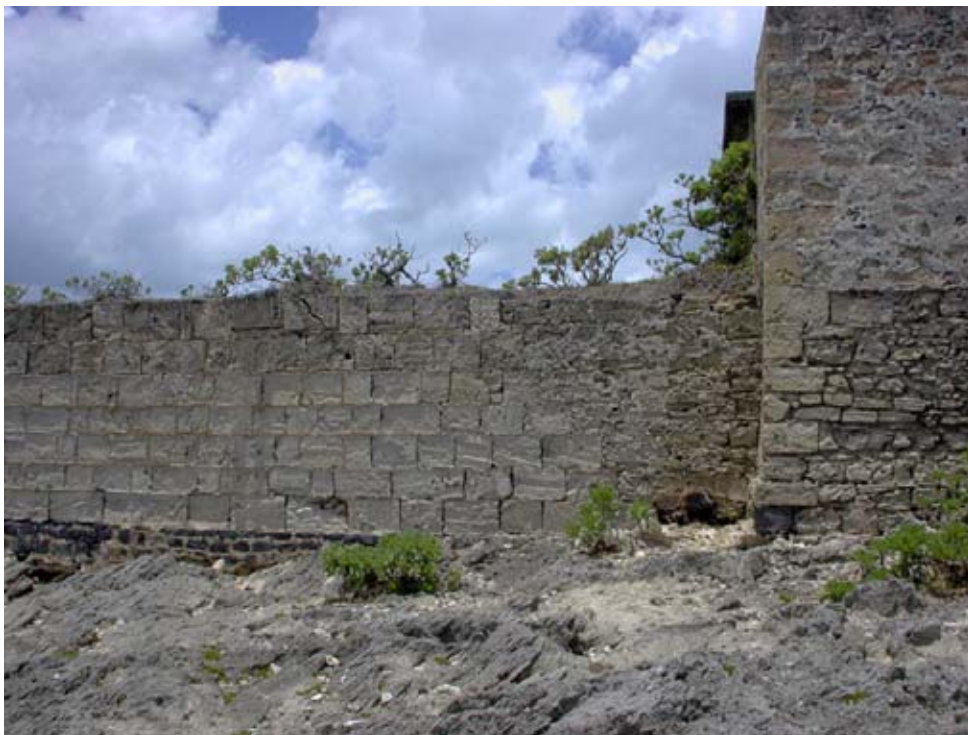
*The end of Wall F was broken where the ashlar face stones step down, and it was rebuilt when the Storehouse was constructed. The bushes are growing on the high bank behind the wall. (02jv0201)*

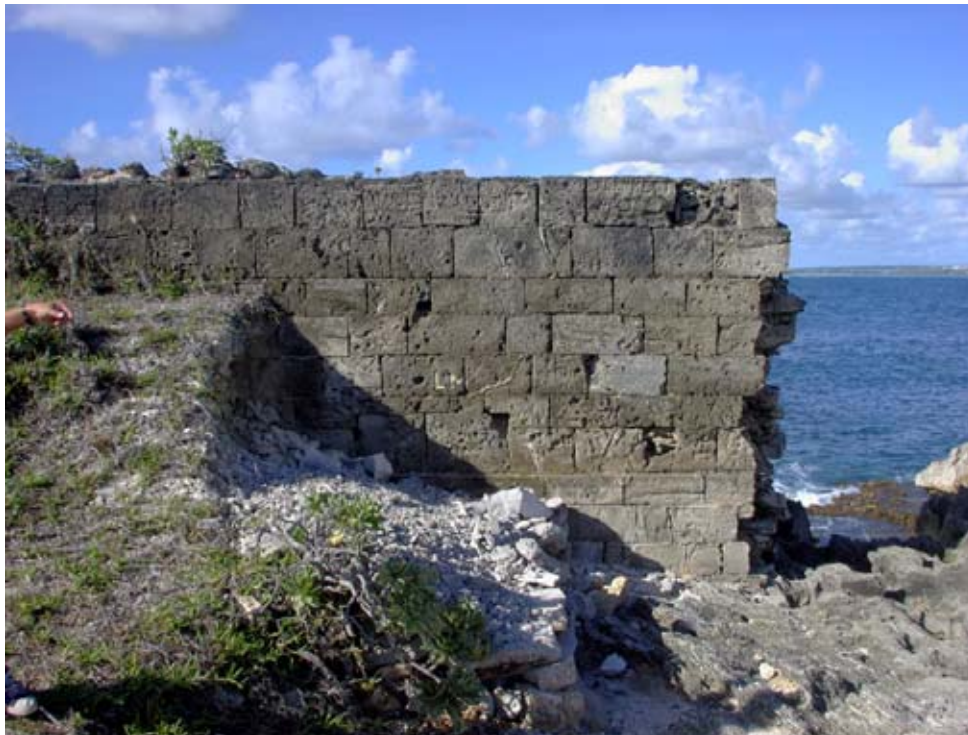
Stretch F5 has been broken through by the sea. While this breach provides an interesting section through the wall, showing its construction, it is certain that remedial action is a priority. Consolidation of the base of the wall on the south side of the breach is very urgently required, and could be accompanied by consolidation of the broken southern edge and further protection of the rampart behind. The north side of the break appears to be more stable, not least because the bedrock is higher here. It would appear that seawater flowing out is causing as much or more damage than waves from the front.

*The south side of the breach in Wall F showing the offset and the urgent need for consolidation. The inner Bank and Berm has now afforded some protection by the piling up of concrete debris from demolition of the Storehouse roof. (02jv1001)*

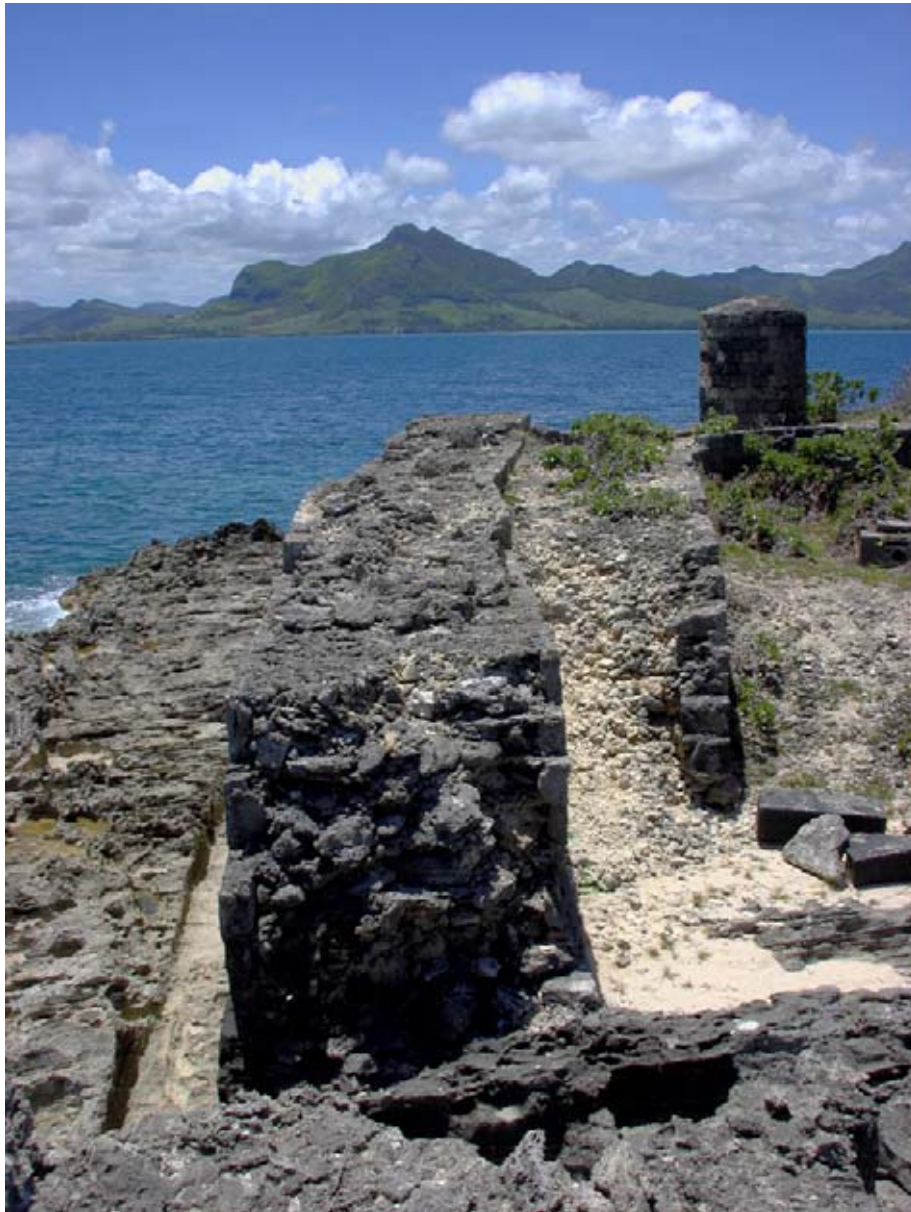
*The North-Western Platform looking north from the breach in Wall F. The rock-cut trench for the Buttress is at left. The face stones and mortared rubble core of Wall F can be seen. The loose rubble fill of the ramp platform retained by, Wall G runs beneath the North-West Sentry Post. 02jv1212)*

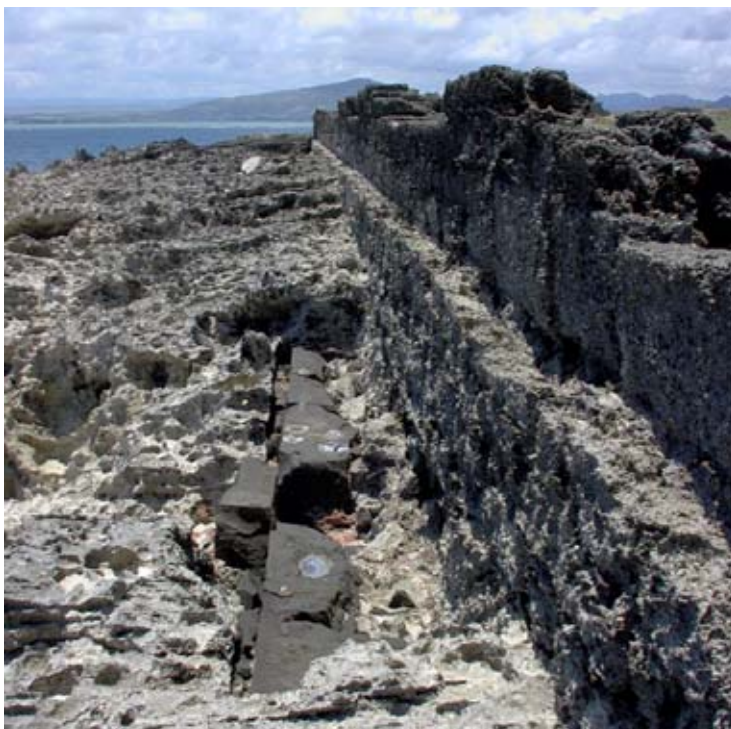
*The Buttress against Wall A. (01jv0211)*

At the first of the two buttresses just described one basalt block has been dislodged and ought to be reset before it ends up in the sea. If a suitable mix could be found there would be a case for some additional consolidation. The iron clamps will continue to slowly decompose and have already lost any structural utility. What little is left of the second buttress appears to be stable.

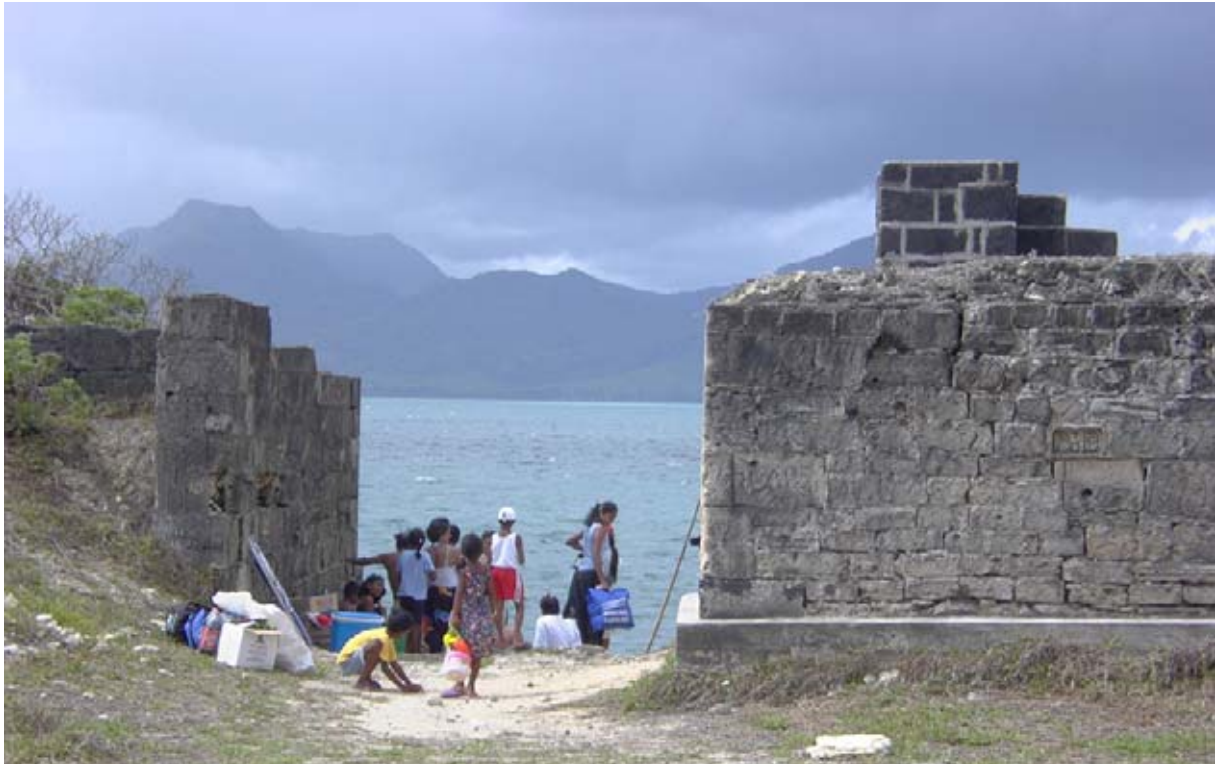
*The landing Point with the west end of Wall H, at right, showing modern concrete underpinning and the flag emplacement, Structure 31, above. (02jv0410)*

The walling at the western end has been rebuilt on at least one occasion and some of the original walling has been underpinned with modern concrete. Further consolidation of the late repair is required.

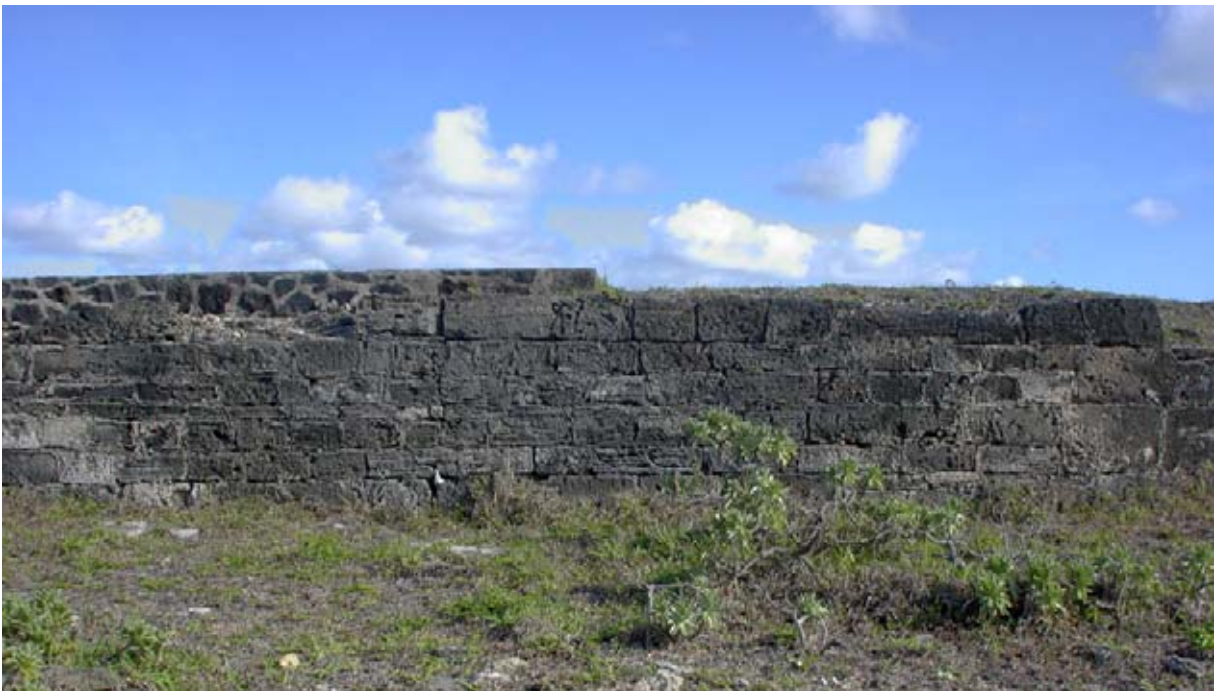
*Wall H with WW II Structure 22 on top. The top edge of the uppermost row of stones is chamfered. (02jv18)*

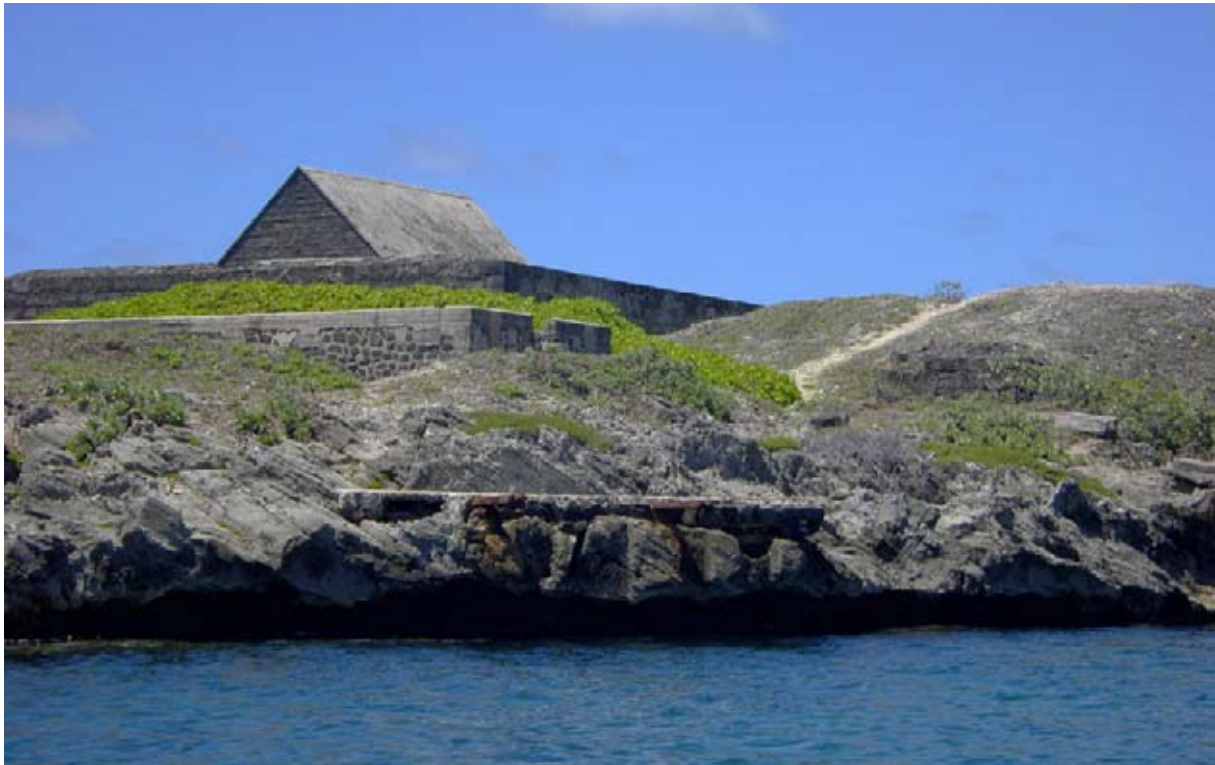
*The low North-East Bank is situated behind the WW II toilets and in front of Structure 24. The depression in the bank marks the footpath to the toilets. To the right is end of the North Bank with the return of Wall H in front of which are fragments of a WW II concrete drain. (02jv1515)*

There are tracks across the bank to the WW II toilet (Structure 30), but the main track along the eastern side of the island keeps inside the bank. The current condition is thus stable.

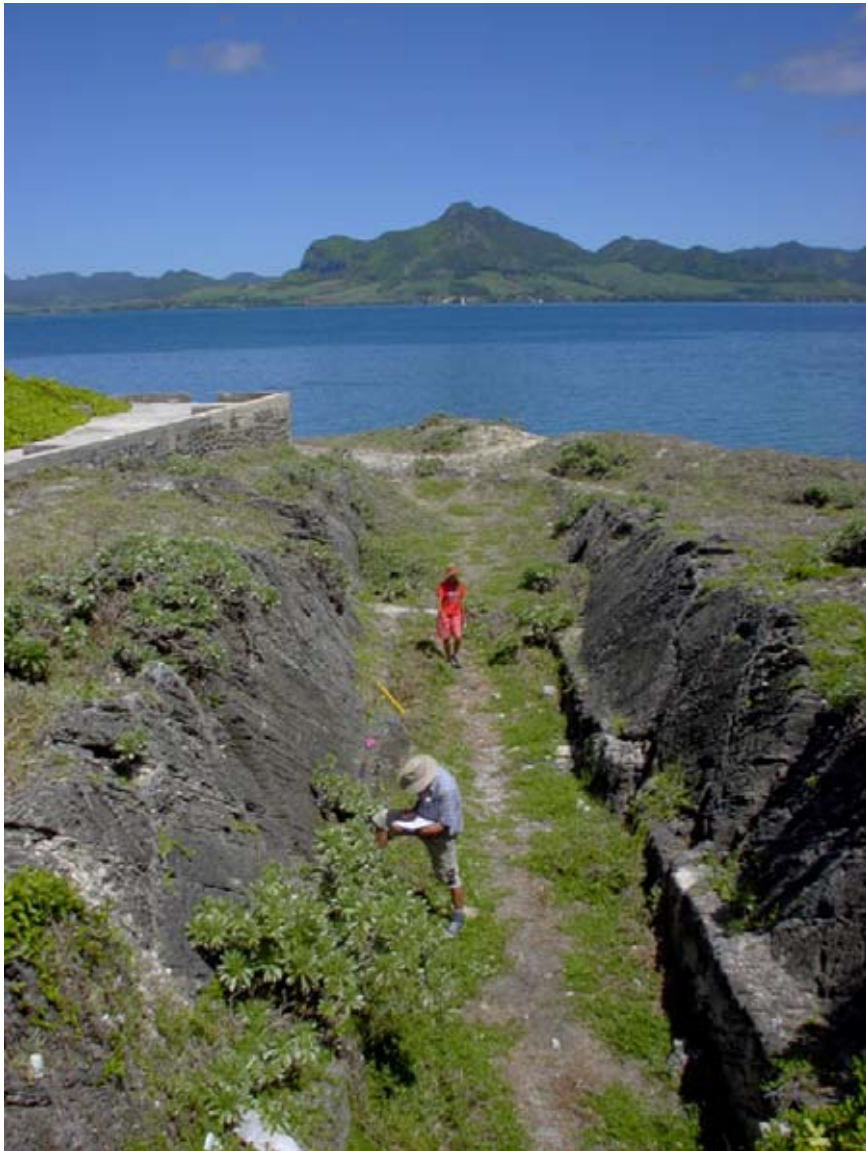
*The Rock-Cut Feature from the top of Underground Generator Halls. The stepped slot in either side is just in front of the figure in the foreground. Structure 26 is at left and the low North-Eastern Bank, traversed by a WW II track to the Toilets, (Structure 30) lies behind. (02jv2210.*

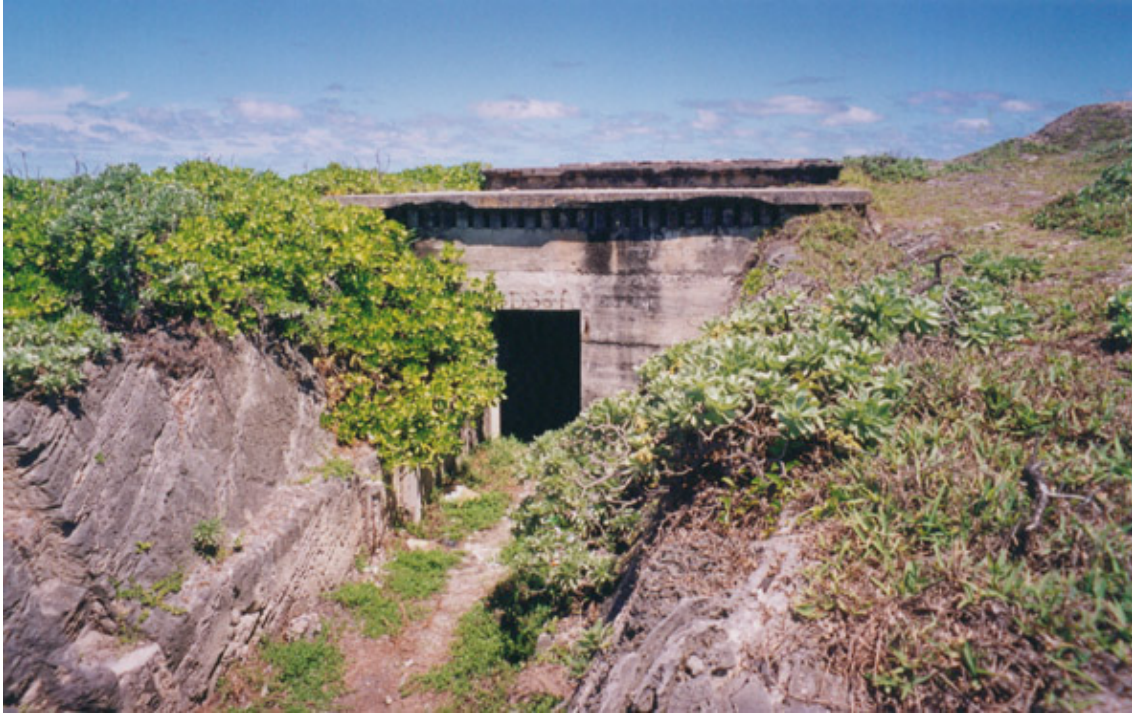
*The Rock-Cut Feature looking towards the entrance to the Underground Generator Halls. The rock-cut channel at the top on either side is almost totally obscured by vegetation. (02cn0417)*

The major long-term concern is the deterioration of the WW II reinforced concrete Generator Halls. The cutting itself is stable.

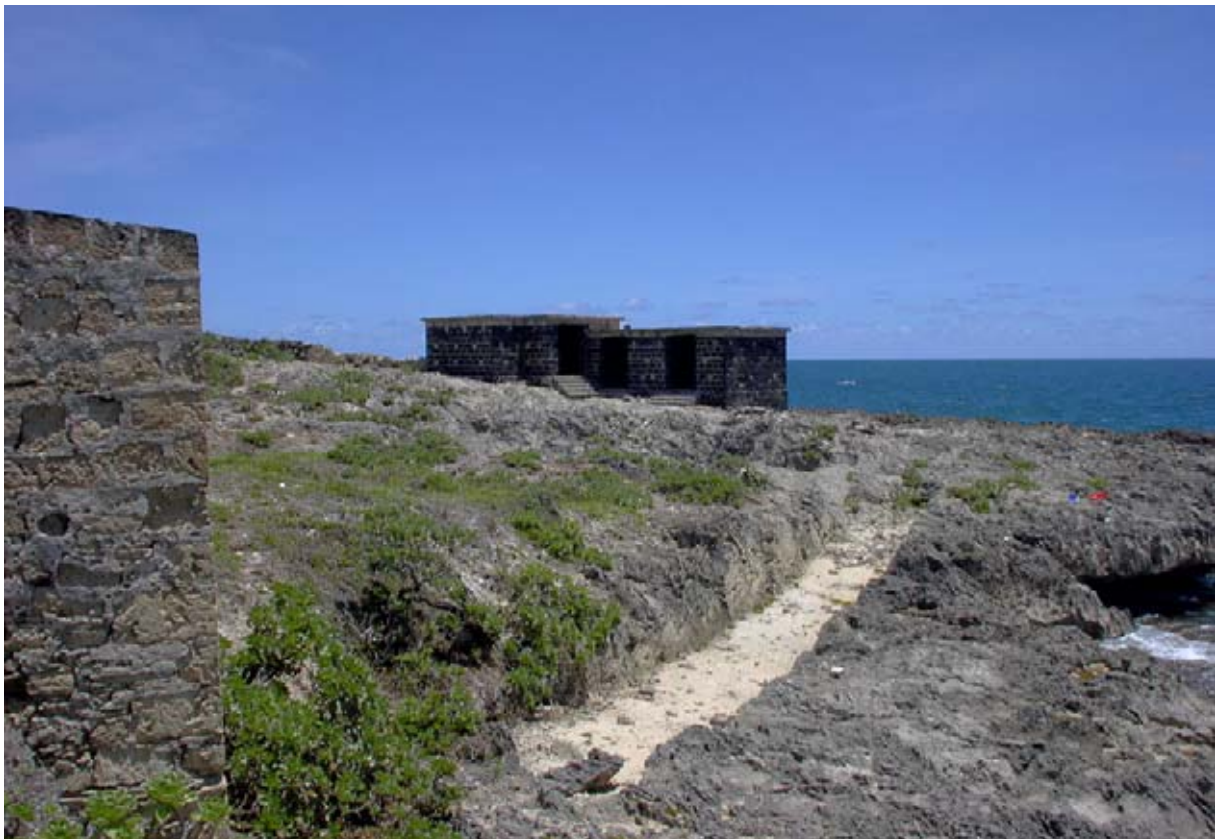
*The Quarry or Ditch with the corner of the Storehouse at left and the Western or Searchlight Building in the background. There is a larger irregular quarry, barely visible, between the end of the Ditch and the Building. In WW II the cables from the Storehouse Generators to the Searchlight Building were laid along the Ditch. (02jv1213)*

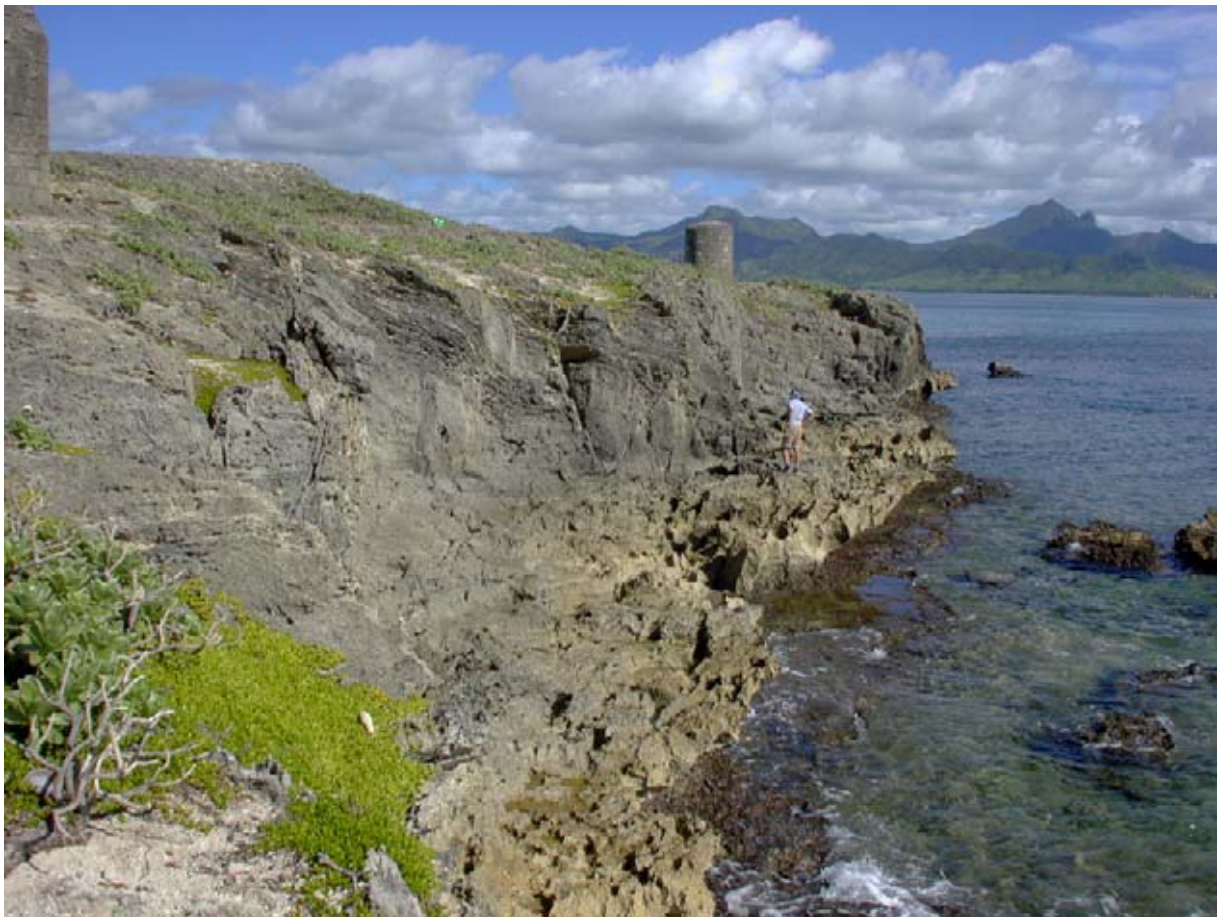
*The large quarry on the south-eastern side of the island at low tide. The corner of the Upper Battery wall is at the extreme left and the Western Sentry behind. (02vj1623)*

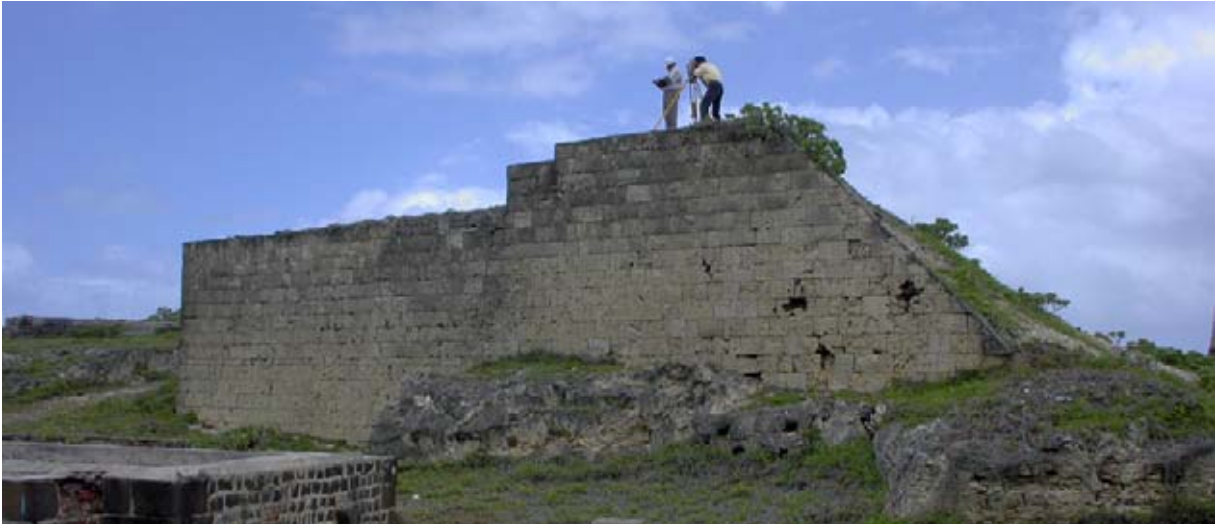
*The North Wall and Rampart of the Upper Battery. The angle of slope is 45°, the berm (missing two top stones at left) is 6.00m wide and the terrace 10.0m. (02jv0612)*
