# **ILE DE LA PASSE**

## **REPORT 1**

### **ARCHEOLOGICAL AND ARCHITECTURAL SURVEY**

**Geoffrey and Françoise Summers**

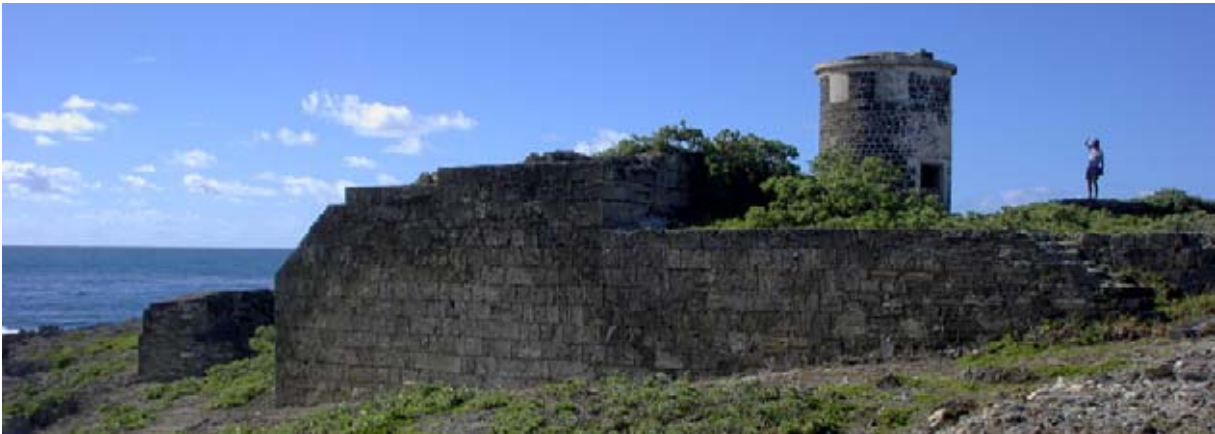
*The South-East Wall of the Upper Battery with broken steps and terrace wall at right. The later Tower is on top and the end of the Lower Battery is at left. (02jv1608)*

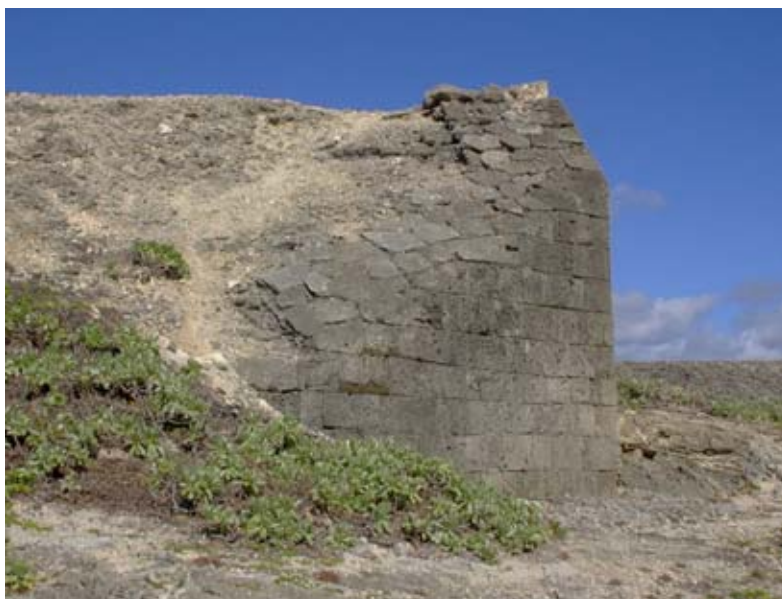
*The South-East Wall and Rampart of the Upper Battery showing the stone cut to fit the different angles and the capping of the wall tops. (02jv1620)*

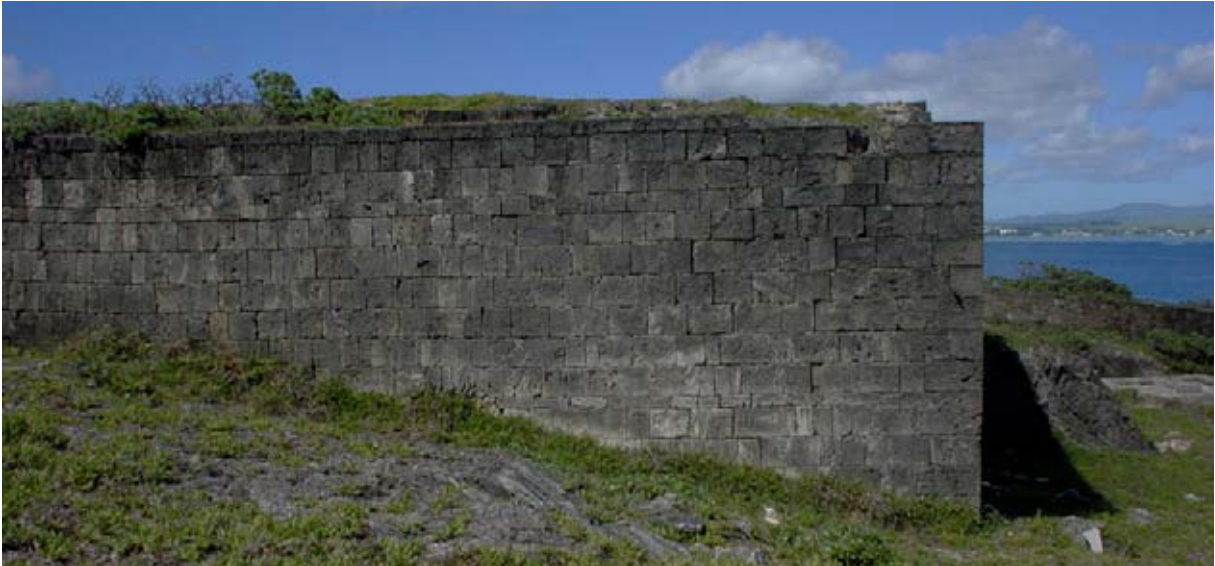
*The Terrace Wall of the Upper Battery showing the corner with the North Wall. (02jv2003)*

Much could easily be replaced in original positions and the stonework of the inner battery wall could be repointed. There are other places where some slight repair would be advantageous, such as the replacement of the displaced basalt steps on the staircase at the south-east end and repair to the face of the northern stretch of the Terrace Wall.

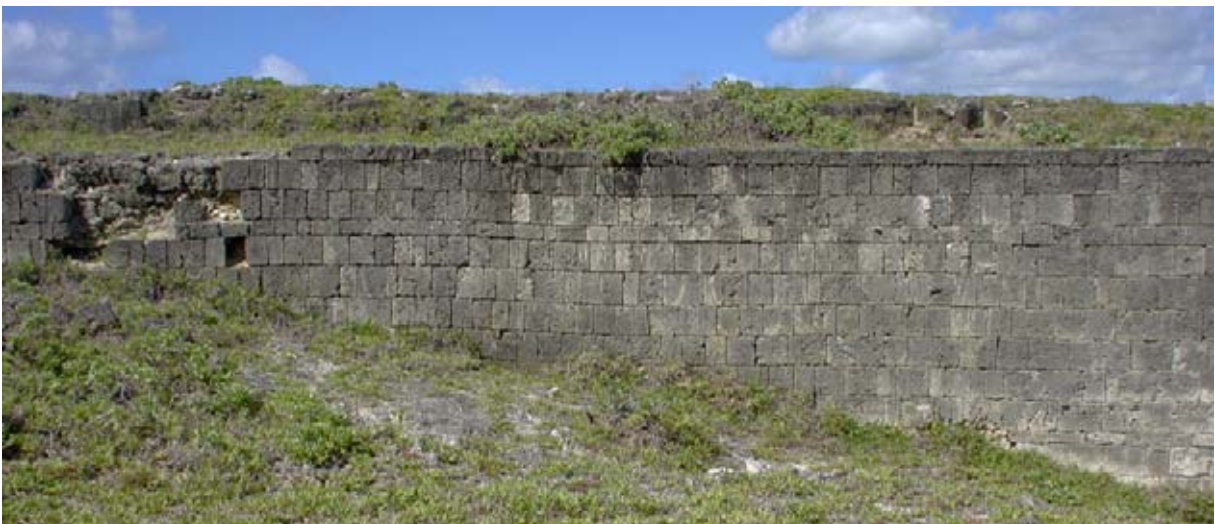
*The central section of the northern stretch of Terrace Wall. The Battery Wall and Cannon Emplacements are above. (02jv2004).*

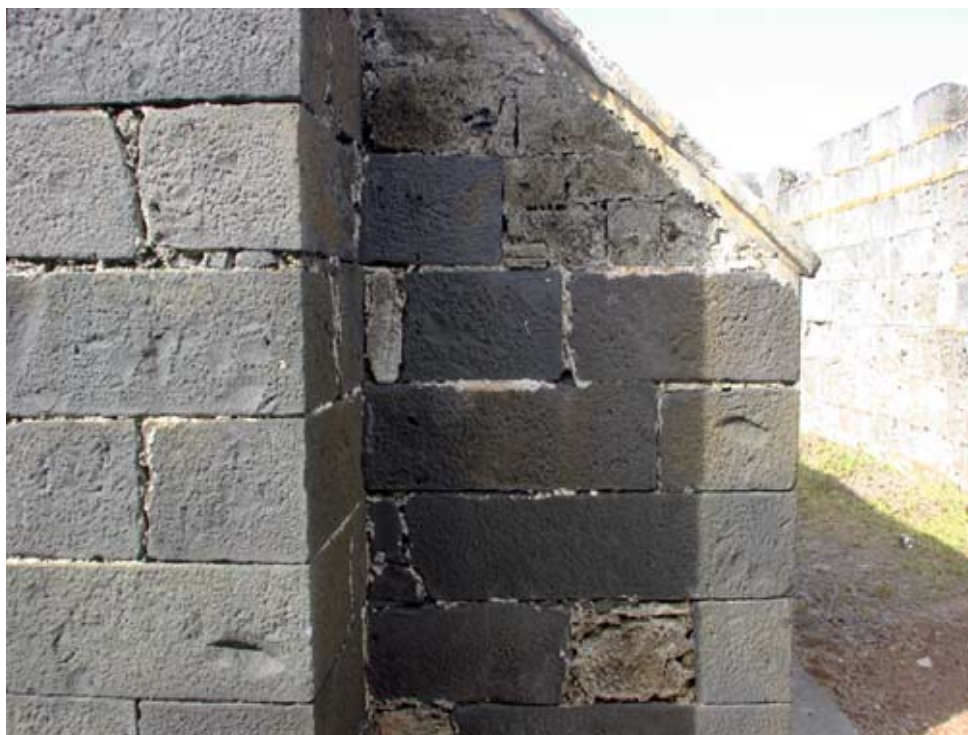
*Basalt and coral construction showing the coral roof slates. (01jv0416)*

In excellent condition, only requiring a minimal amount of repointing and some slight repair, especially at the corners of the roof. At two points the slanting top of the enclosure wall was levelled in order to seat water tanks for the WW II showers and washing facilities (Structures 25 and 26).

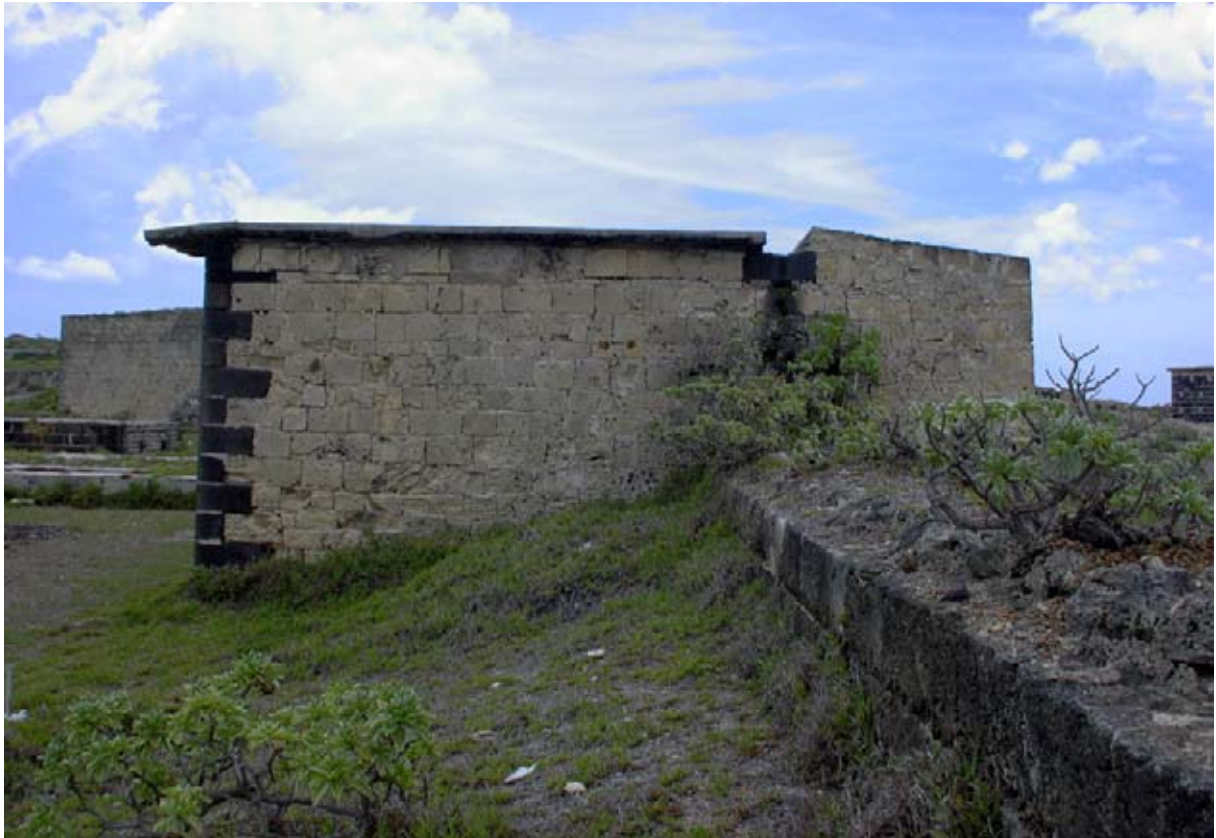
*The south side of the Storehouse, Wall F5 and the internal bank. Note the roof drain, the blocked vent and the sloping top of the casemate. (02jv011).*

The current state of this fine building is discussed in detail in the *Basic Architectural Survey*. Briefly, the WW II reinforced concrete roof needs to be replaced and a decision has to be taken about the safety of the partition walls.

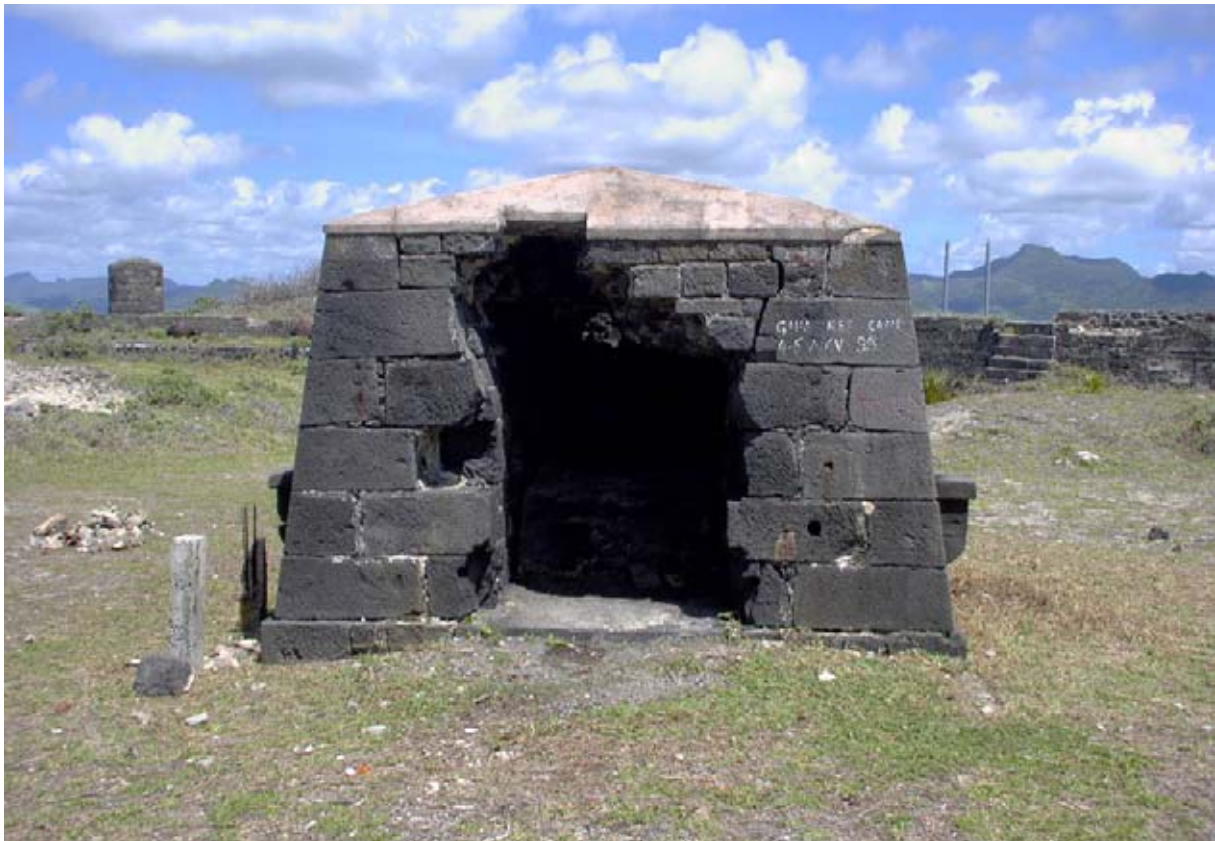
*The front and east side of the Shot Furnace with a fragment of an earlier structure at the front right. Note the opening at the front of the roof, the single course of offset footings and the drafted margins of the basalt ashlar. (02jv1023.*

The Reverberating Shot Furnace is in very urgent need of protection and, in the longer term, of expert restoration. It is possible that further cleaning around the furnace would shed useful light on the earlier structure(s), even though the bedrock is so very close to the modern ground surface, with the result that little if anything will have survived. The authors of this report are attempting to create a virtual reality model of the furnace as a first step in drawing up proposals for restoration. Further recommendations will be found in the *Basic Architectural Report*.

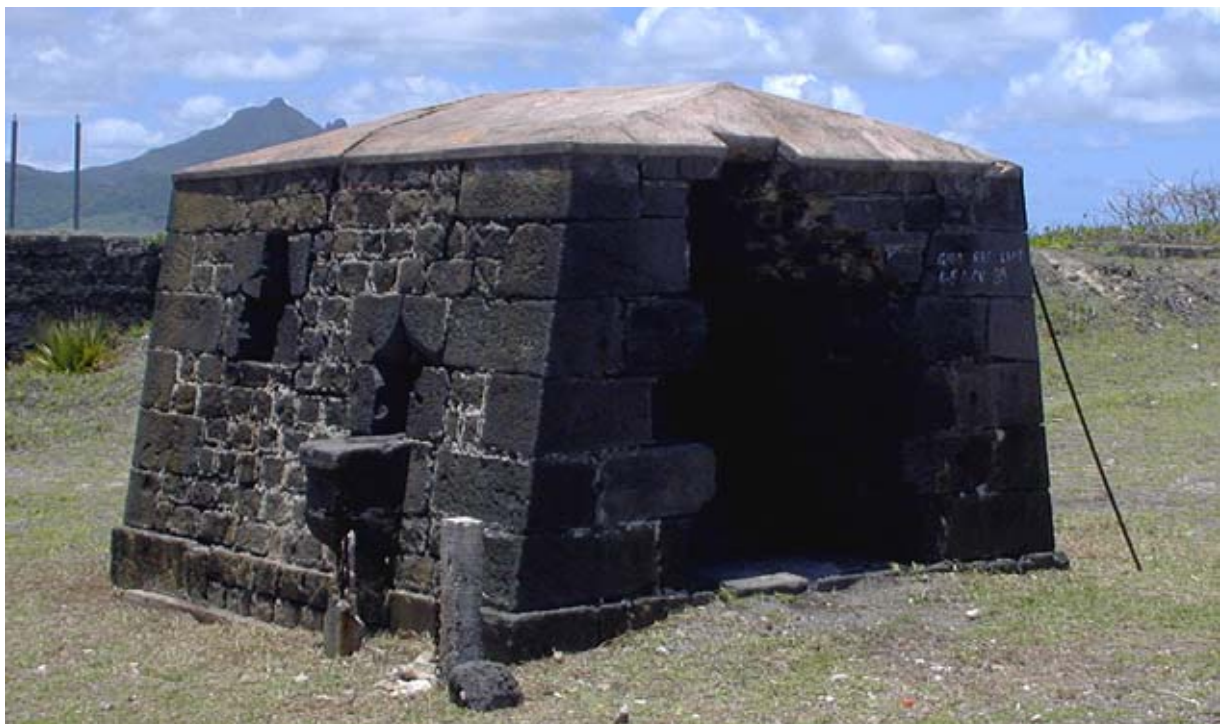
*The west side of the Shot Furnace showing the cantilevered receptacle and the higher opening behind into which cannon shot was placed. The form of the roof can be clearly seen. The concrete posts are modern. (02jv1118)*

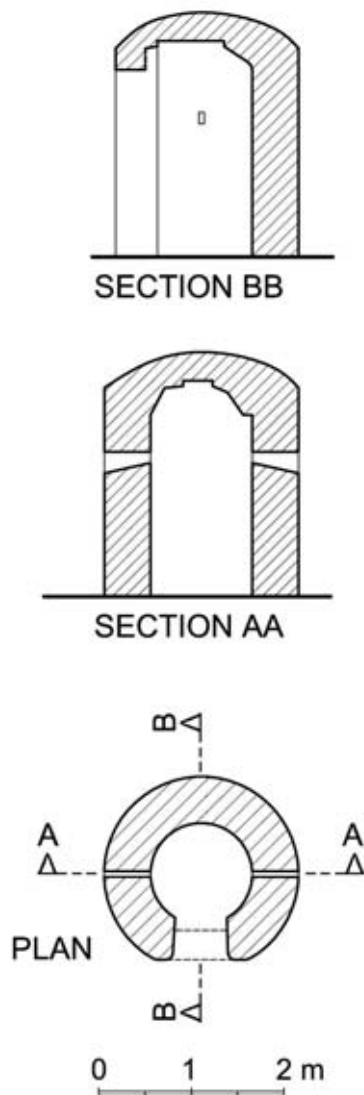
STRUCTURE 8  
NW SENTRY POST

*The North-West Sentry Post, at left, atop the defences, showing recent damage to the door. (02jv0217)*

Blocks have very recently been pulled out of the north side of the door in the North-West Post. These need to be mortared back into position as a matter of urgency. Otherwise there is no immediate cause for concern.

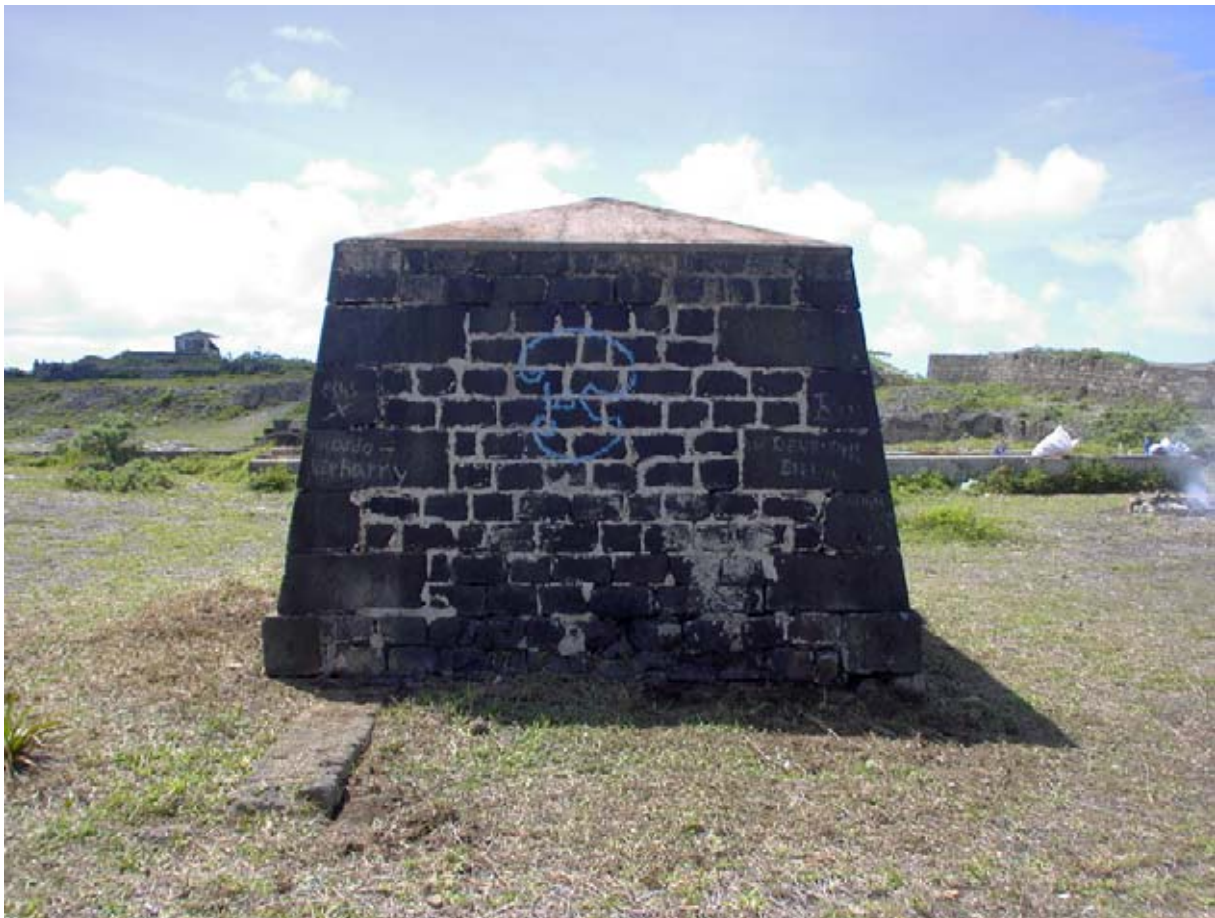
There are a number of structures and features that appear on the two French maps of the island that it has not been possible to trace. Indeed, it is very uncertain as to which, if any, of these structures were actually built. There are two exceptions. The first is an enigmatic fragment of lime-mortared coral wall that is mostly buried in the bank behind the North-West Battery, and the second is represented by fragments of coral walling that project from beneath the Shot Furnace.

*Coral walling projecting from beneath the Shot Furnace. (02jv1102)*

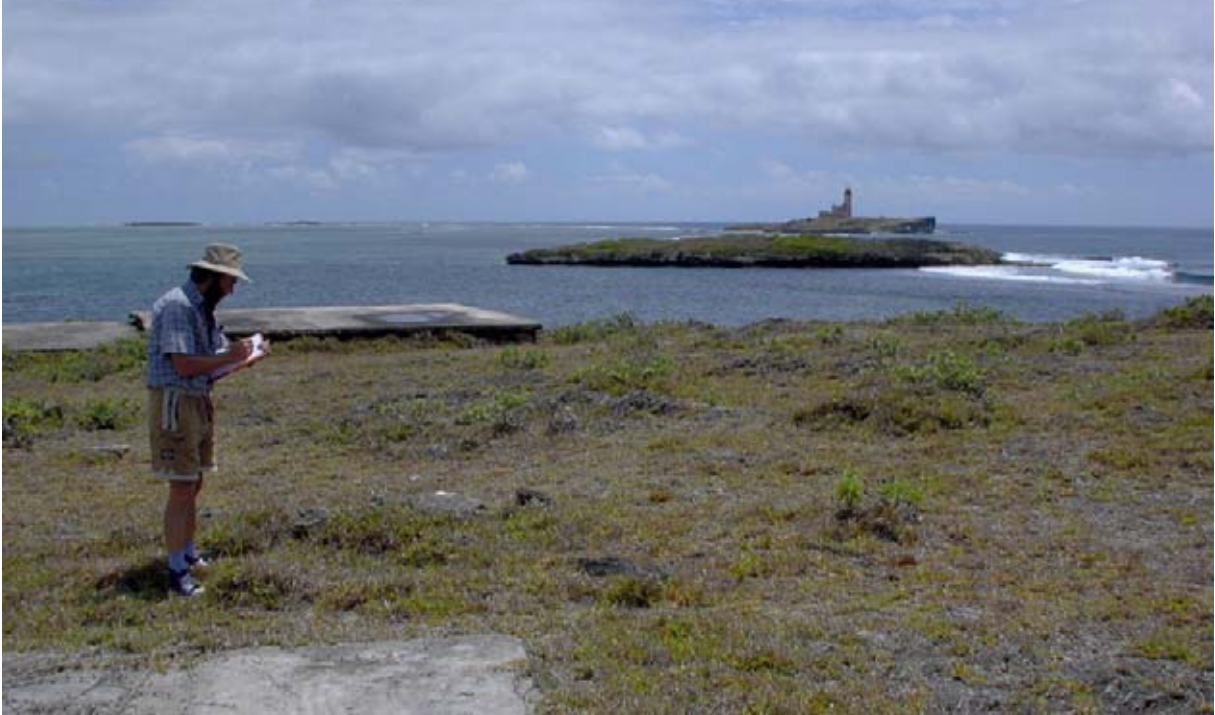
A single grave, apparently with the head at the east, is clearly visible on high level area to the north-east of the Powder House. The grave comprises a roughly rectangular area edged by a single level of unhewn stones that have clearly been deliberately placed. A reused basalt slab bearing an inscription now lies face down between the grave and the corner of concrete foundations from a WW II structure. The three line inscription reads the 86<sup>th</sup> Rg<sup>t</sup>, as reported by Pike (*op.cit.* 328-29):

*Standing by the lower corner of the Grave from which the Headstone, now laying face down in the grass, apparently came. Structure 18 is in the foreground and the Underground Generator Halls (Structure 7) lie beyond. (01vj0102)*

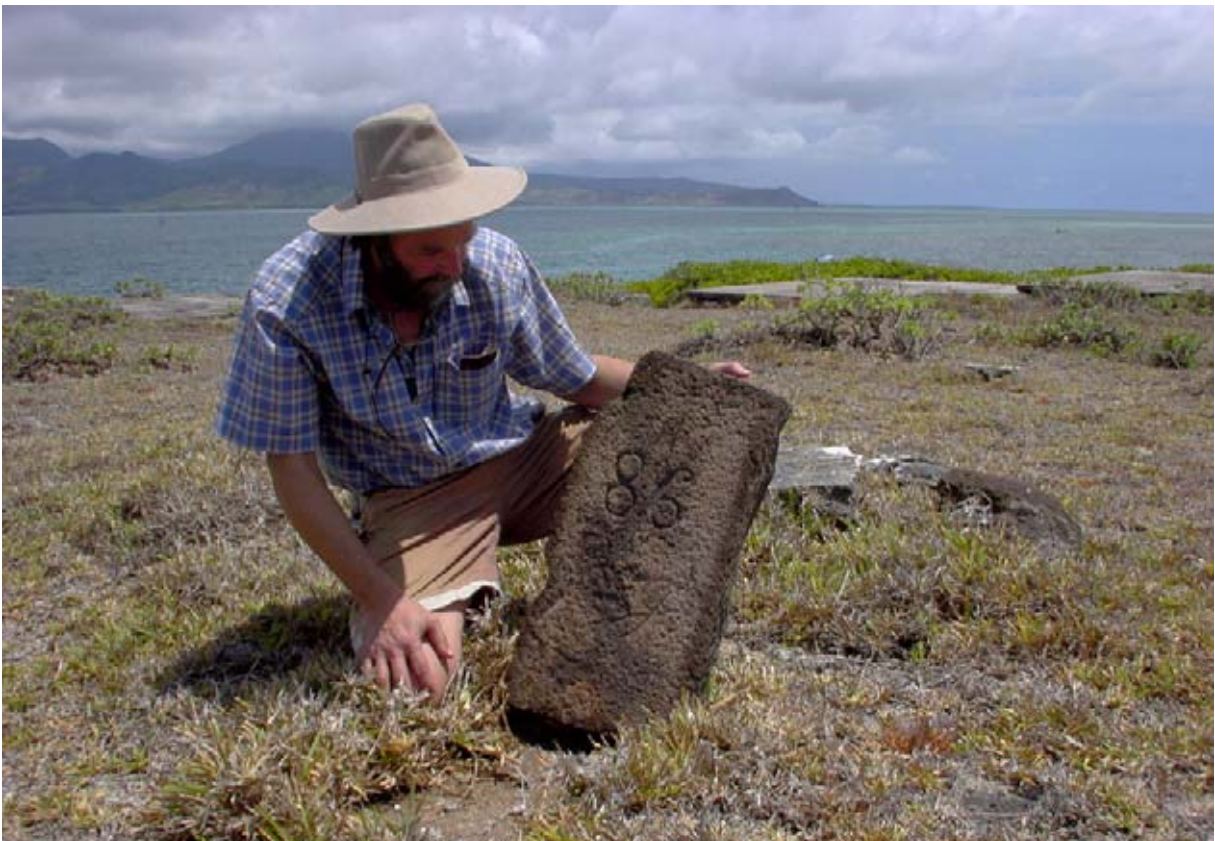
*The Headstone: the broadly cut **86** is clear whereas only cursive **g** of the more faintly cut Reg<sup>l</sup> is obvious in this photograph. (01jv0107)*

The 86 is very clear, being broadly and deeply cut, but the cursive script used for the lettering is rather superficial. The height of the 8 is 10.5 cm.

There is now a threat to the inscribed headstone which has, for the interim, been left face-down exactly in the same place as it was when rediscovered. Ideally the headstone should be replaced at the head of the grave once its security can be assured.

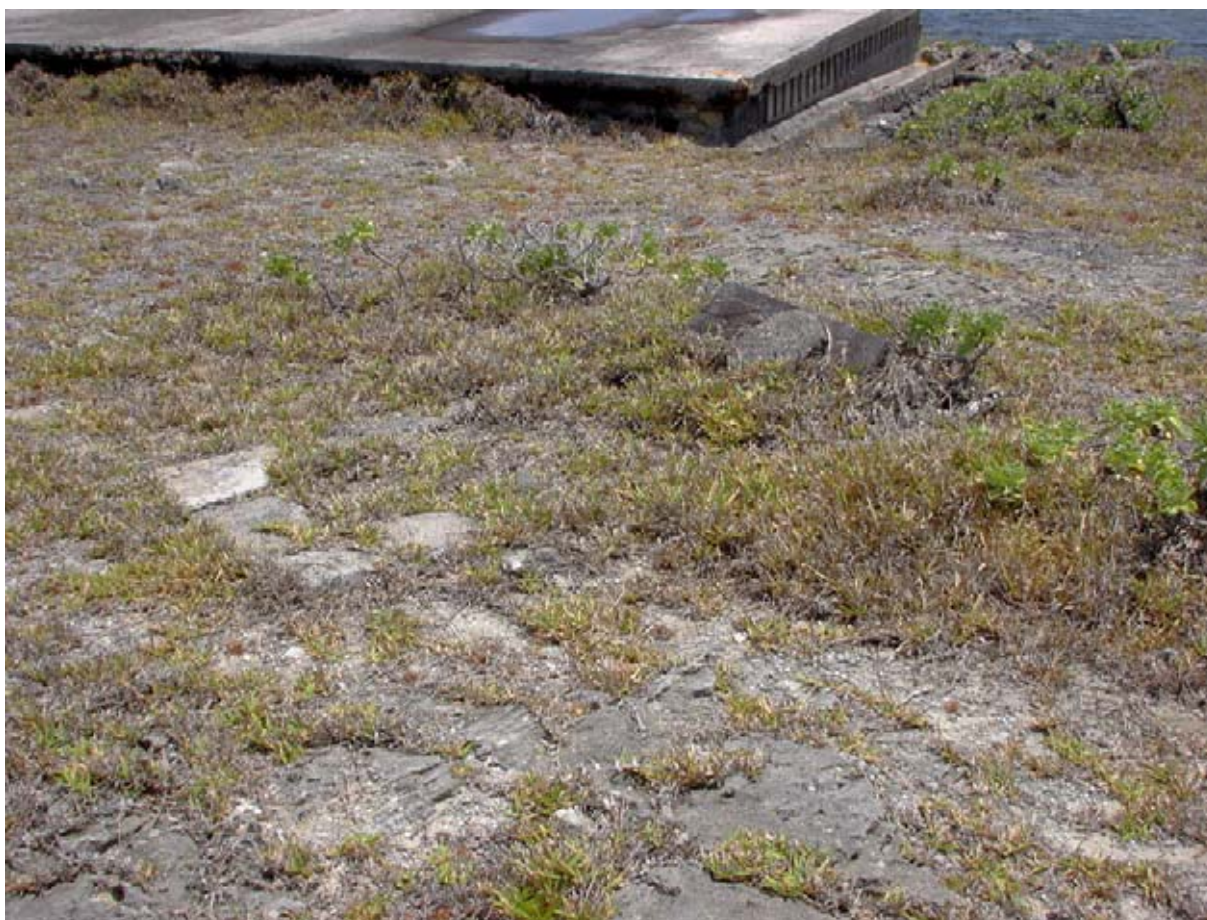
Other graves appear to have been moved a few meters further to the north-east, or to have been refurbished, in WW II, but few are now discernable.

*A second feature that appears to be a grave which was cleaned and relined or, perhaps, relocated in WW II. (01vj0115)*

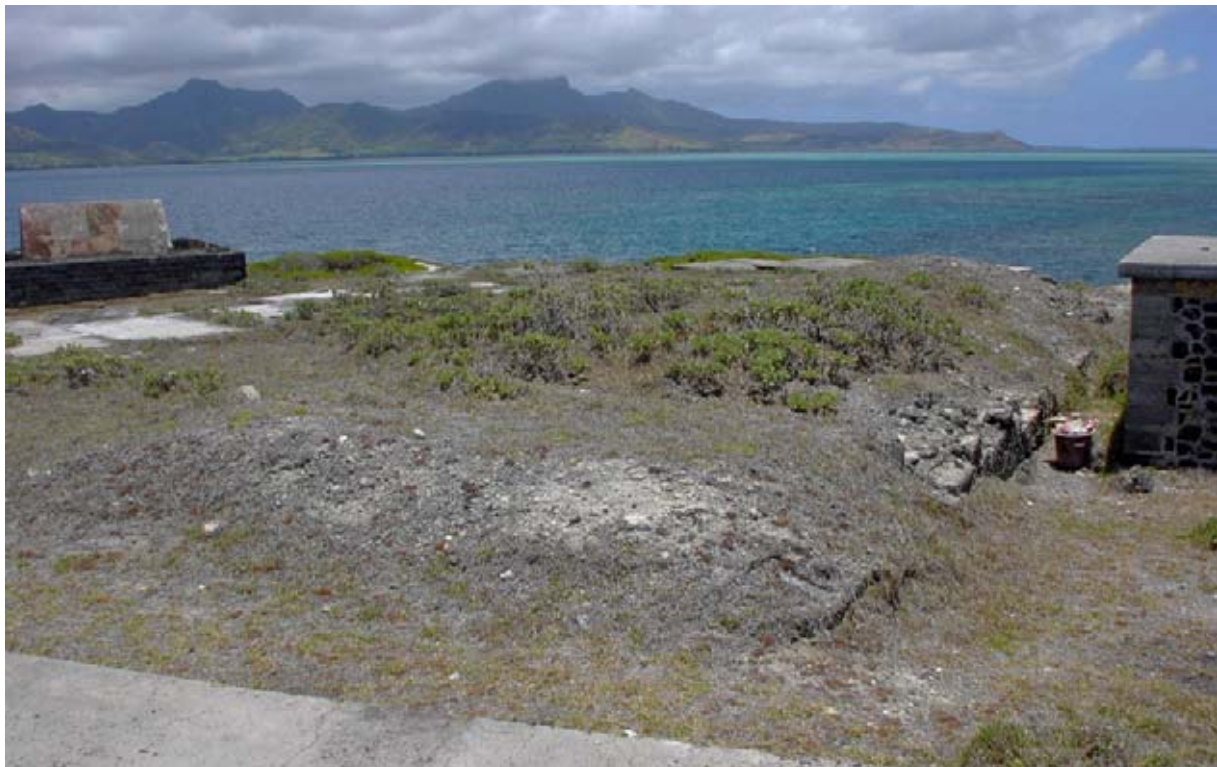
*The Platform of Structure 13 from the Upper Battery with the Central Building at right and the roofing of the Underground Generator Halls beyond. (01jv0204)*

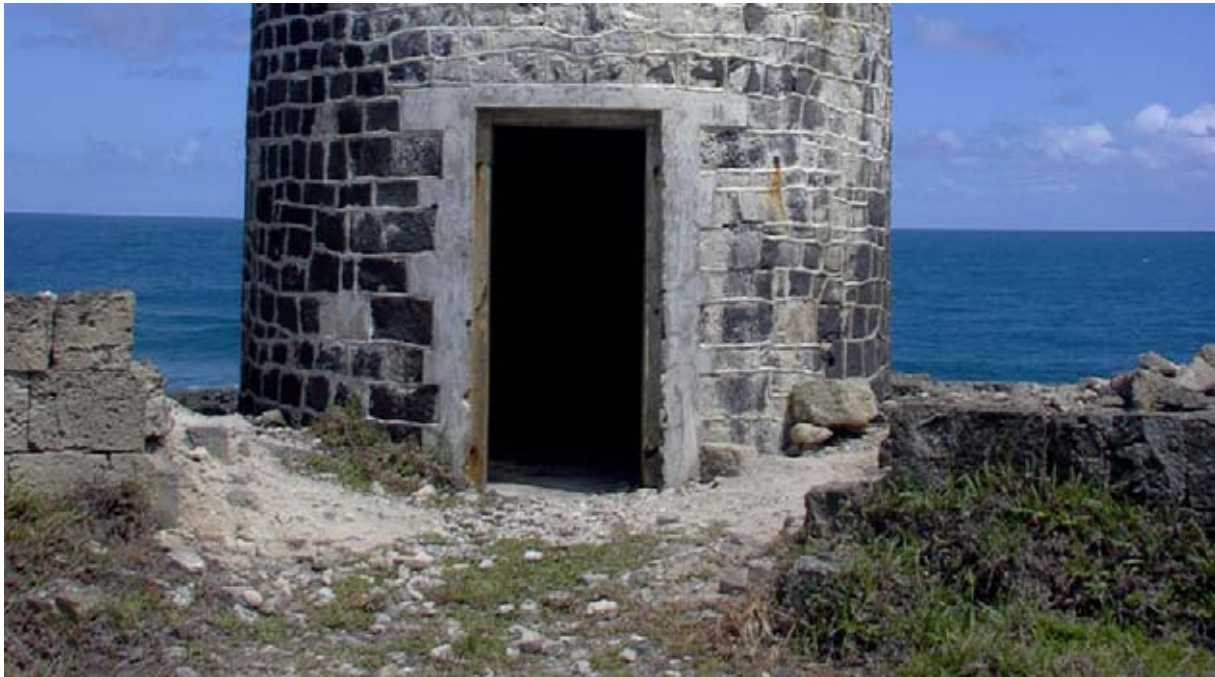
*The base of the Tower constructed in the earlier emplacement. (02jv0912)*

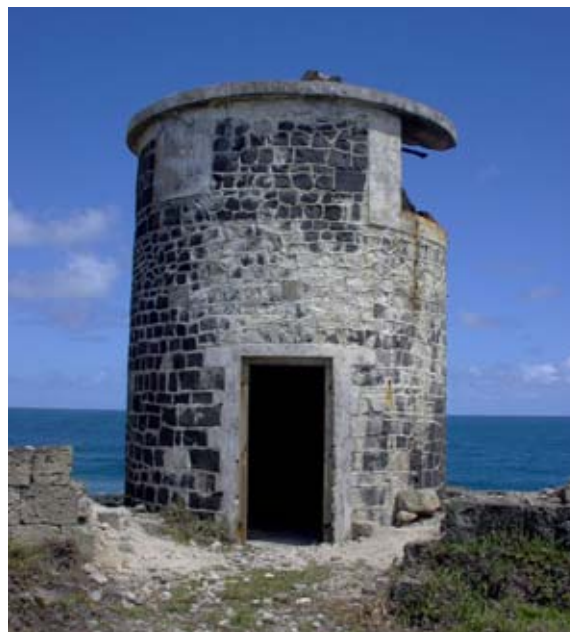
*The Observation Tower  
showing some of the alterations  
made in WW II. (02jv0416)*

The roof has partially collapsed, cracking the upper part of the walling on the east side, and is now extremely dangerous. There is neither door nor shutter, with the result that the wind and rain sweep in. The main stone wall of the tower, however, appears to be structurally sound.

In the *Basic Architectural Survey* the Tower has been singled out as having great potential as an attraction, and recommendations have been made for its consolidation and refurbishment.

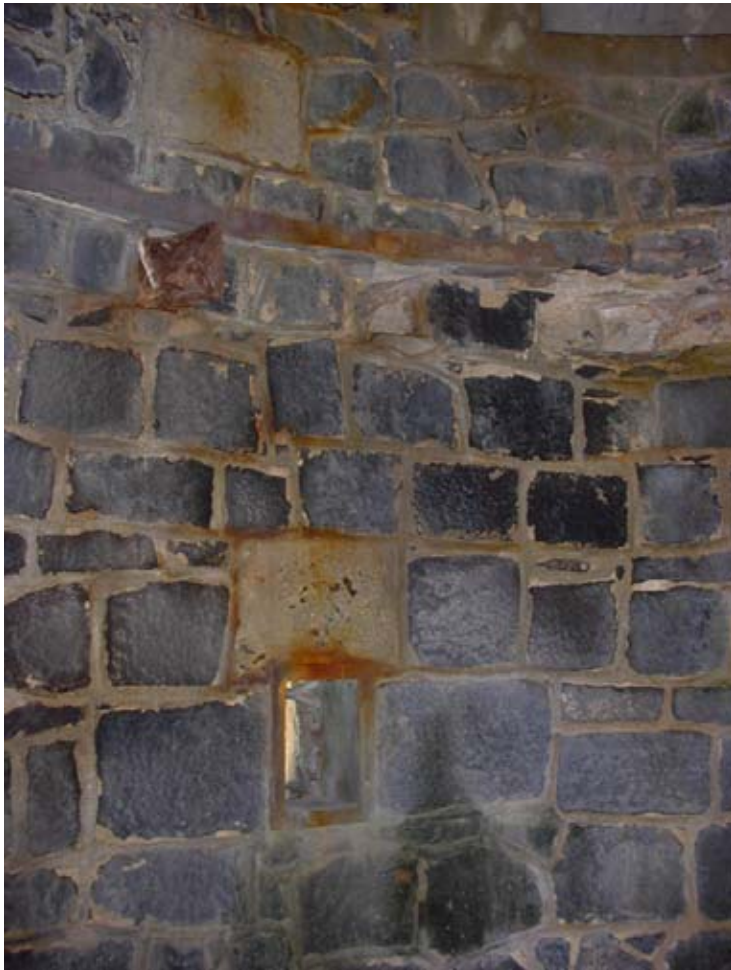
*Inside: a vent capped by a pre-cast concrete tie block and flanked by shaped stones. The cement rendering formed a skirting above the timber floorboards.  
(01jv0920)*

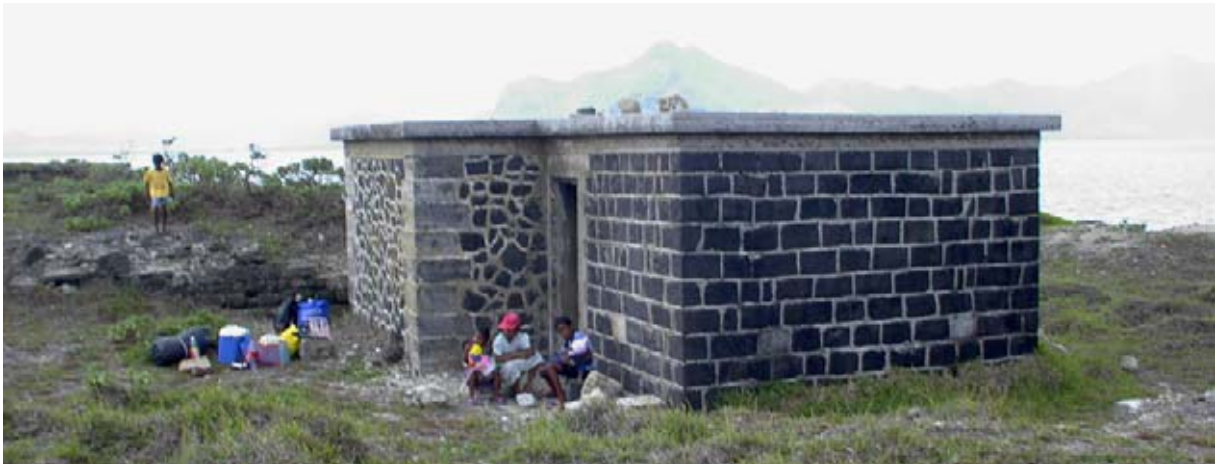
*The original phase of the Central Building comprised a single room built of basalt ashlar with concrete tie blocks. The addition was uncoursed with pre-cast quoins. (02cn0423)*

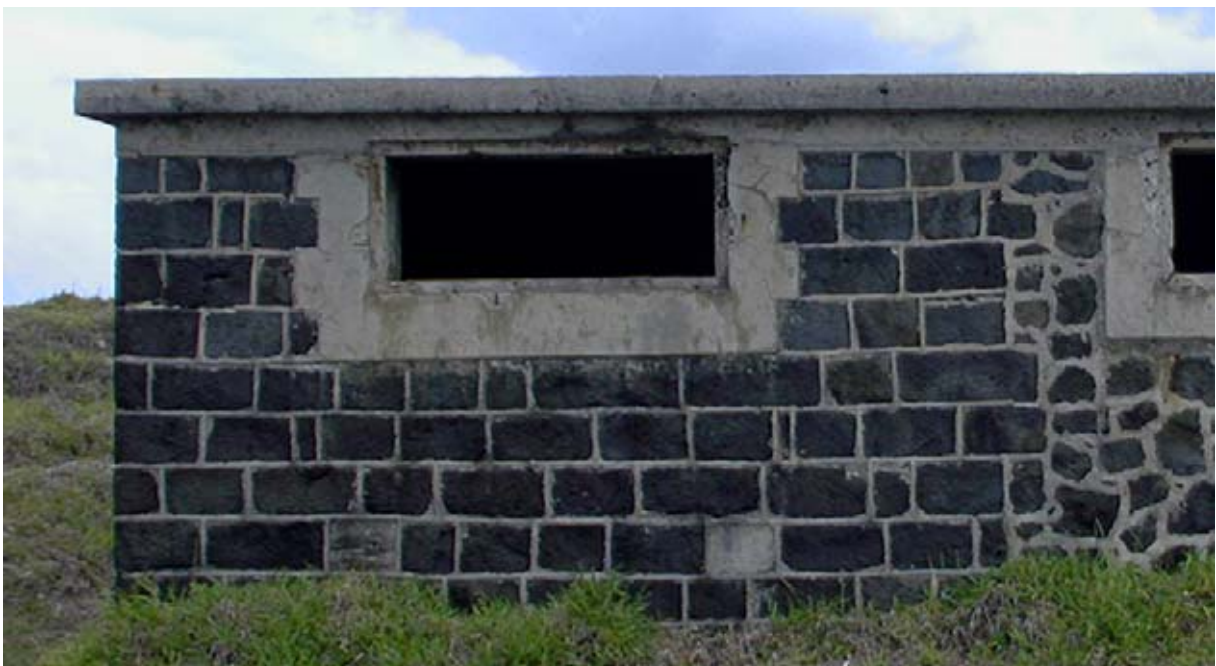
*Basalt ashlar and concrete tie blocks characterise the first building phase of the Central Building. The concrete window surround is WW II. (02jv0204)*

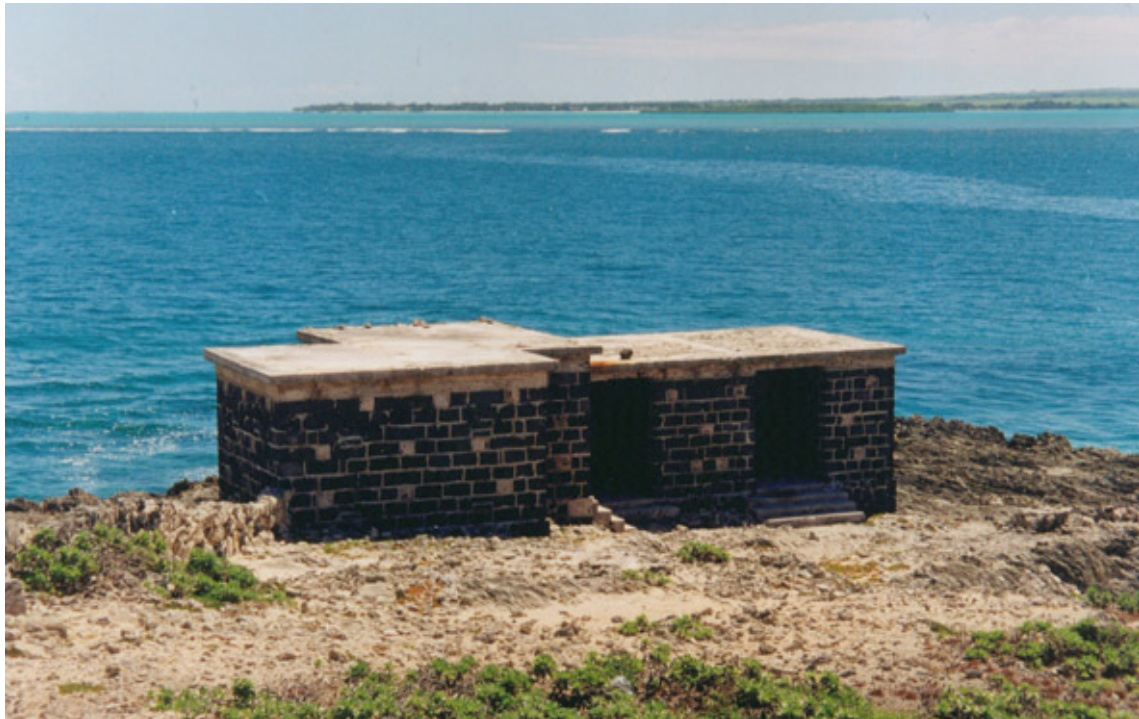
*The Western or Searchlight Building, Structure 12. (02cn0427)*

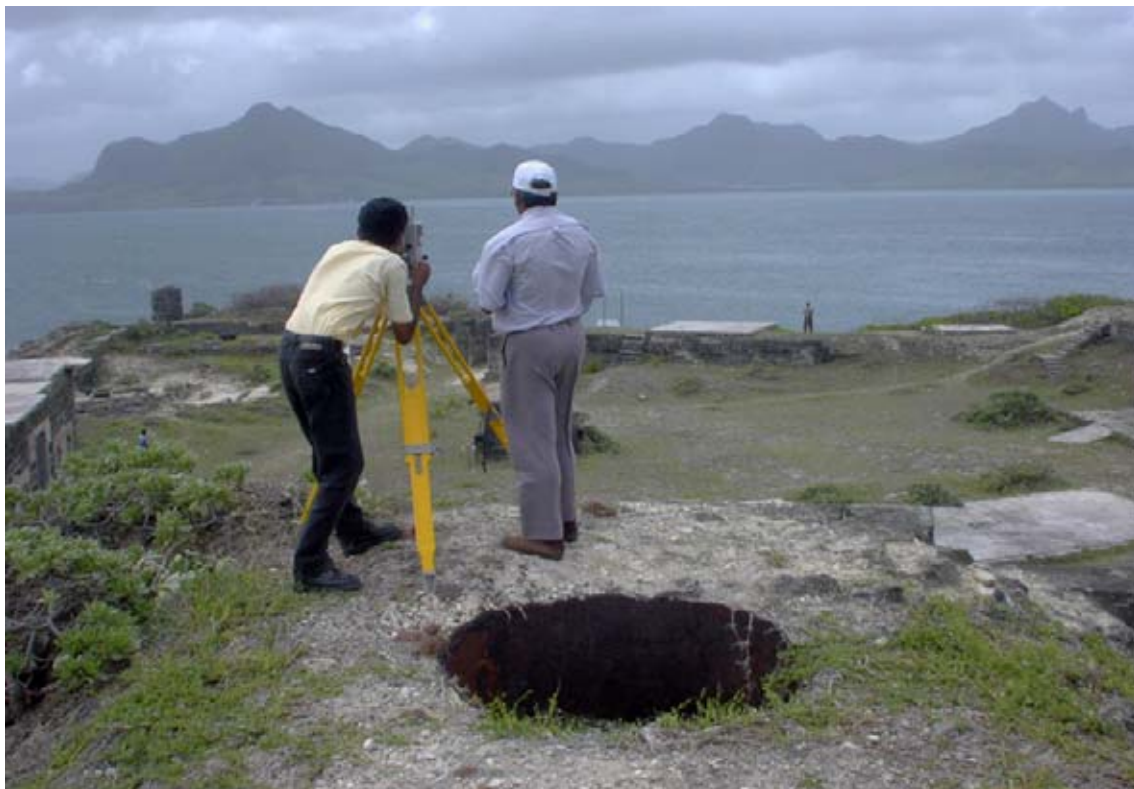
*The north end of the Upper Battery with the cylindrical iron feature. (02jv0618)*

The ironwork is in a poor state. Of the three cylinders in the top of the battery only the northernmost remains and this is in urgent need of consolidation if it is not to disintegrate. The concrete is solid and stable with very little cracking.

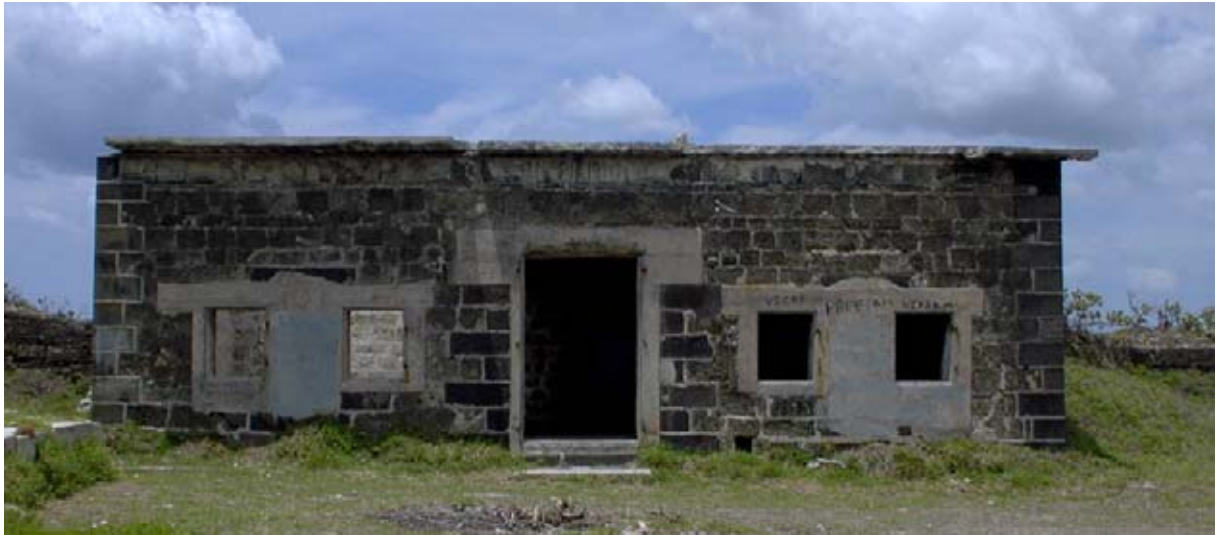
*The Storehouse Generator Building showing WW II modifications to the façade that entailed raising the door and replacing single windows with pairs in such a way that there was a new window in front of each generator. The basalt lintels to the original French windows can be seen. A new reinforced concrete roof was added and four openings were made at the level of the electric cable ducts in the new floor, one of which can be seen to the right of the door below the corner of the window. (02jv0114)*

The roof of the southern room has been largely removed. In general the remainder of the roof and the two partition walls are extremely dangerous. The French structure, on the other hand, is in very good shape. This structure is a major priority for conservation and restoration. Recommendations have been set out in the *Basic Architectural Survey*.

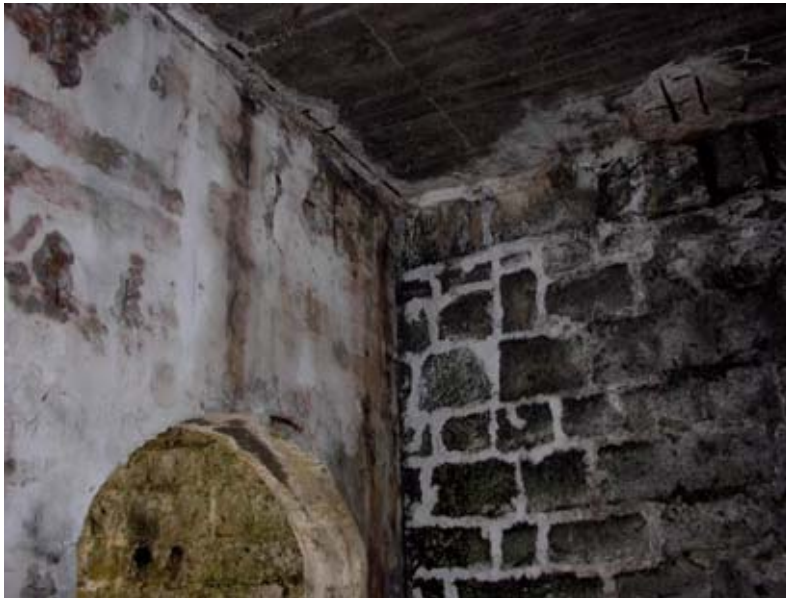
*The Storehouse Generator Building showing the southern reinforced concrete partition with the arched door and the roof, both added in WW II. (02jv0810)*

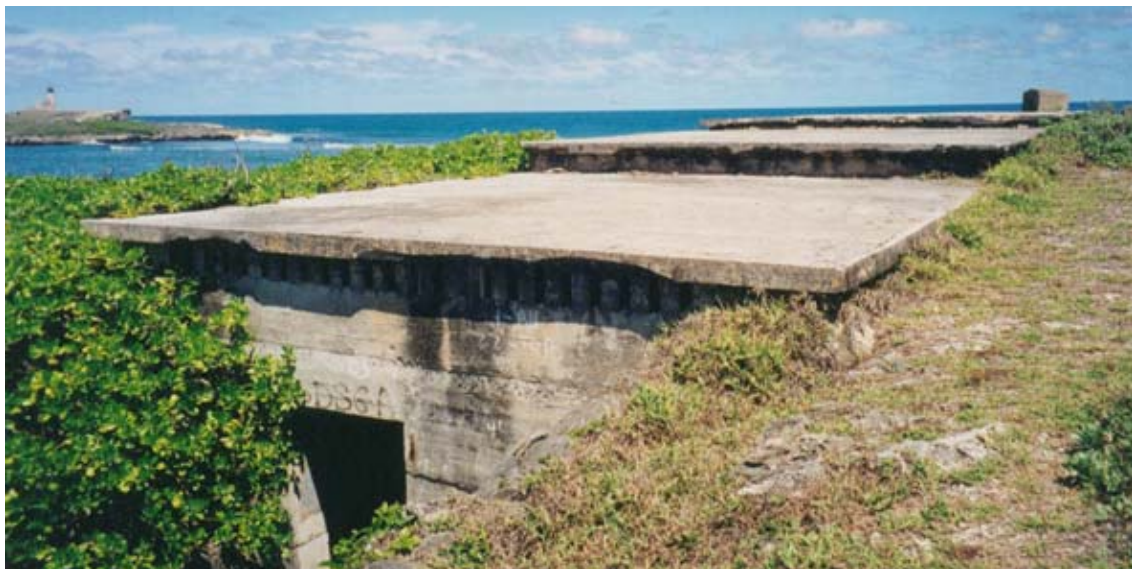
*The Underground Generator Halls, Structure 7. The ventilation grills can be seen in the shadow of the roof. (02cn0415)*

Fouled and marred by recent graffiti, the structure is also somewhat dangerous because the reinforcement in the concrete is corroding and, as it does so, splitting away pieces of concrete, especially from the underside of the roof.

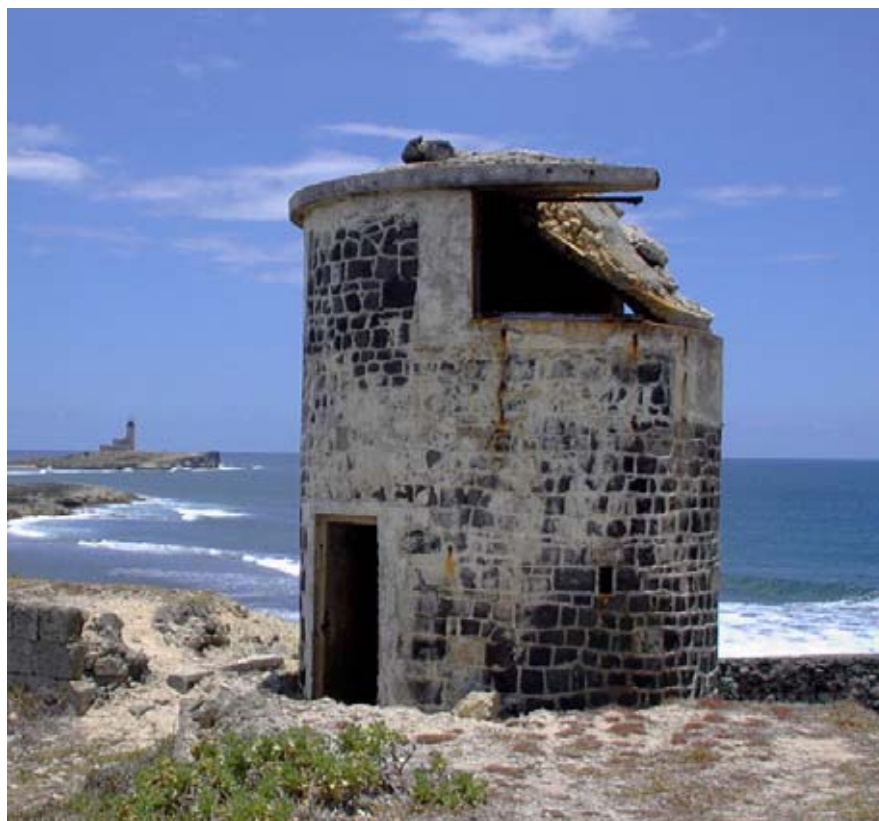
*The Observation Tower with WW II blocking below the wide window. (01jv0203)*

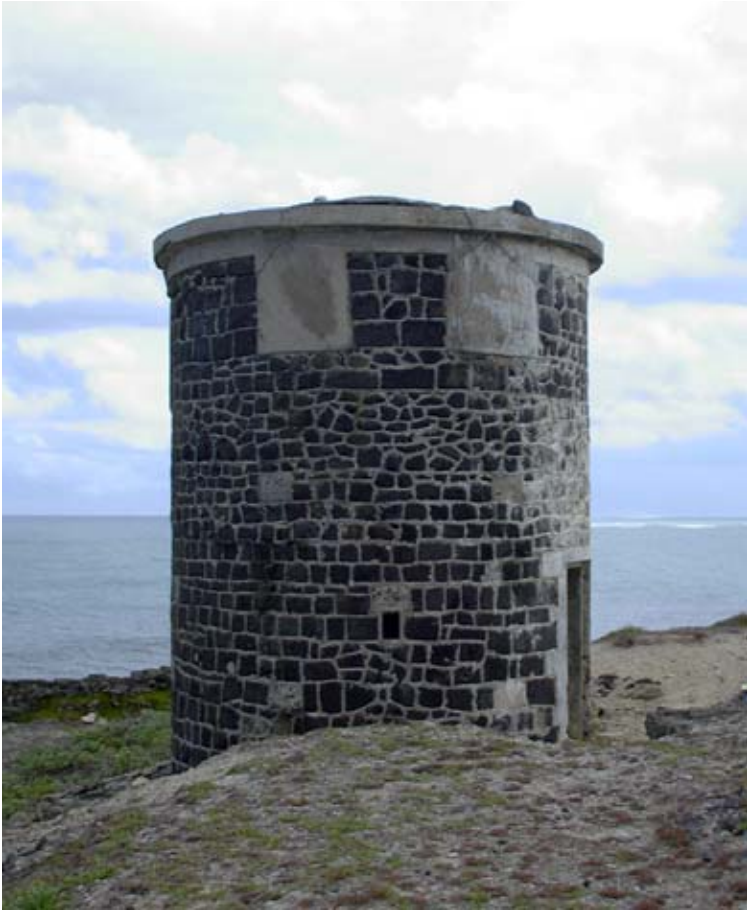
*The upper windows, blocked in WW II, the construction stages and the original precast tie blocks. (02jv0415)*

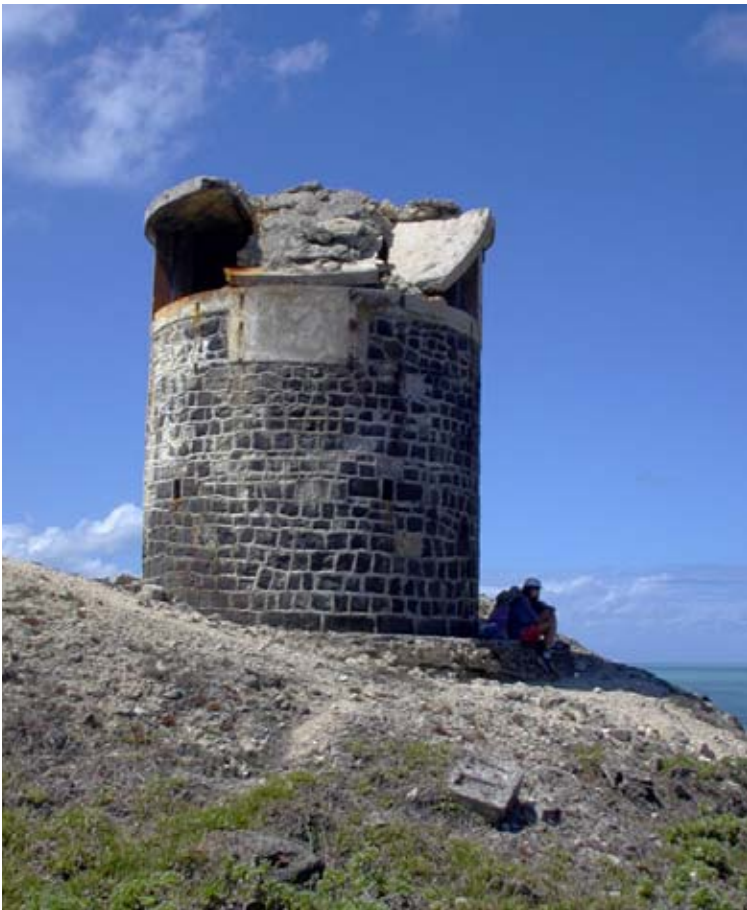
*The bottom course of large shaped basalt blocks sits directly on the concrete base. Large shaped stones also flank the vents. The WW II roof has collapsed. (02vj0913)*
