# **ILE DE LA PASSE**

## **REPORT 1**

### **ARCHEOLOGICAL AND ARCHITECTURAL SURVEY**

**Geoffrey and Françoise Summers**

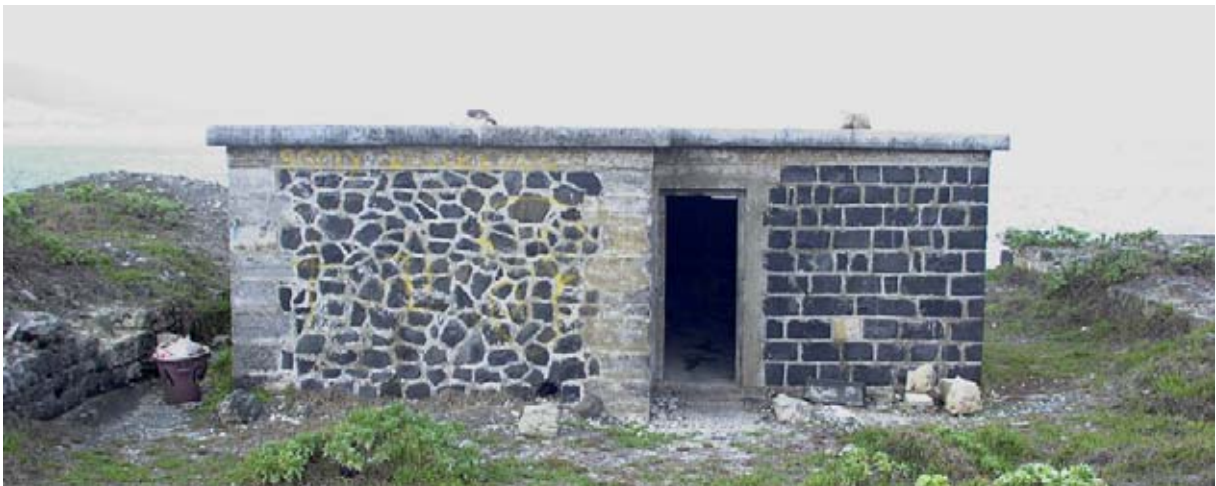
The entire structure is currently stable. The iron reinforcement in the slab roof, and to a lesser extent in the lintels, is badly corroded. As metal corrodes it expands, thereby causing the concrete to break up, and loses its strength. At some point in the future it will be necessary to take some appropriate action to preserve (or replace) the roof.

*The west side of the Central Building showing the earlier walling on the right and the addition on the left with pre-cast cement blocks used as quoins, and the uncoursed masonry style. The entire building was given a ring beam and new roof and the earlier doorframe was revamped. (02jv0402)*

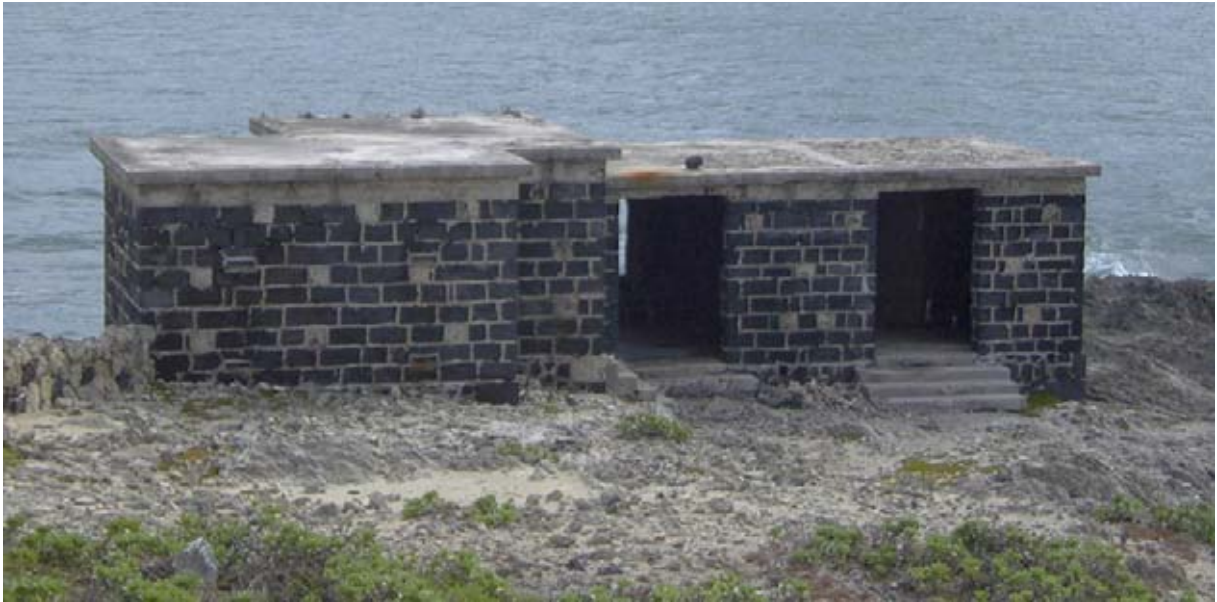
Apart from a small amount of repointing and repair, which it might be expedient to carry out in the very near future, the building is stable. As with other WW II structures it will, at some point, be necessary to take some appropriate action to preserve (or replace) the roof.

*The Western, Searchlight, Building - Structure 12. Note the pattern of pre-cast concrete tie blocks and the keystones over each of the vents in the original structure. In WW II a ring beam, reinforced concrete roof, concrete steps and a new floor containing ducts for electrical wires were added. The walling was repointed and the openings on the seaward side were greatly reduced. (02jv0419)*

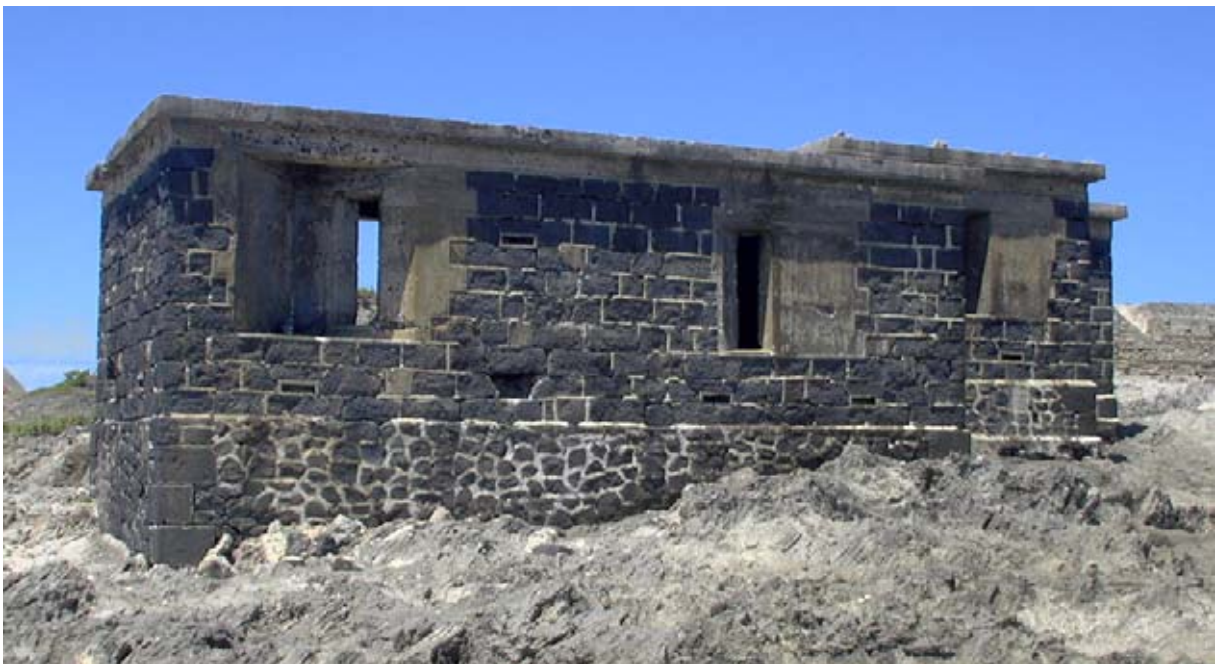
*The Western, Searchlight, Building (Structure 12) from the west showing WW II modifications to the original windows. (02jv0902)*

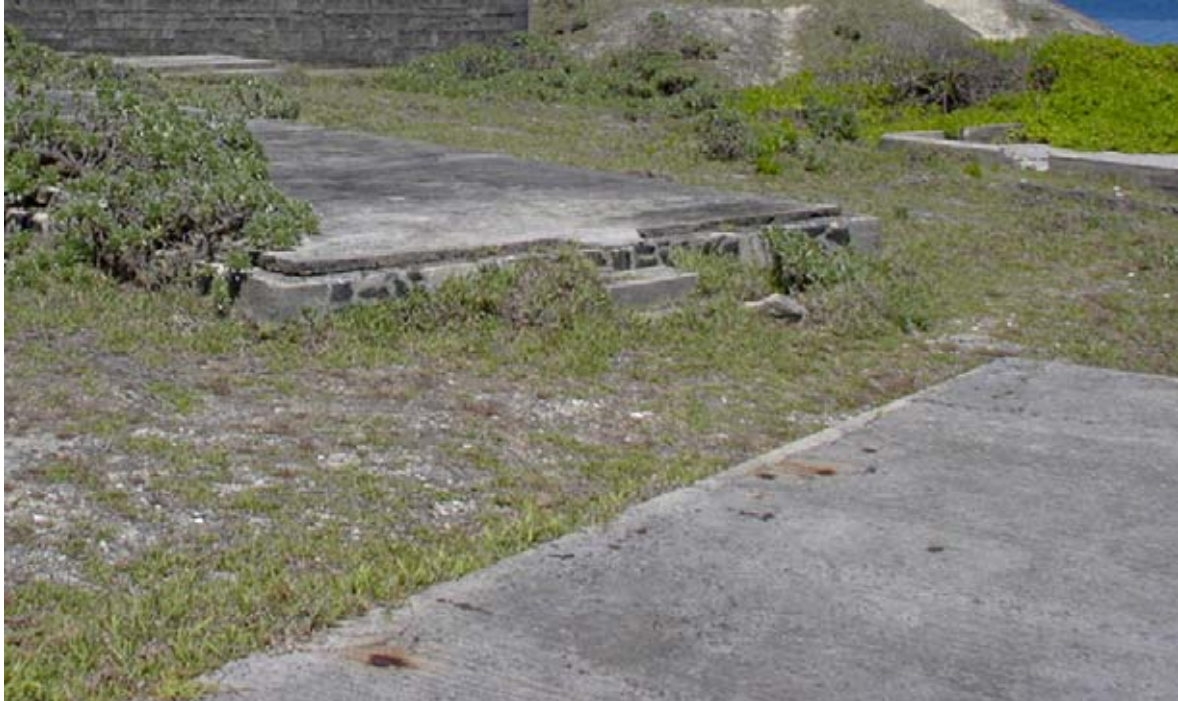
*Rusty remains of iron pins can be identified on some of the structures. Most of the building platforms were made of uncoursed basalt with precast concrete corner blocks. (02jv2215)*

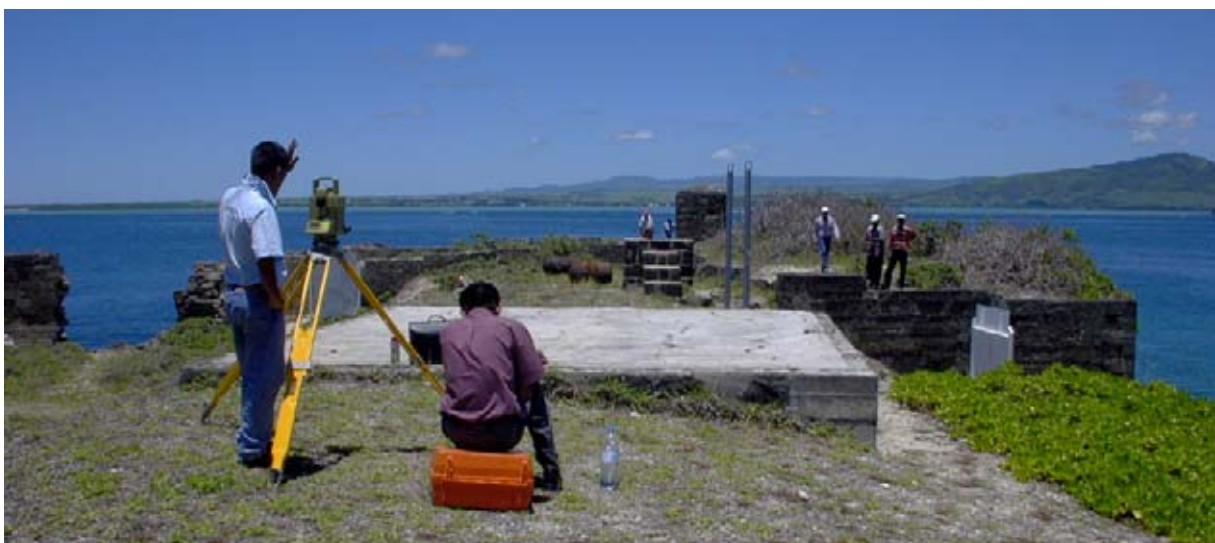
*Structure 22, on the North Platform, from the east. Precast concrete corner blocks and the concrete in which the metal pins were set can be observed. (02jv2217)*

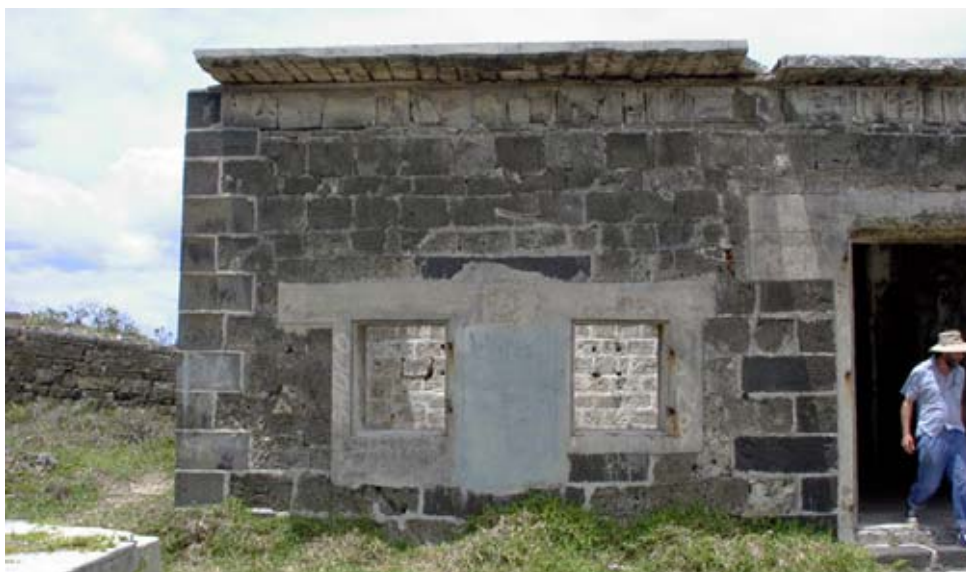
*Two new windows replaced single opening which is indicated by the surviving basalt lintel and sill. The door was also remodelled with a concrete lintel and sides. (02jv0115)*

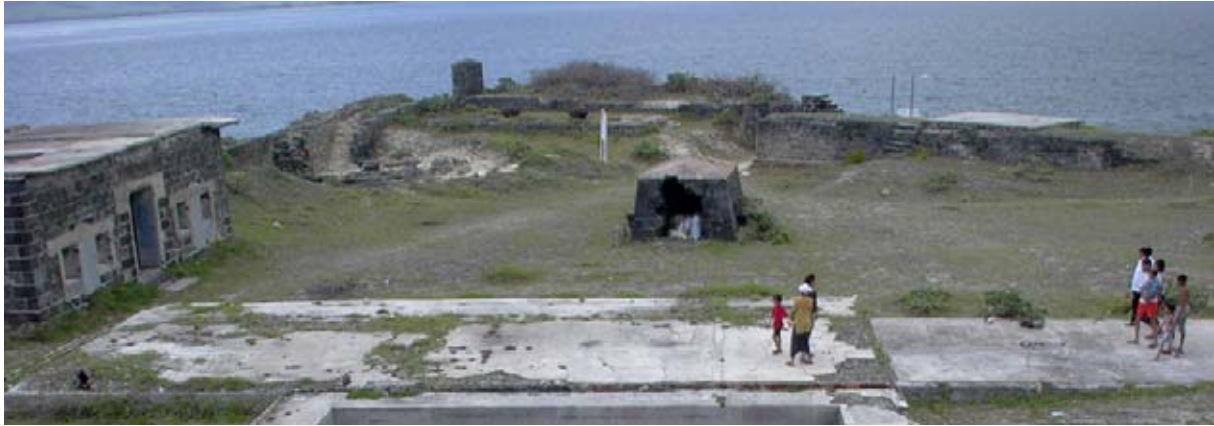
*The Barracks (Structure 5) with Structure 18 at right and part of the cistern in front.  
(02jv0318)*

Floors are fragile and peeling off. Vegetation should be discouraged from growing into the cracks but should not be pulled out because this will cause further damage.

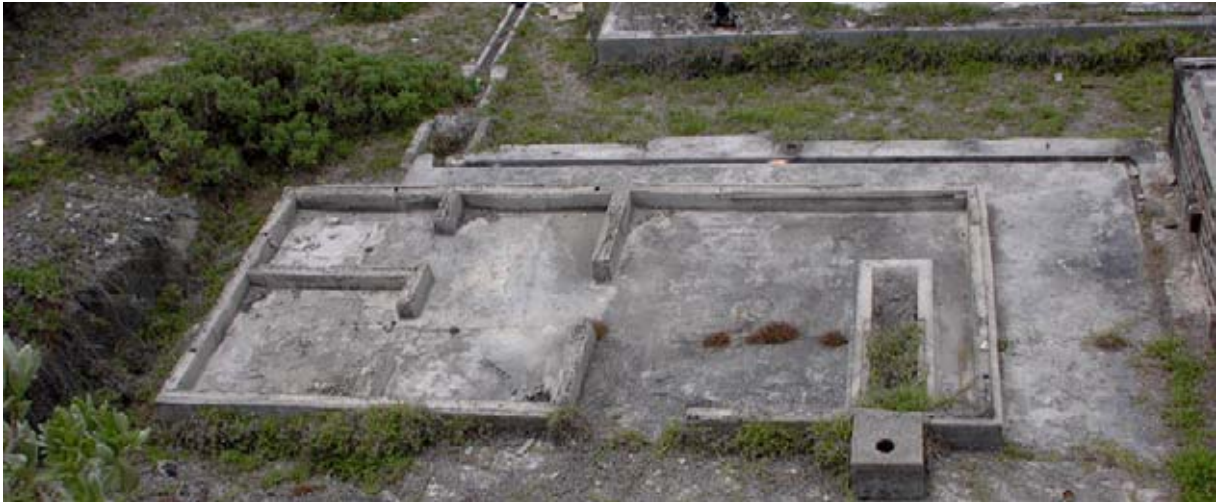
*The Cookhouse - Structure 6 - and drain with the end of the Barracks behind. This Structure retained both its form and its function from the earliest French period, as seen on the maps. The oven and a base for an iron chimney are seen at left and the only external door was from the back. Hygiene was improved by the addition of a concrete surround and good drainage. Note the drain with its sump at to, the internal ash pit which was beneath the oven and the external base for the iron chimney pipe. In WW II the only entrance was in the rear wall. (02jv0317)*

Requires removal of the vegetation and perhaps some patching or repair. Earlier and contemporaneous walling and floor to the south needs to be carefully revealed and studied.

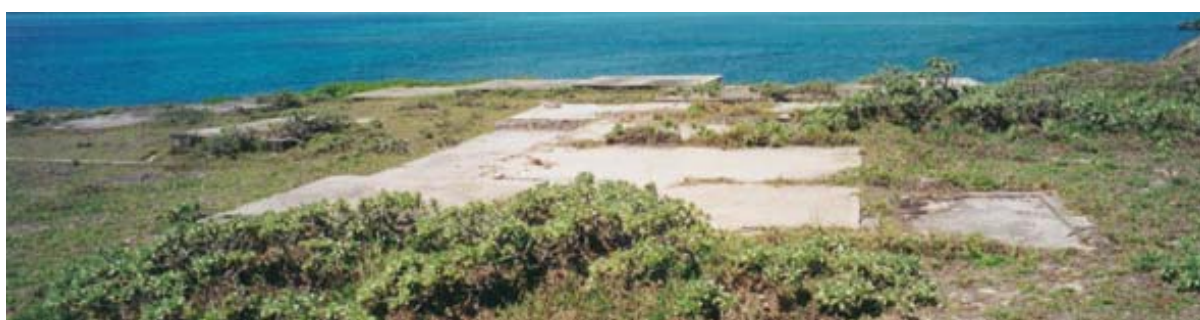
*Structure 14 showing the additional room on the south-west corner at right. (02cn0429)*

Some vegetation and resultant cracking.

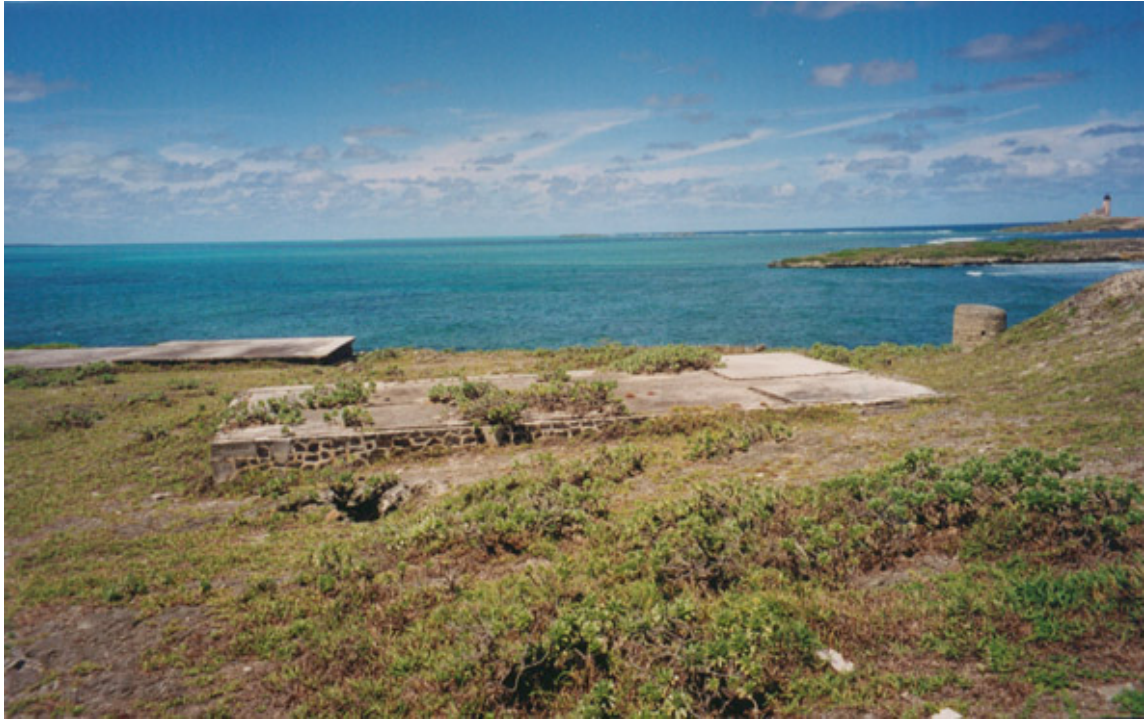
*Structure 15 with the Underground Generator Halls behind at left and the East Sentry at right. (02cn0419)*

Some vegetation and resultant cracking.

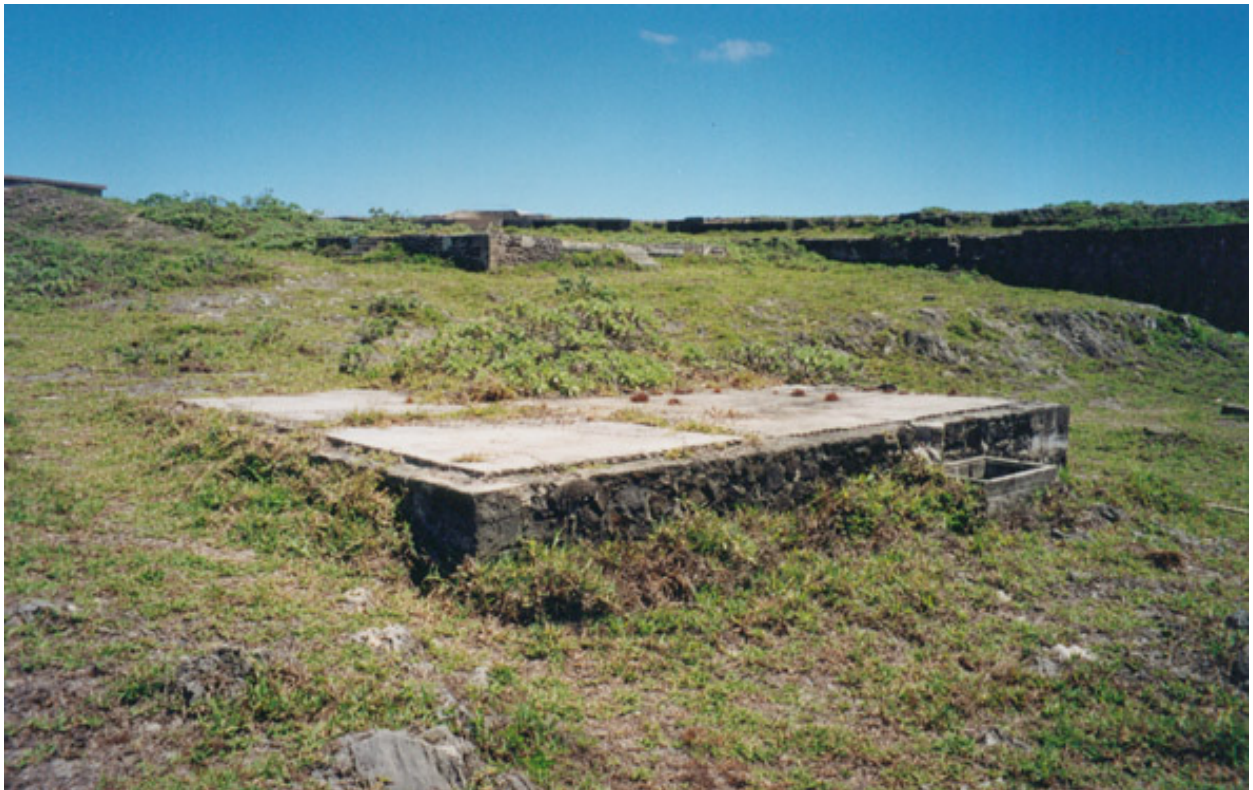
*Kitchen (Structure 16), showing the sump for the drain, with Structure 14 behind. (02cn0418)*

The concrete floor and partition slots are being broken by vegetation.

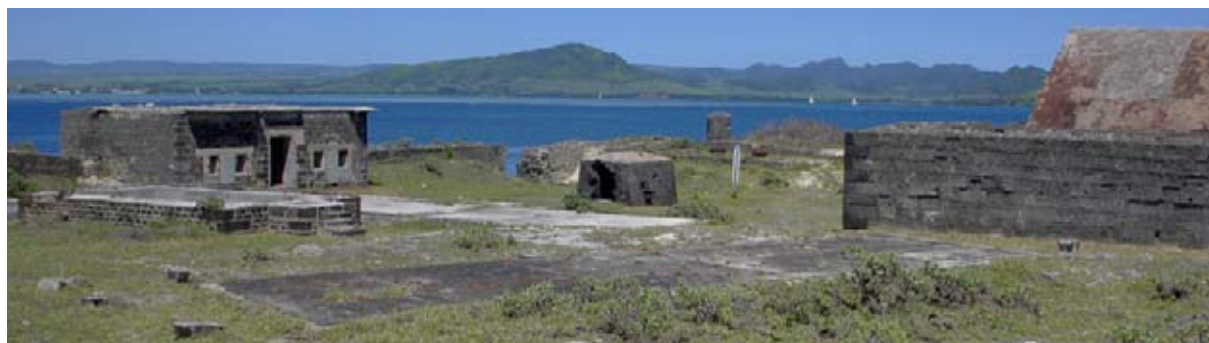
*Structure 17 from the south-east, looking across Structure 18 to the Shot Furnace. The Cistern is on the left with the Storehouse beyond. The North-West Sentry Post is in the middle distance and the Powder House at left. (02jv2216)*

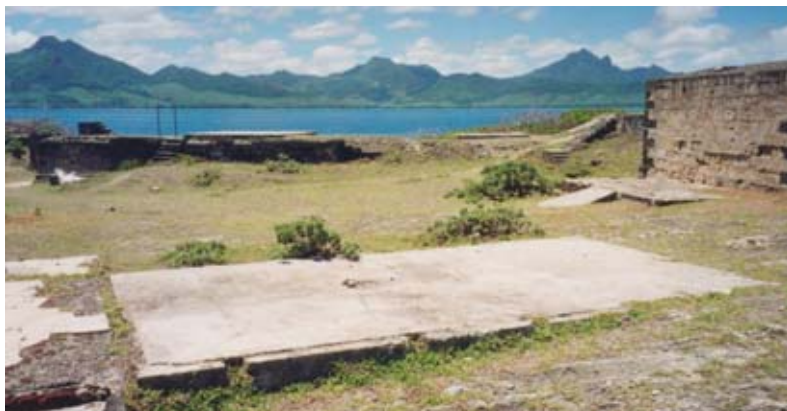
*Structure 18 was butted against the east end of the Barracks (Structure 5). Structure 18 differs from other WW II platforms in having had vertical iron rails, since removed, that supported the superstructure. (02cn0405)*

Structure 18 is butted against the existing wall of Structure 5. This wall was seemingly shared by the two buildings. The foundations incorporated large iron posts or rails, only indicated on the front wall on the plan, that were levered out and taken away when the superstructure was removed.

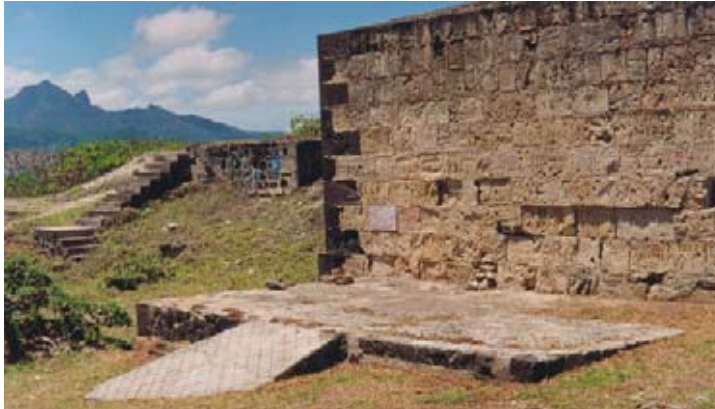
*Structure 19 built against the enclosure wall of the Powder House. Two of the concrete settings that held the iron frame for the superstructure can be seen in the front, one immediately adjacent to the ramp and one by the near corner. (02cn0406)*

The floor and the ramp are both cracking.

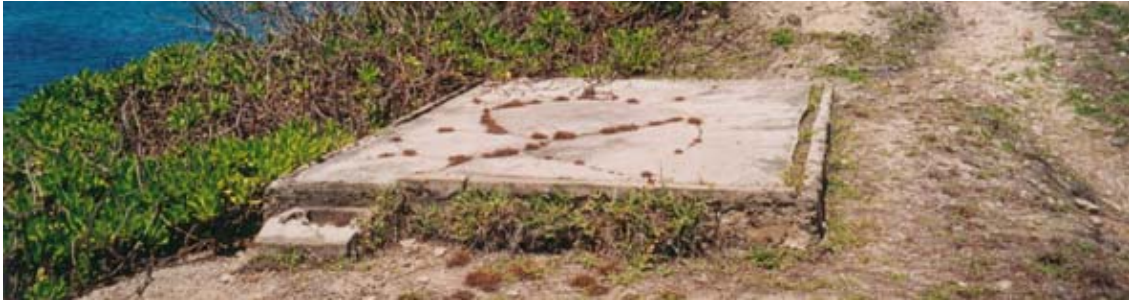
Structure 2: the step to the doorway, at bottom left, was a sump originally covered by a metal grill. The sunken wall base is not seen on other platforms. (02cn0410)

The floor is cracked.

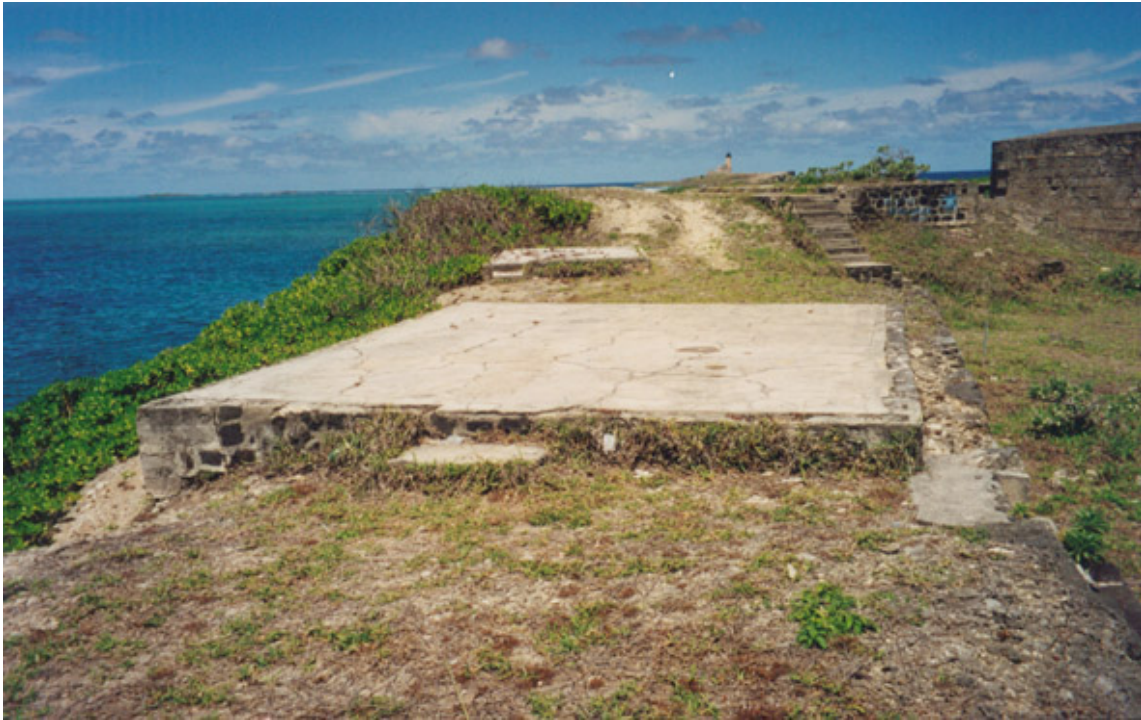
*Structure 22 with Structures 21 and 20, with the stairs, behind. The WW II steps onto the top of the earlier platform are at bottom right and the doorway into the single roomed building can be seen in the centre foreground. (02cn0409)*

The floor is cracking.

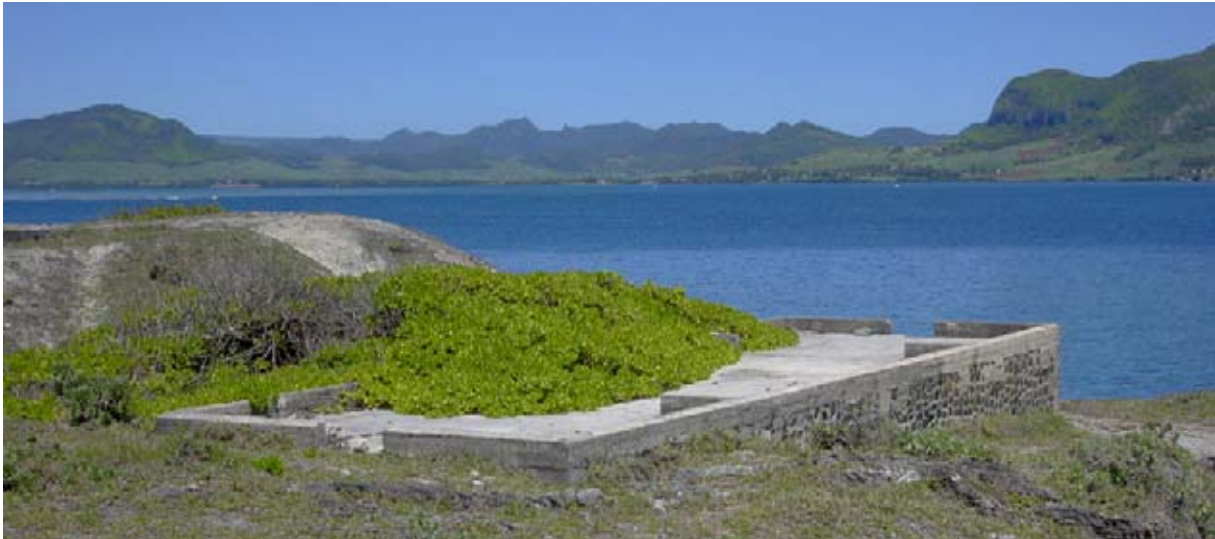
*Structure 24 from the south-east with the North Battery behind. The solid low walling is only seen here and at the Cook House (Structure 6). There are central doors at either end and short partition walls on each side. The patches of concrete in the basalt terrace wall housed the base of the iron frame. (02jv2209)*

Stable, although there is some cracking of the floor and alcove walls. The west side is attractively obscured by bushy vegetation.

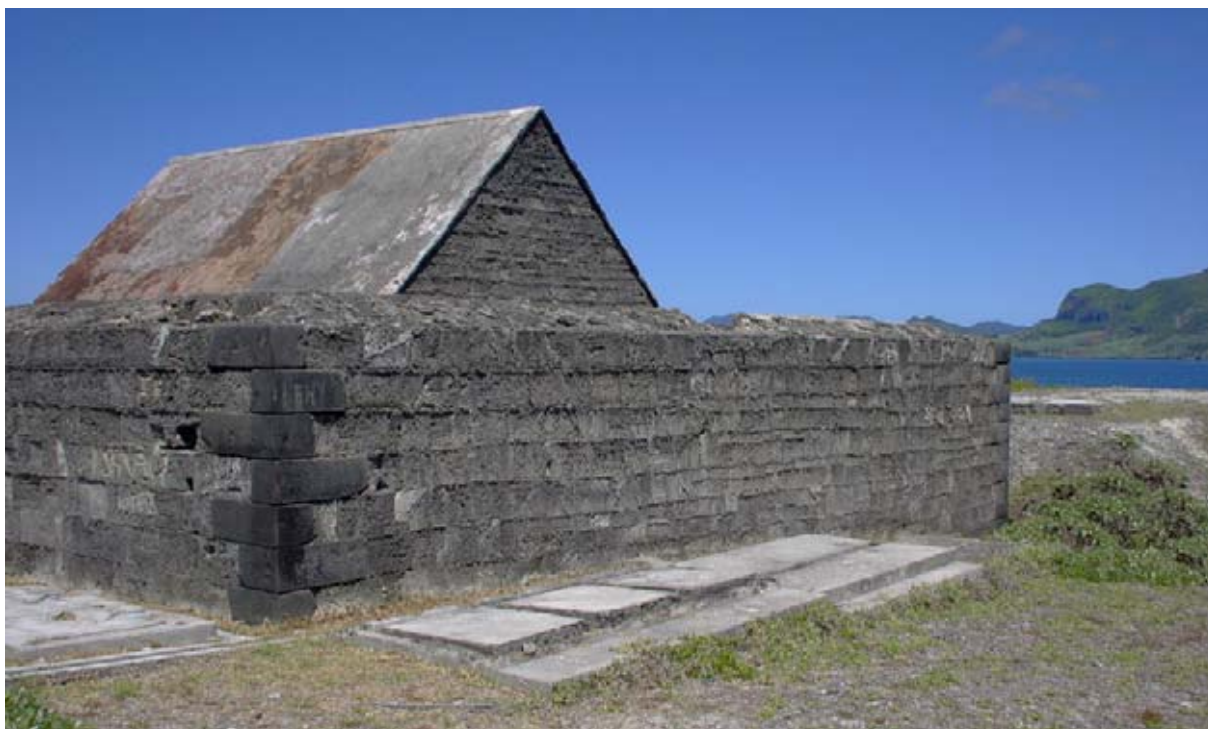
*Washing Facilities, Structure 26, by the east wall of the Powder House Enclosure. (02jv2207)*

Well preserved.

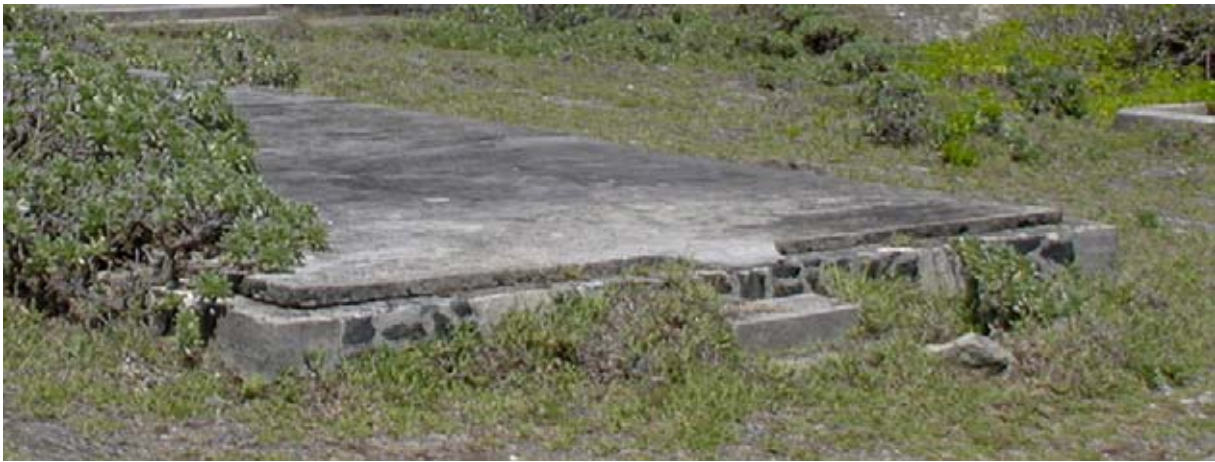
*Pre-cast concrete blocks have been used at the corner of the building platform. (02jv2215)*

Vegetation is cracking the floor.

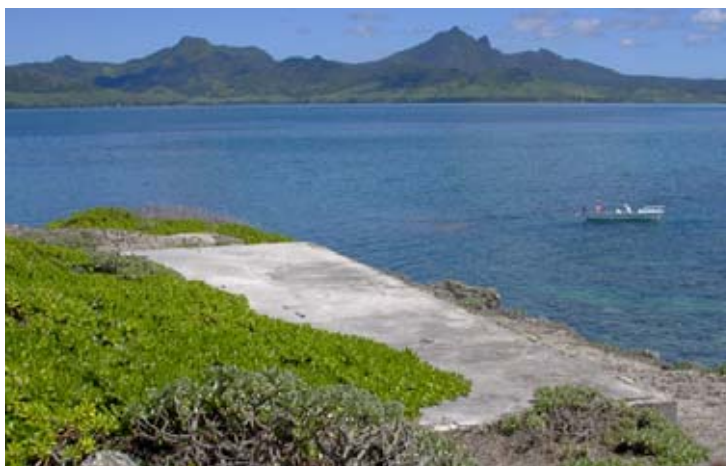
Structure 29 from the north.  
(02jv2214)

Overgrown along one side, the cement floor is cracking.

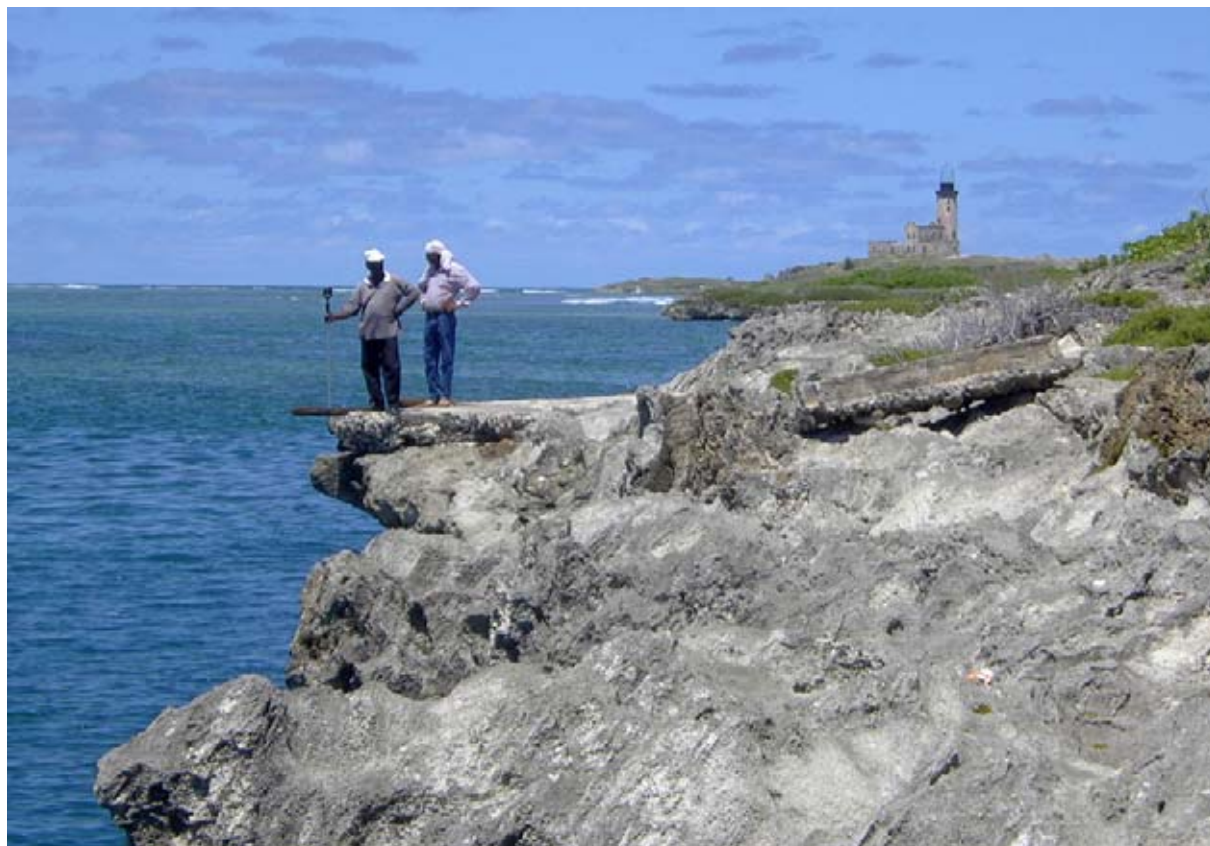
*The Toilets, Structure 30, above earlier rock-cutting. A length of displaced concrete drain is in the centre and the low North-Eastern Bank at right. (02jv2222)*

The iron is slowly rusting away.
