# ILE DE LA PASSE

## REPORT 2

### BASIC ARCHITECTURAL SURVEY OF STANDING STRUCTURES

Geoffrey and Françoise Summers

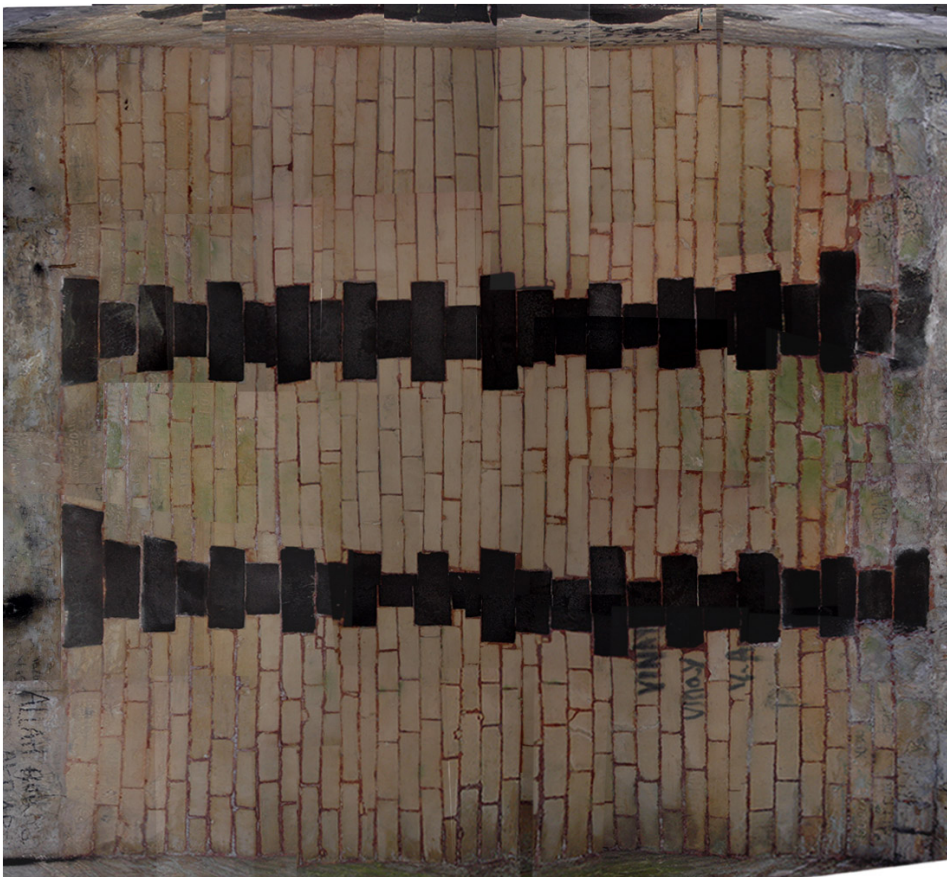
The barrel vault, with its basalt arches, supporting the pitched roof is of notable architectural interest.

*Flattened view of the Powder House barrel vault created in Photoshop from digital photographs.*

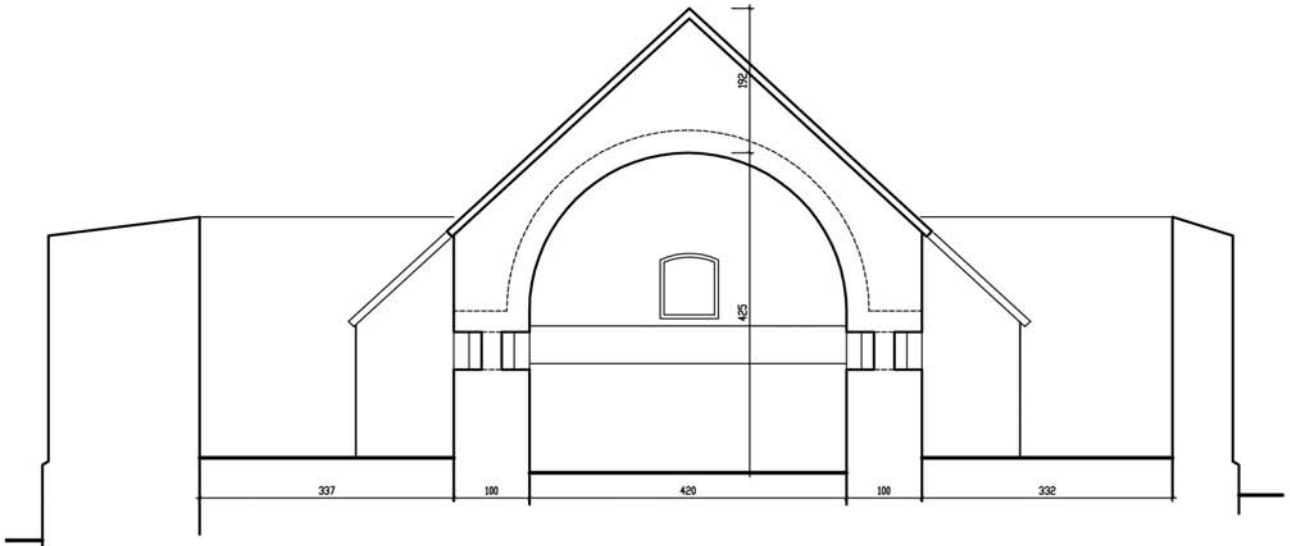
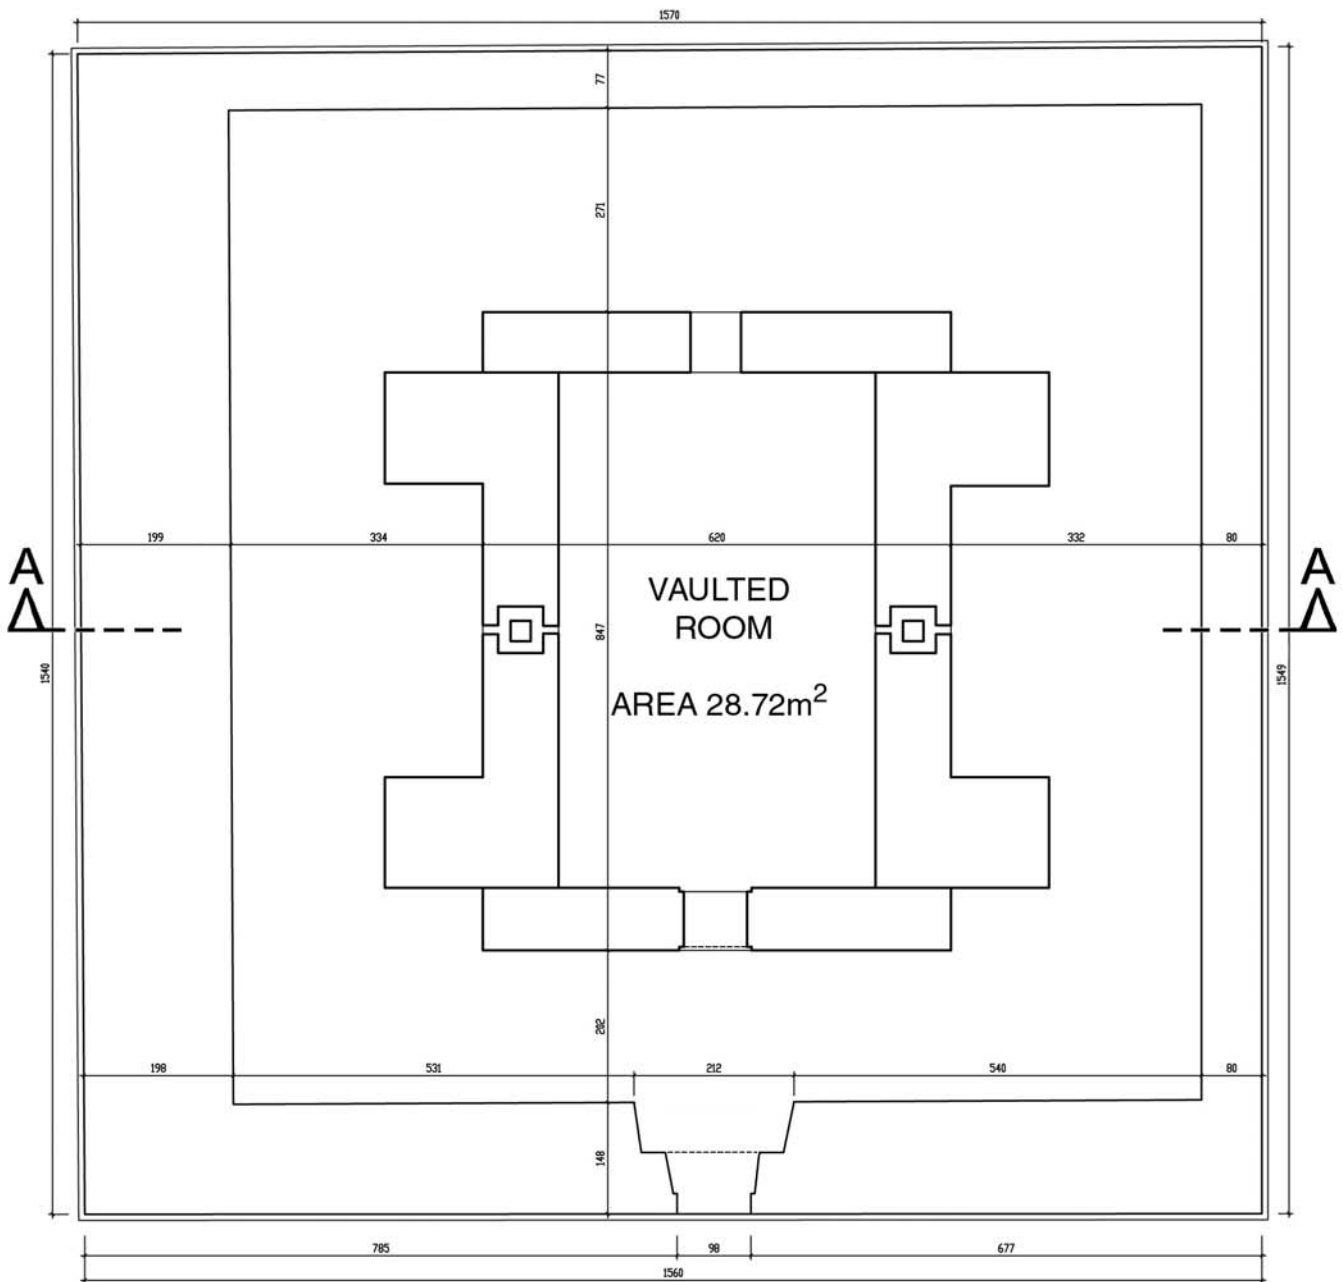
STRUCTURE 1 - POWDER HOUSE

The building is generally in good condition requiring only minor repairs. The sloping top of the enclosing walls was levelled in places, presumably to house water tanks for WWII washing facilities. The weathering of the coral, a soft material, is unavoidable. In some places where fires have been lit, the surface of the coral has cracked and peeled off. More recent graffiti are unsightly.

The Powder House is clearly the most important structure on Ile de la Passe and its preservation should be closely monitored. Minor repairs are needed to some corners of the roof. The top of the enclosure wall, where it was levelled to seat WW II water tanks, needs to be examined. Further damage caused by fires lit in proximity of walls must be prevented. There is no immediate need to replace doors and windows. Nothing that would distract the visitor from fully appreciating the unique architectural features and qualities of the Powder House should be imposed on or inside this structure. Expert advice will be needed if recent painted graffiti are to be removed.

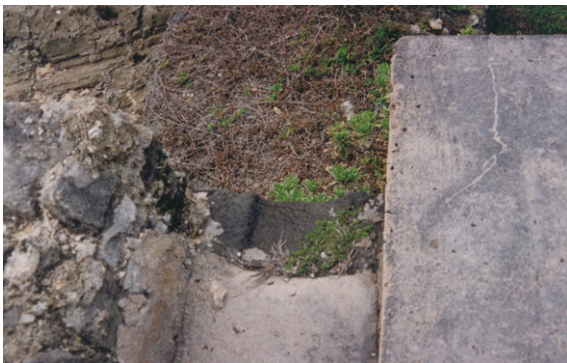
- The overhanging eaves of the reinforced concrete slab, which replaced the original flat roof supported by timber beams, only survive in places;
- A gutter, part of the original roof construction, with basalt end blocks drains the roof;

*Gutter with basalt end block. (02cn0105)*

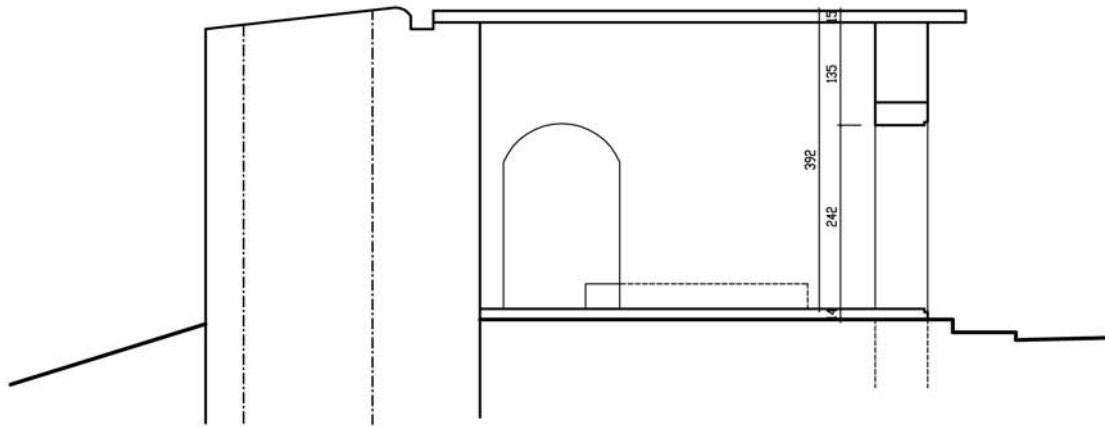
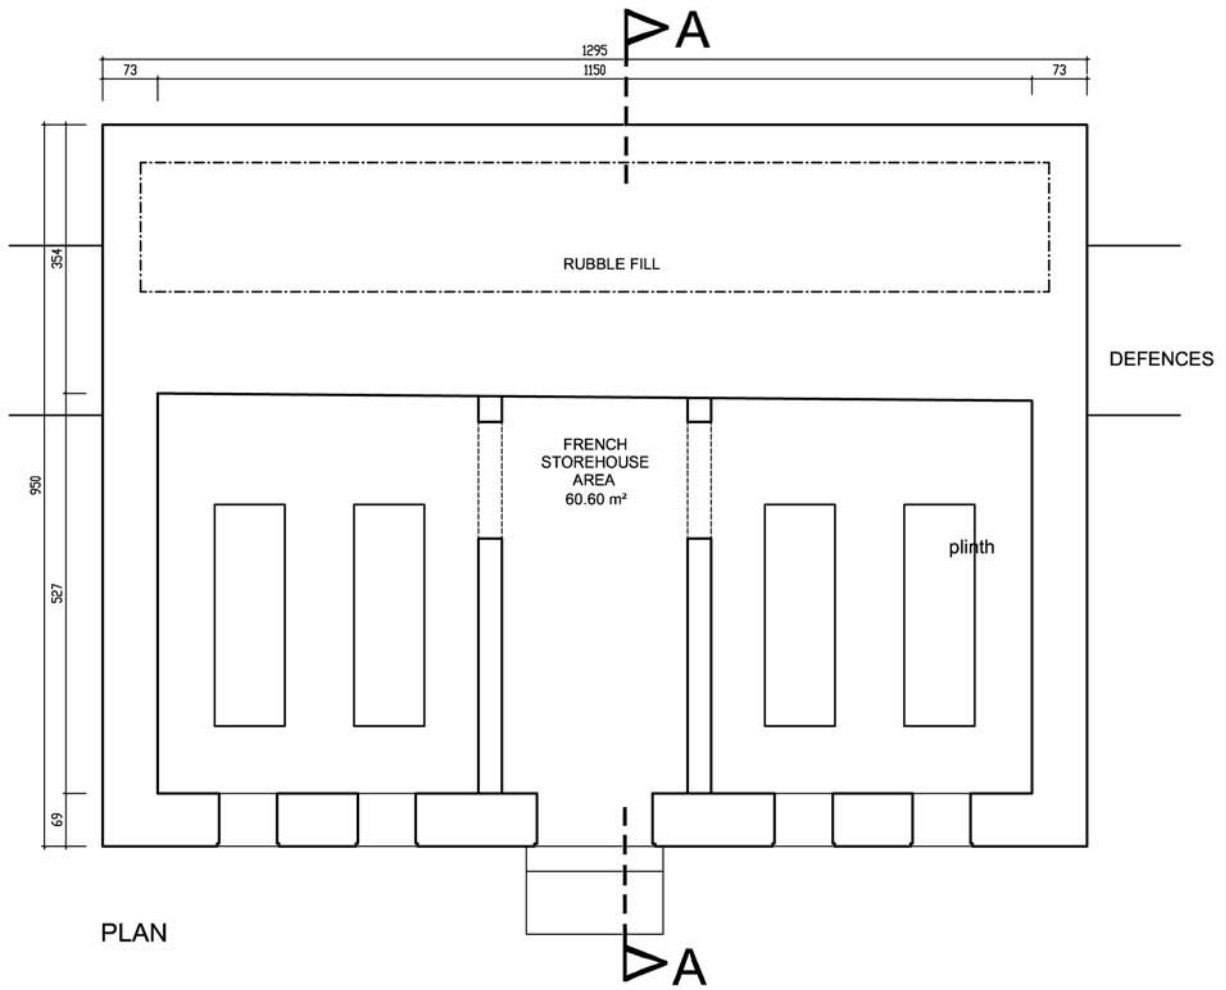
STRUCTURE 2 - STOREHOUSE

The reinforced concrete roof is in a dangerous state and the remaining portions will have to be carefully removed so as to avoid damage to the walls. Concrete partition walls also reveal advanced corrosion of reinforcement.

An architectural study needs to be done on the different ways to convert the structure so that it may perform some new function as discussed in *Report 3, Management, Development and Research: Recommendations and Proposals*.

Further study of the building and perhaps sample analysis of mortars may reveal the answers to some unsolved questions related to the original French roof and the construction details of the back wall over the defences.

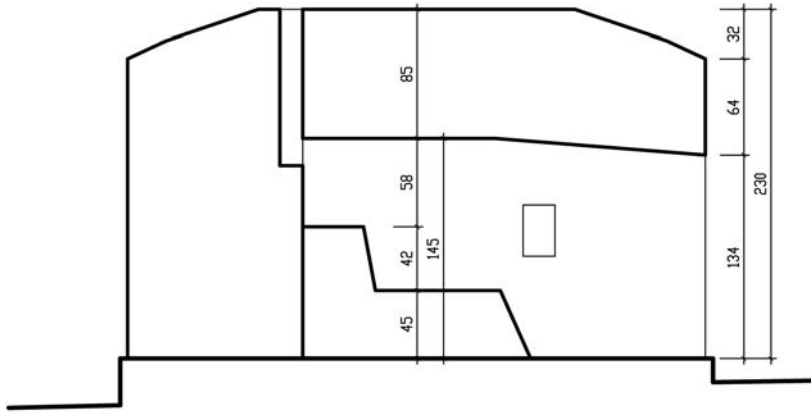
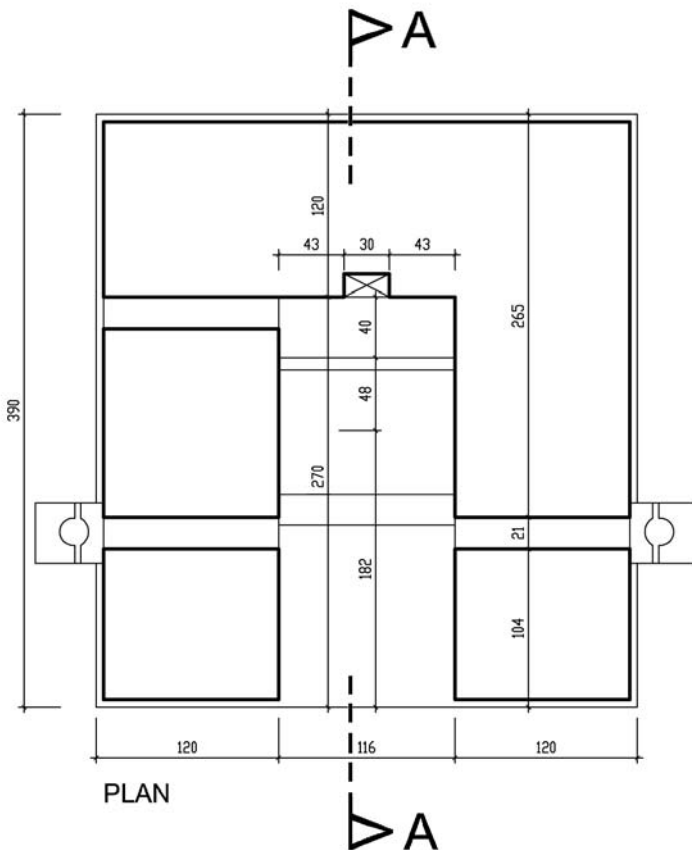
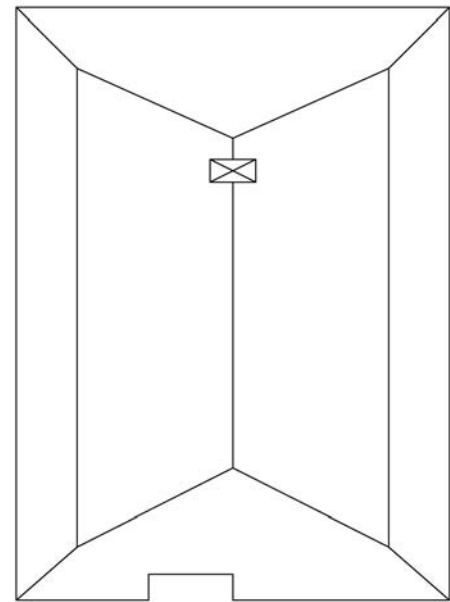
STRUCTURE 3 - SHOT FURNACE

An important portion of the ceiling has collapsed and more is in danger of collapsing. The base of the rear wall is in a bad state as a result of campfires that have been set against it. The west wall has been underpinned with concrete in the recent past. Some of the basalt has cracked, presumably as a result of heat when the furnace was in use. Other stones have been dislodged by visitors. Much of the brick lining is missing. The original ironwork is in a very poor state.

The repair and restoration has to be preceded by detailed documentation and recording. A study of literature sources and archive materials might help to understand better this very complex construction. Repair and restoration work should be carried out by specialists and experts. This is a building of great importance and interest. Any temporary shoring should be done with great care.

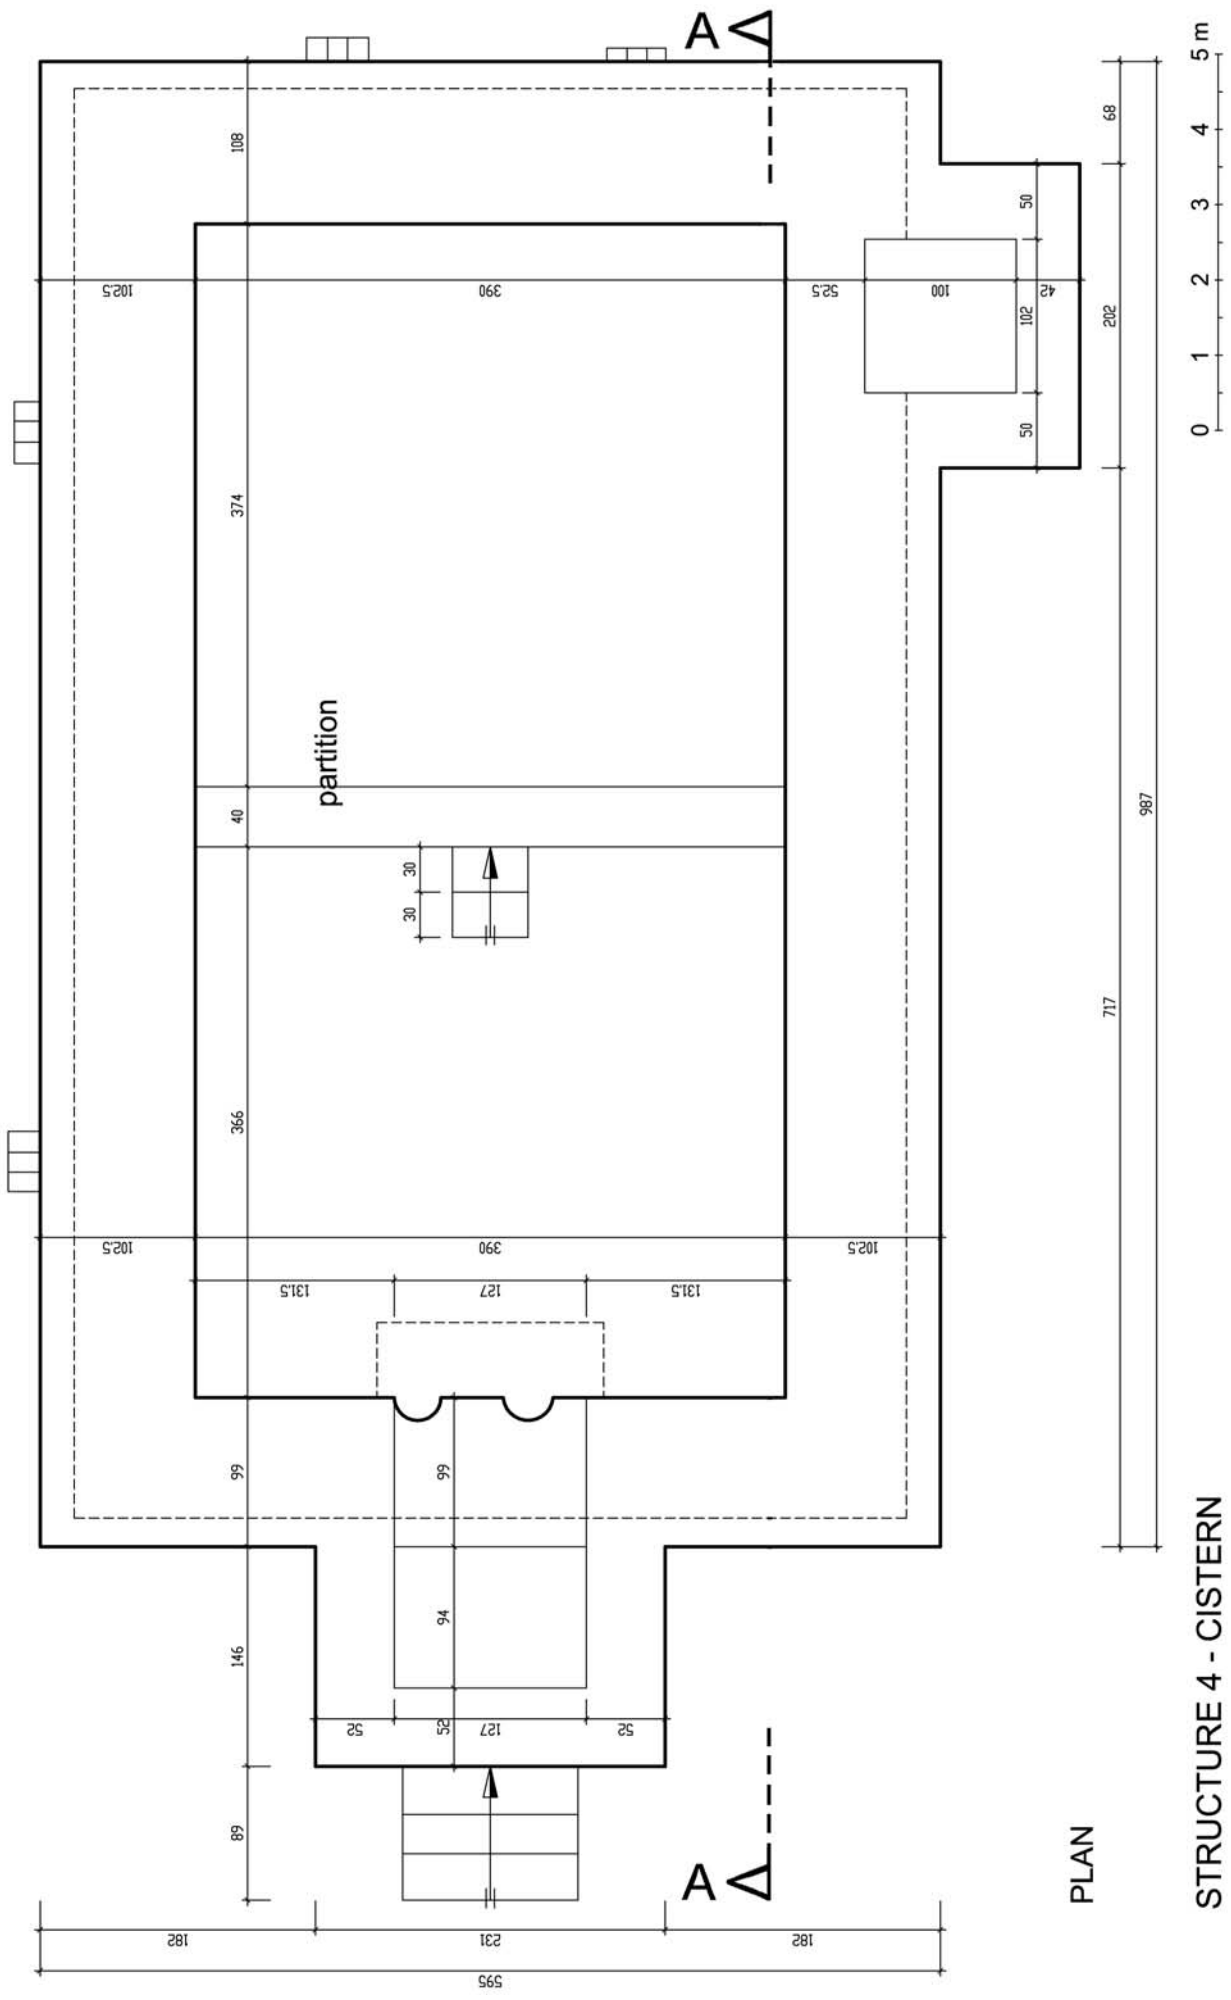
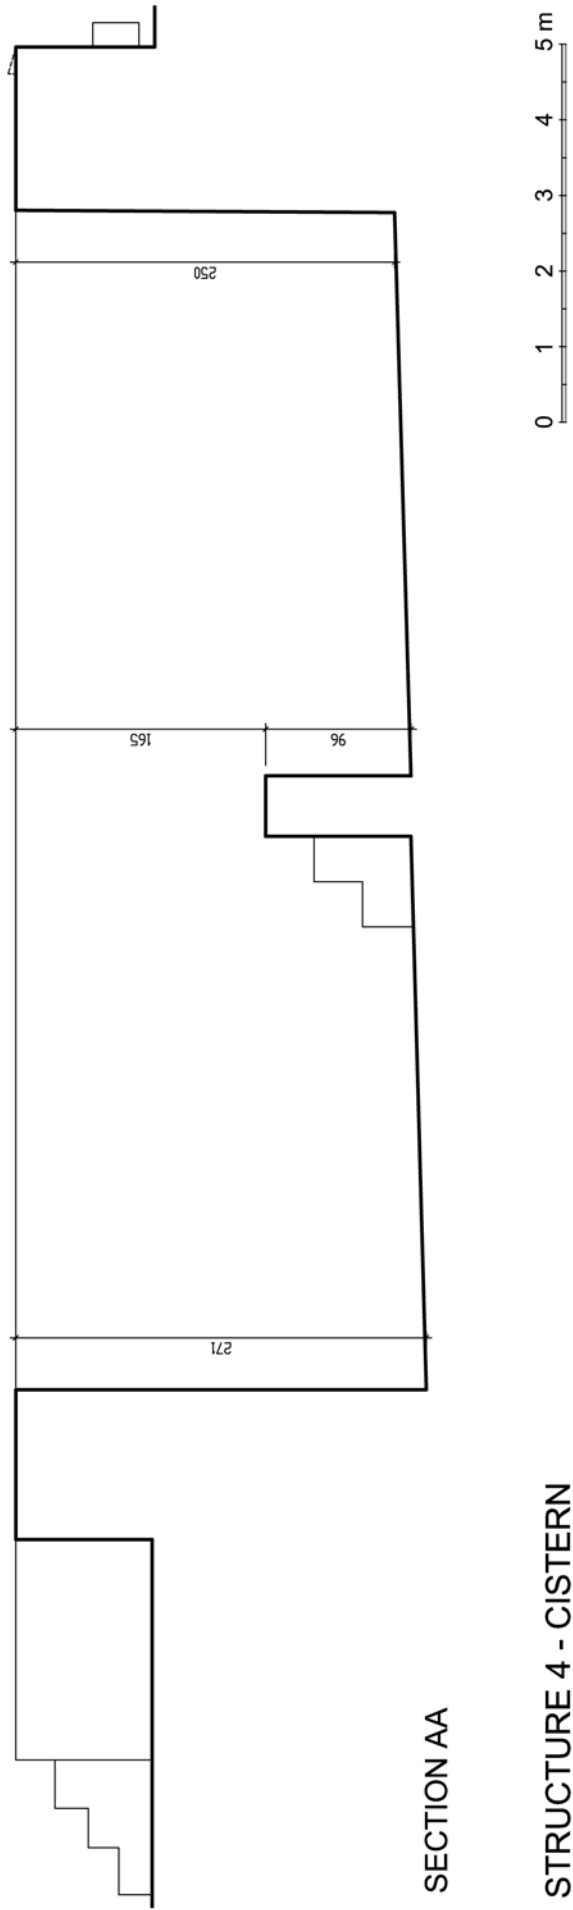
STRUCTURE 4 - CISTERNA

The cistern is in an overall remarkably good state of preservation. A few blocks along the upper course have been displaced and some of the rendering has cracked and broken away.

The displaced blocks, most of them lying nearby, should be put back in their original positions and mortar, of an appropriate composition, used to repair the surface rendering.

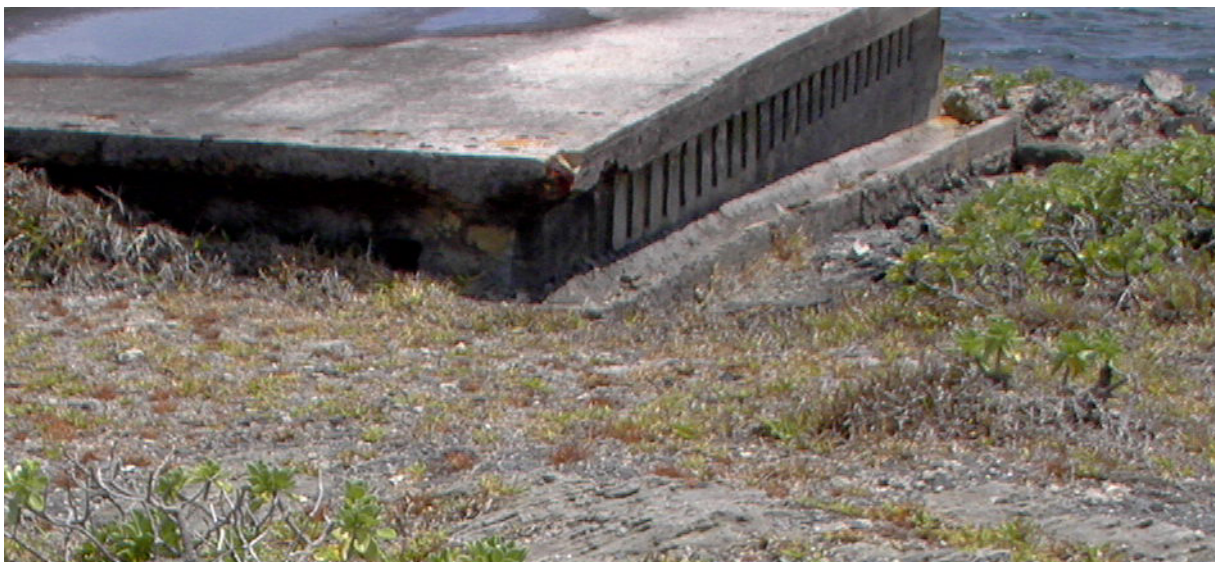
The reinforced concrete structure is in a serious condition because the reinforcement is corroding. As the metal corrodes it expands and splits the concrete in which it is embedded. The interior, in January 2002, was foul.

*Concrete drain and vents under the southernmost roof slab. (01jv0115)*

A structural engineer is required to assess the strength and safety of the concrete walls and roof, and to make recommendations accordingly.

Some assessment of water intake through the vents and door under cyclonic weather conditions also needs to be made and drainage needs to be investigated. If the structure can be made safe it could be utilised as part of a visitor centre but investigation regarding the drainage of water, especially in cyclonic conditions, will have to be made.

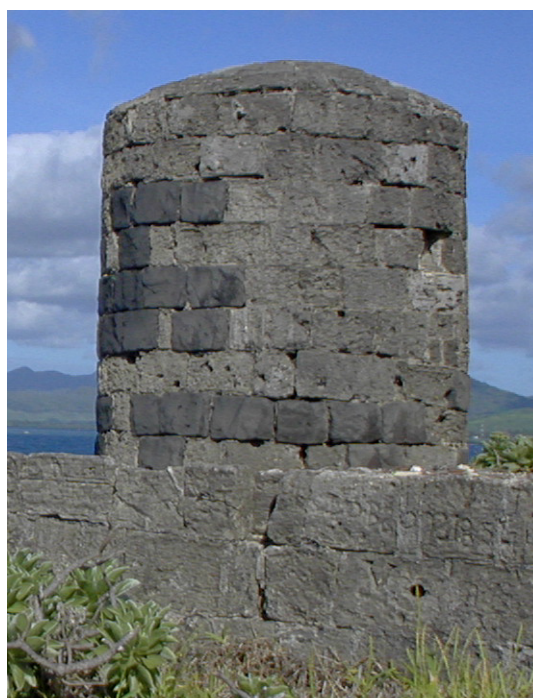
*Rear view of North-West Sentry Post showing one of the small windows. The random mixture of coral and basalt blocks is to be noted.*

Repair of the door is an urgent requirement.

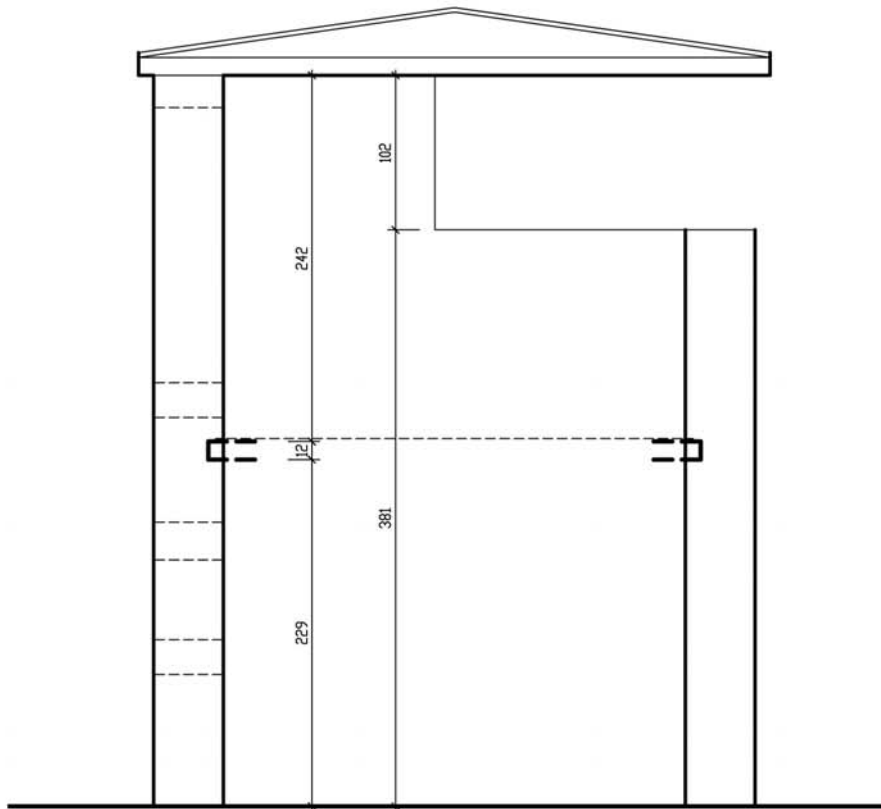
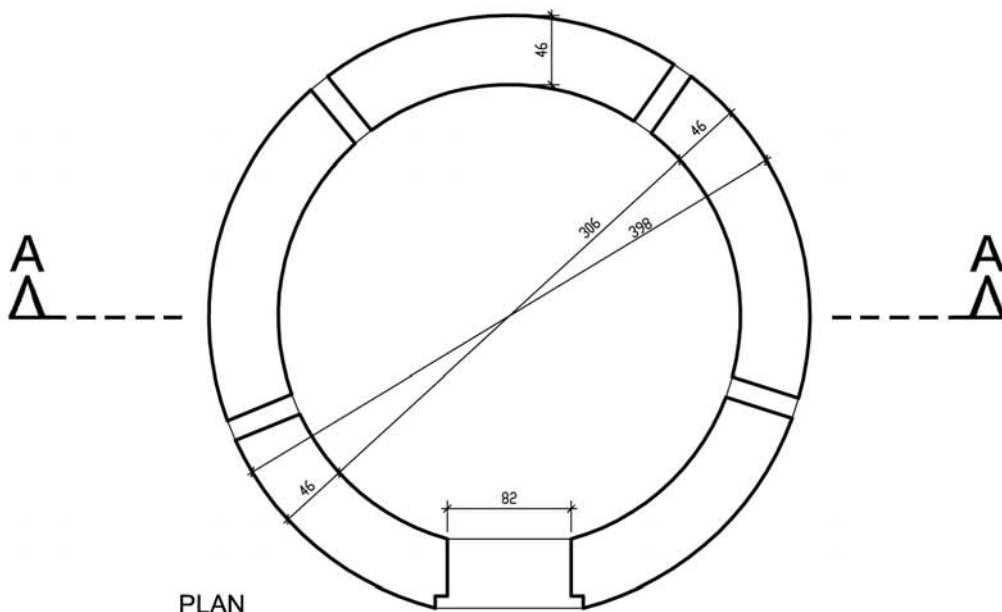
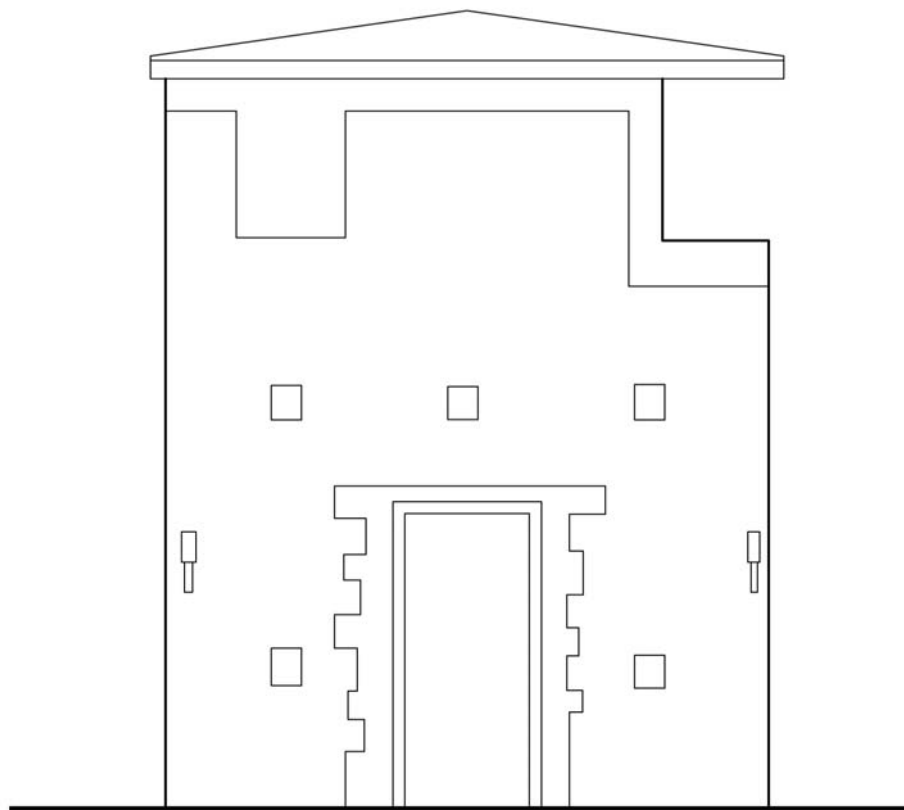
STRUCTURE 10 - OBSERVATION TOWER

The roof has partially collapsed, cracking the upper part of the wall which otherwise appears to be structurally sound. The wooden floor, at the first storey level, has been completely removed. Remains of iron fittings on the wall indicate the position of stairs or a ladder and other installations.

As it stands the Observation Tower presents a danger to visitors. The concrete roof slab and steel beams should be completely removed and a new roof erected. A number of alternatives for the new roof are possible and the choice will depend on the final scheme chosen for the adaptation of the tower to a new function. This is discussed in *Report 3; Management Development and Research: Recommendations and Proposals*.

A structural engineer must be consulted over the steps to be taken regarding the roof, especially if the concrete slab was to be partially removed as a temporary measure awaiting sufficient finances to implement the complete refurbishing of the tower,

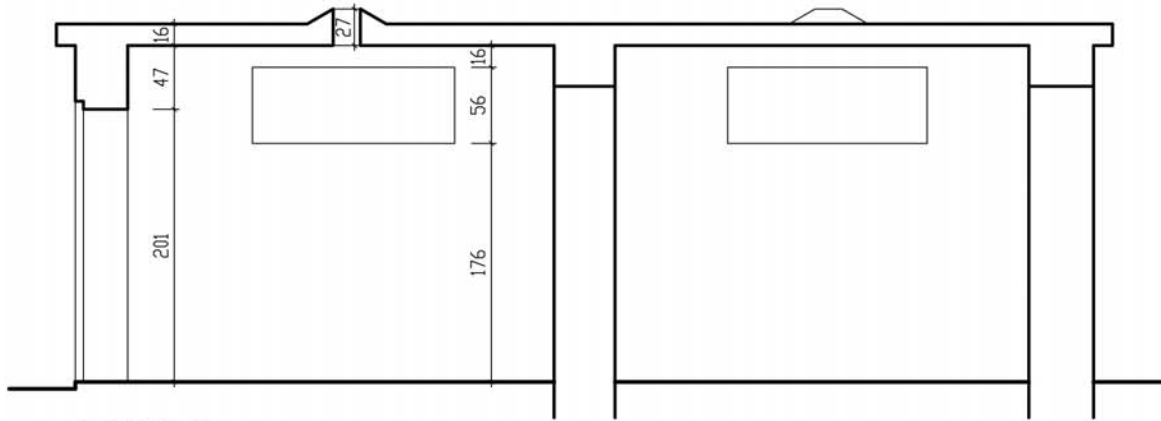
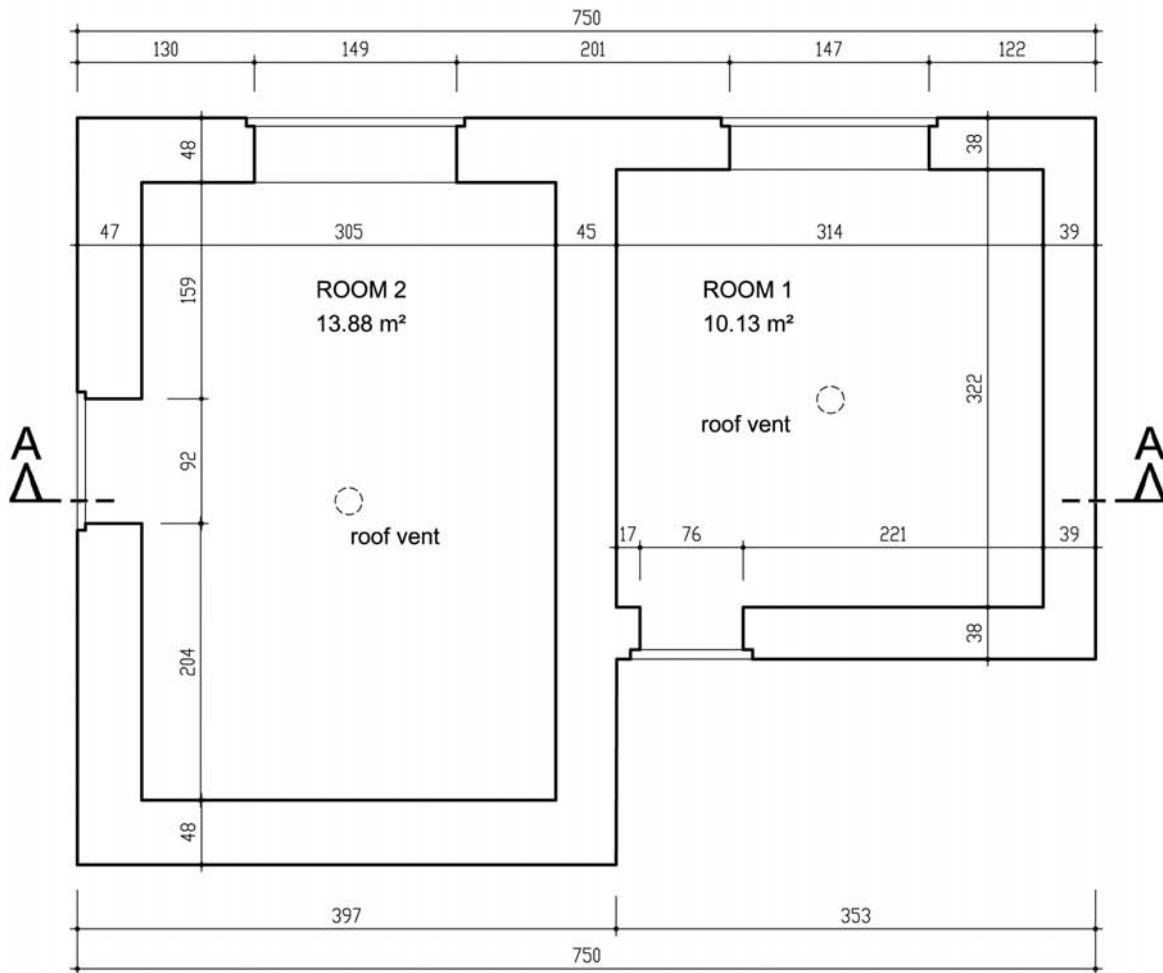
STRUCTURE 11 - CENTRAL BUILDING

The Central Building is structurally in good condition.

Surveillance will ensure that further damage does not occur. There is a question over the strength and long term safety of the reinforced concrete roof. Expert opinion is required concerning the prevention of further deterioration of the reinforcement. The building could be refurbished, including the provision of doors and shutters, as suggested in the *Report 3; Management Development and Research: Recommendations and Proposals*.

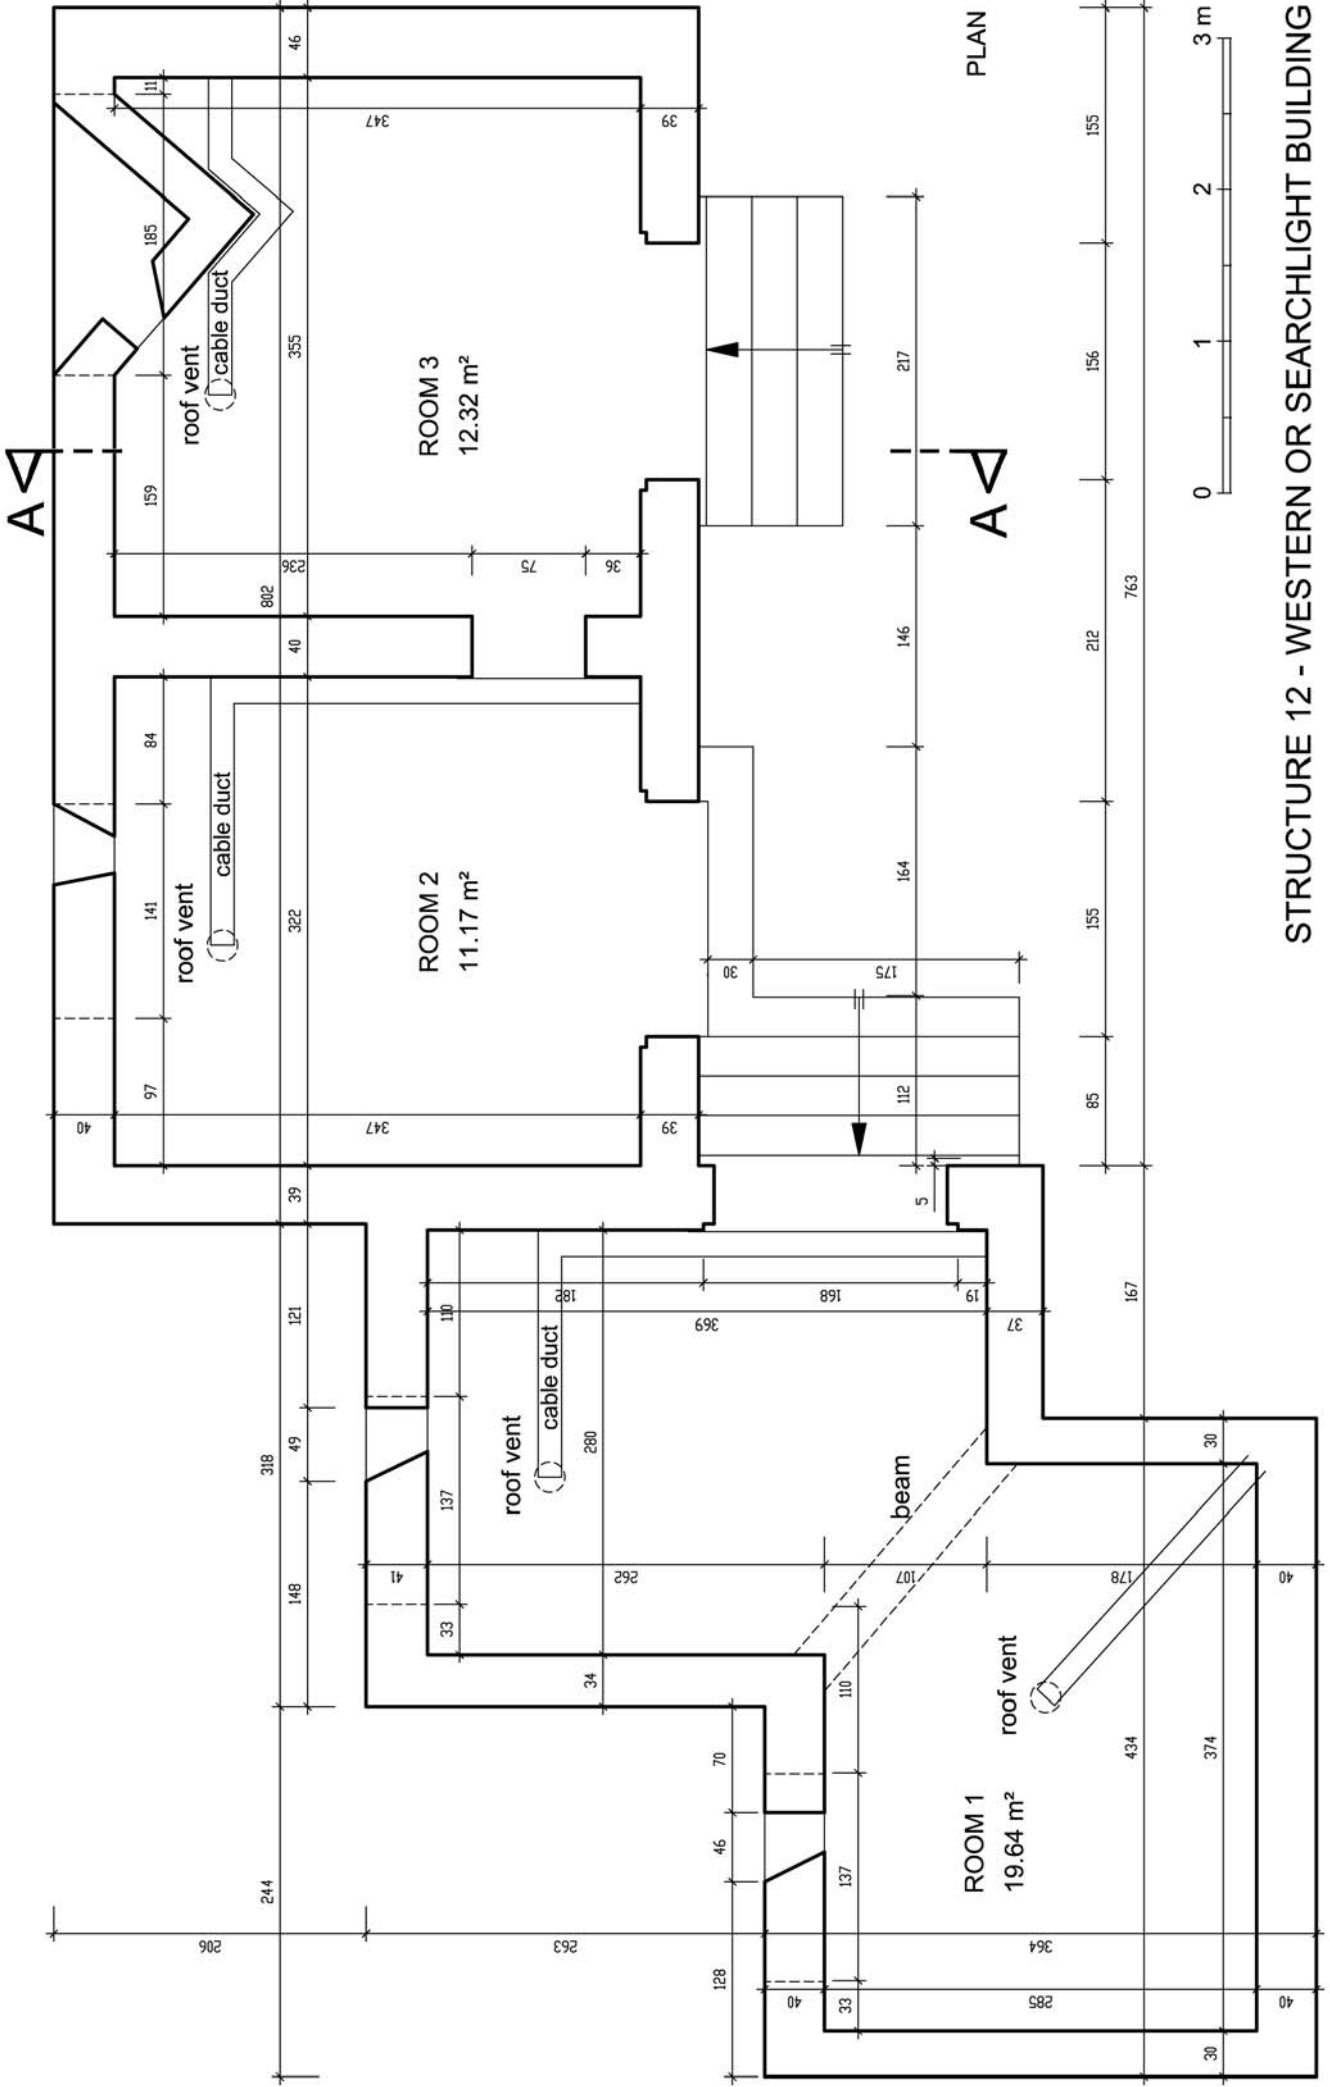
STRUCTURE 12 - WESTERN OR SEARCHLIGHT BUILDING

The walls appear to be structurally sound, although some of the blocks have been displaced over the inclined vents. The roof is in poor condition and some of the reinforcement has been exposed, showing advanced stage of corrosion.

A structural engineer should advise on whether the roof has retained its structural soundness and can be repaired or whether a new roof is needed. Walls should be repaired and perhaps repointed when studies have defined an appropriate mortar, possibly a lime mortar.

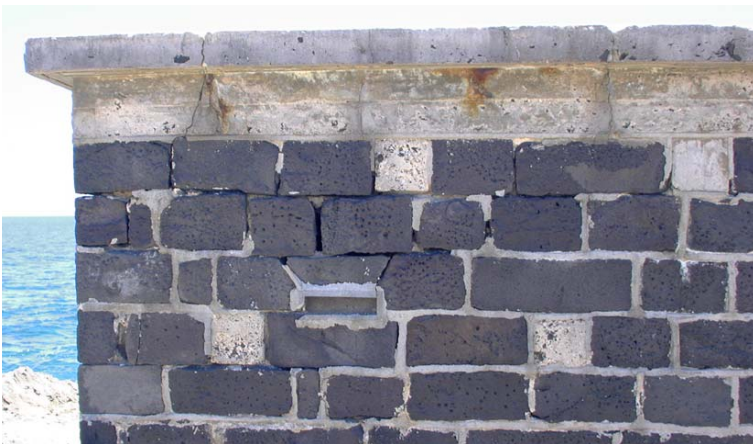
*Concrete tie blocks and inclined vent.*
