WORLD WAR TWO MILITARY INSTALLATIONS ON THE SOUTHEAST COAST OF MAURITIUS: A PRELIMINARY SURVEY

Geoffrey and Françoise Summers

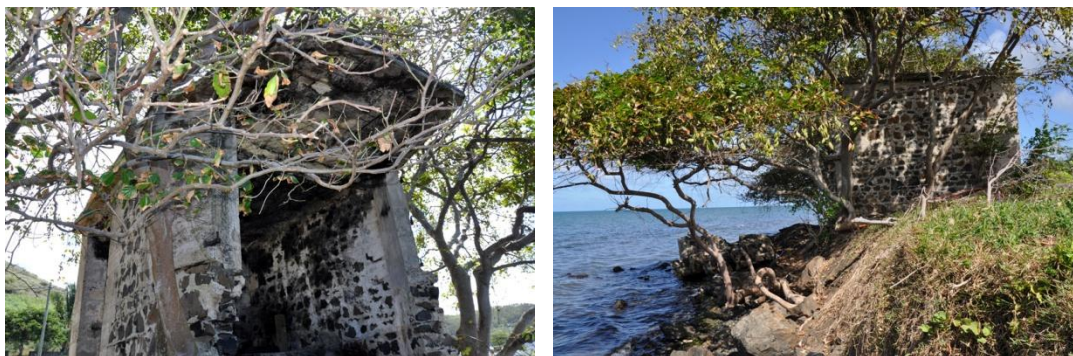
Six structures have been identified (Fig. 2). The two observation posts on the sea are of standard type. The northern one has partially collapsed into the sea (Fig. 4) but the southern one is intact (Fig. 5).¹² In the fields behind are two adjacent concrete structures (Figs 6 to 8). One is a generator room with part of the machine bed visible, the other, built back into the slope, comprises a row of five rooms with a corridor at the rear. The corridor had doors at both ends, its rear wall is battered. The three rectangular central rooms each have a window which looks out onto the back wall of the generator room. The end rooms, which project forwards by a few feet, are windowless. This appears to have been magazine for ammunition. On the slopes above are two observation posts. They are probably of identical design but it was only possible to visit the northernmost one (Figs 9 to 11). This is rectangular with a lightweight sloping roof (not of concrete) and a long open front. Low concrete piers seem to have supported a viewing platform. Philippe la Hausse de Lalouvière mentions a semi-buried barracks which has not been located. More critically, we were no more successful than la Hausse in finding the gun pits. Work needs to be done in the field with the help of local landowners as well as a search of the archives.

Figure 4. Two views of the northern observation post at Pointe aux Feuilles showing how the front has collapsed as a result of coastal erosion. GDS 2012 0968 and 0970

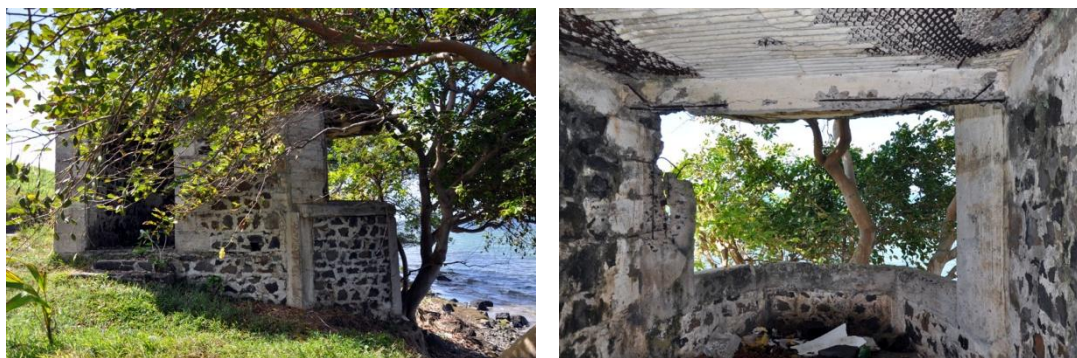
Figure 5. Two views of the southern observation post at Pointe aux Feuilles showing basalt masonry, precast concrete blocks, and the iron mesh reinforcement and corrugated shuttering used to make the roof. GDS 2012 0968 and 0970

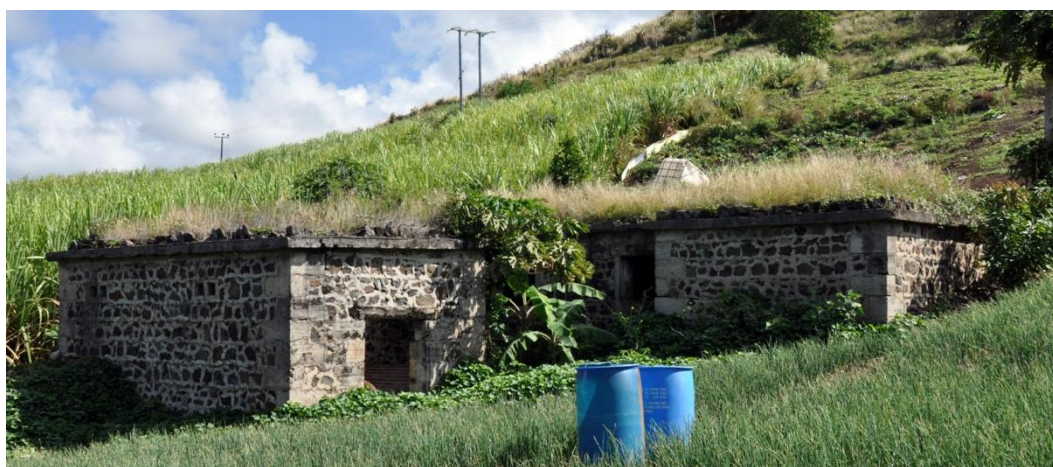
Figure 6. Pointe aux Feuilles, the generator room at left with the magazine cut back into the slope behind. GDS 2012 0990

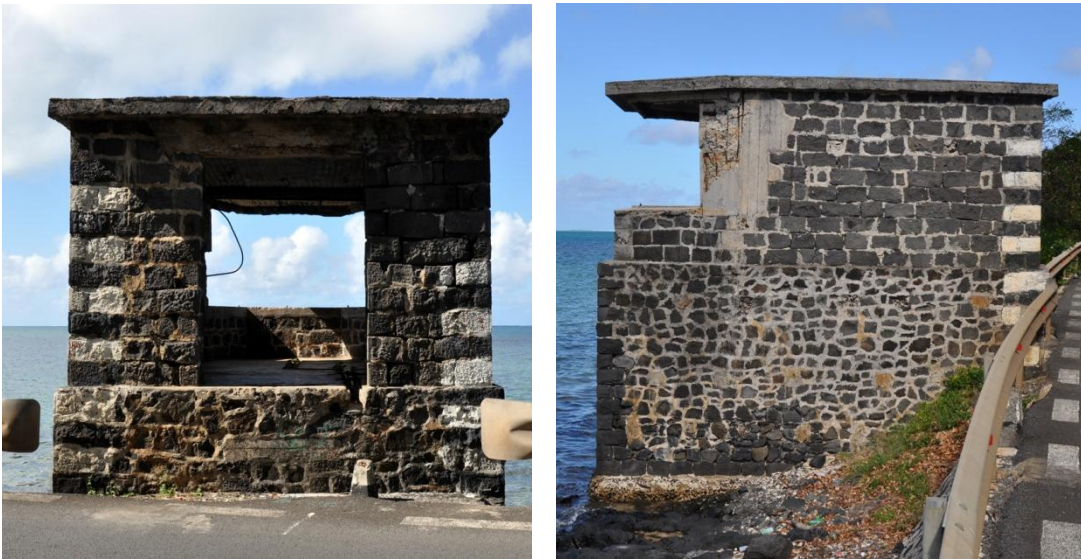
Figure 18. The standard observation post on the shore showing the two phases. Original corners were of basalt with drafted margins rather than the later precast concrete blocks. Here the light coloured corner stones next to the road have been painted by the highways authority. GDS 2012 1034 and 1036

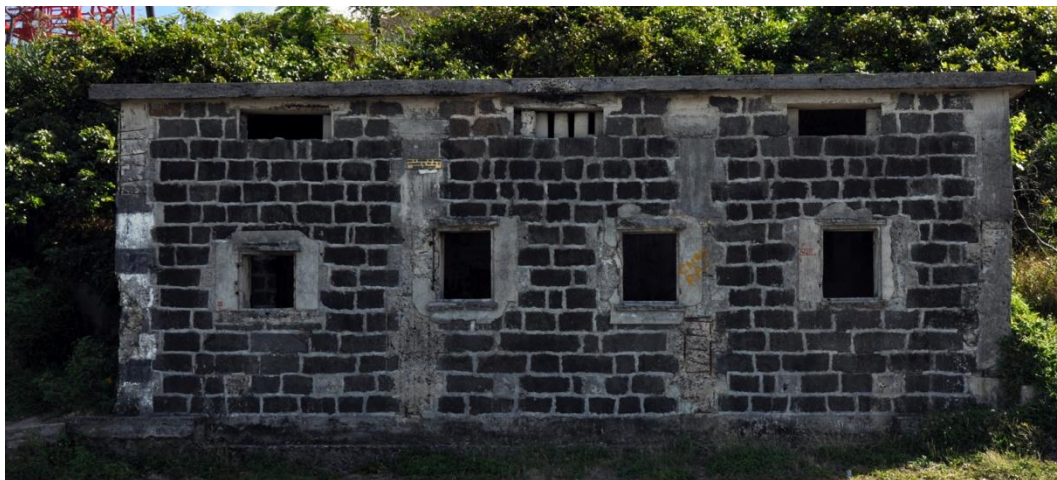
Figure 19. Front façade of the generator building at Pointe du Diable showing the two building phases. Note that the window at left is different. GDS 2012 1020

Electricity for the searchlights that swept the North Entrance and the channel was provided by three diesel powered generators installed in the larger, rectangular, building further to the south, on the west side of the present road (Figs 19-20). This generator room was constructed on a terrace cut back into the base of the slope behind. The terrace cut is lined with a battered basalt and mortar revetment wall similar to the one further north just described and to revetments at the battery described below. Examination of mortars might provide a clue to the sequence of construction, i.e. which phase the revetments should be ascribed to. The generator room itself, as noted above, also went through two phases of construction. In the second phase the basalt corners were removed and two vertical cuttings were made in the basalt walling for the insertion of reinforced concrete columns to support horizontal beams that carried a new reinforced concrete roof. Unlike buildings on Ile de la Passe there is no reinforced concrete ring beam. The single door in the south wall was revamped with reinforced concrete while windows and air vents were added or altered.

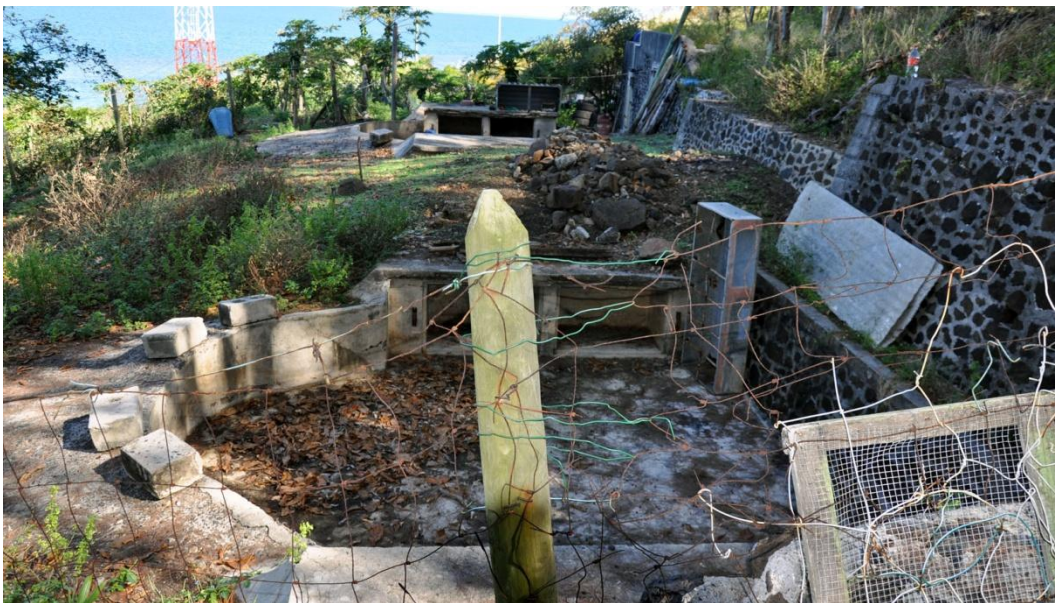
Twin gun pits with semicircular fronts and aprons, all of concrete, retain their iron holdfasts (Figs 23-26). Pairs of ready-use ammunition lockers, now doorless, are located either side of each gun. Drainage channels, cable ducts and other features are preserved. The emplacements were constructed on a level terrace cut back into the hill slope and revetted with basalt walling that include precast concrete blocks used for corners.

Figure 23. Gun pits at Pointe du Diable looking south. There are ready-use ammunition lockers either side of each pit and a revetment at the rear. GDS 2012 1043

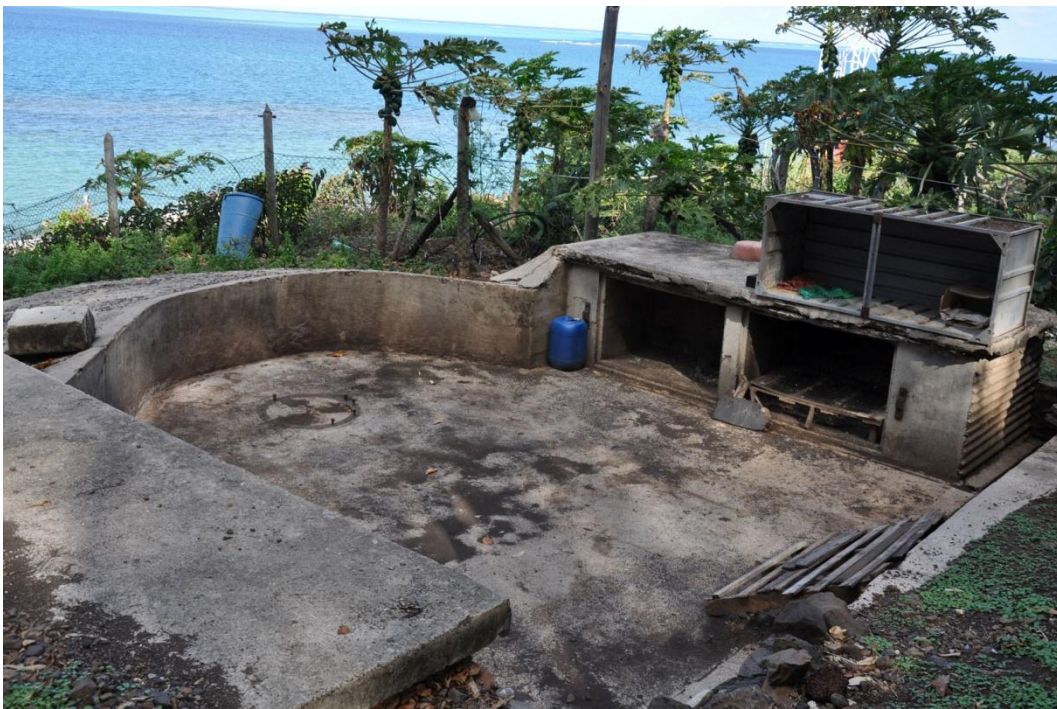
Figure 25. The southern pit with sloping apron, ready-use ammunition lockers and the iron holdfast for the gun. GDS 2012 1067

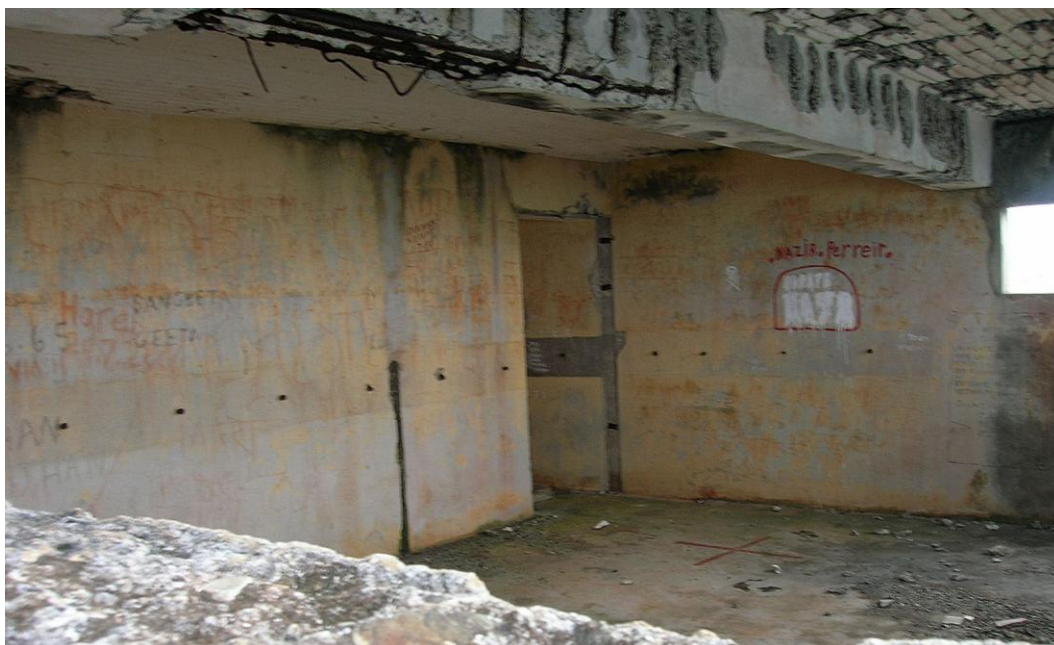
The Fire Control Post (Figs 33-35) comprises several rooms behind the observation deck. It is now used as part of the telecommunication system and thus not accessible without arrangement. In 2005 and 2007, as can be seen from the illustrations, the reinforced concrete was in a poor condition. It was not re-examined in 2012. A small mast has been put up on the building while a much larger mast has been erected next to it.

Figure 34. The Fire Control Post on the summit of Pointe du Diable in 2005. md05nn0111

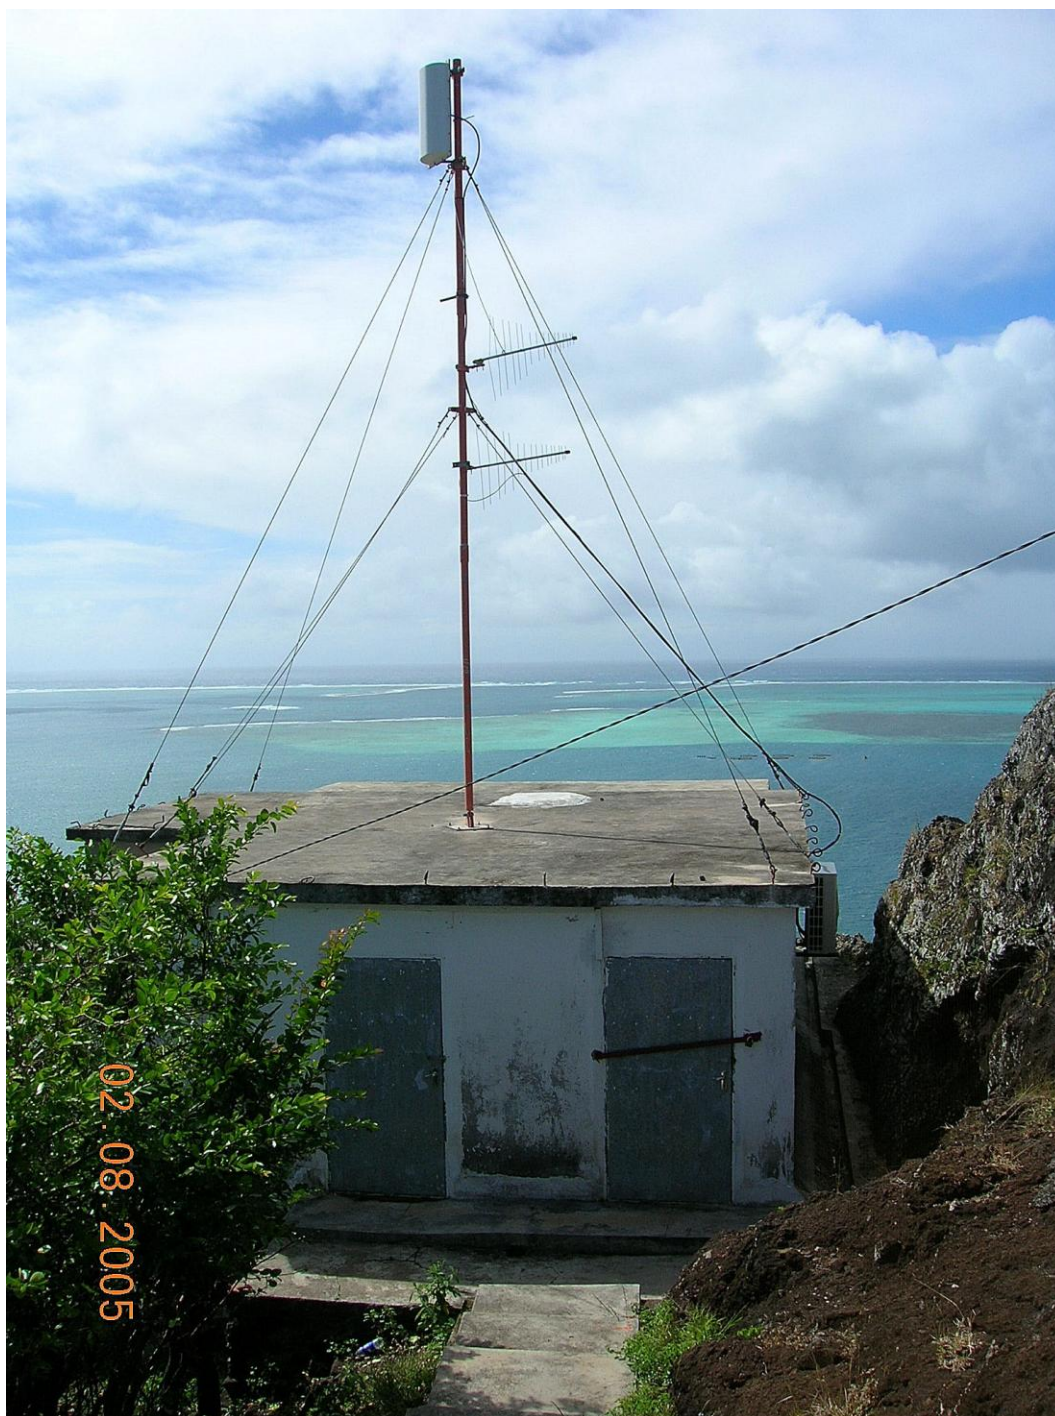
Figure 35. The rear of the Fire Control Post as it was in 2005. It is little changed today.
md05nn0108

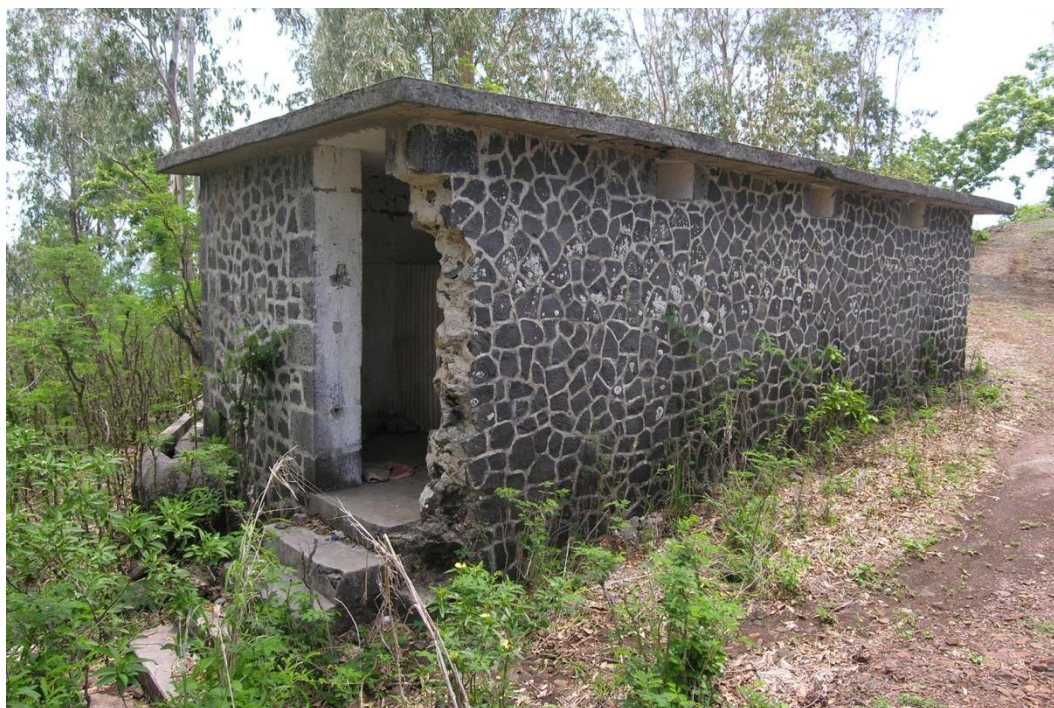
The toilet block was built in a completely different style (Figs 43-44). Only the corner stones were cut. Both the roof and the internal partitions are of reinforced concrete built with corrugated sheet shuttering. It is entered via a short flight of concrete steps. There are presumably cess pits hidden in the undergrowth behind.

Figure 43. The toilet block. 07mdnc0234

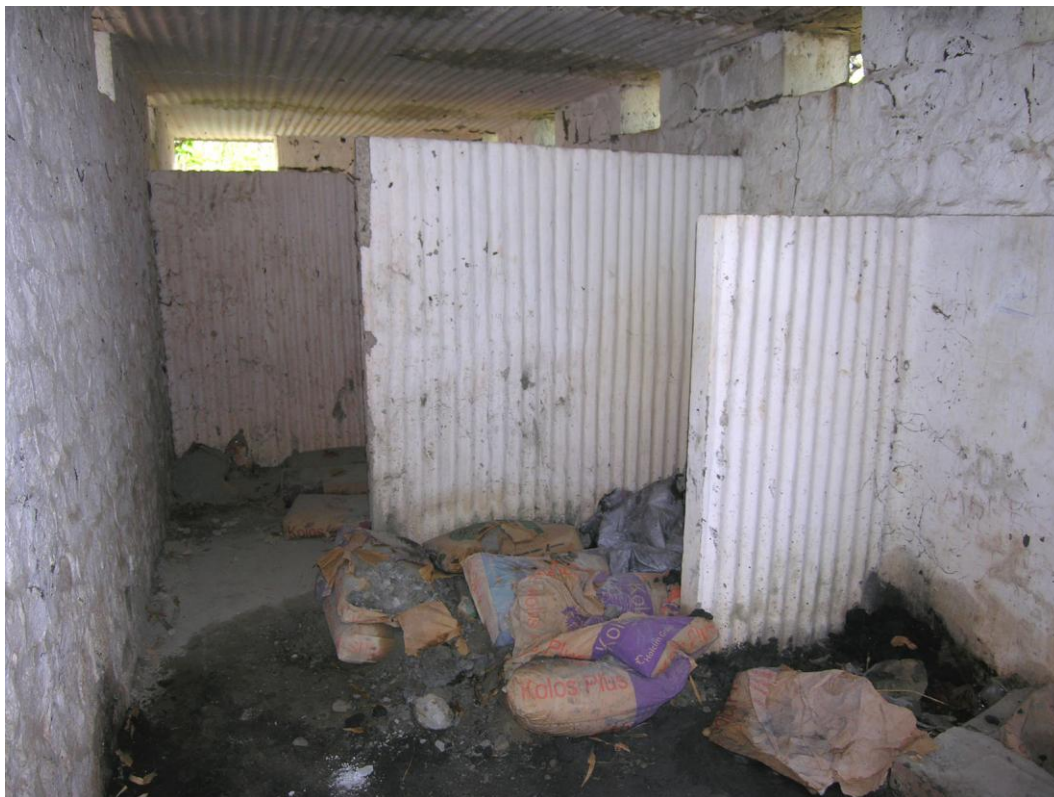
Figure 44. Interior of the toilet block. 07mdnc0232

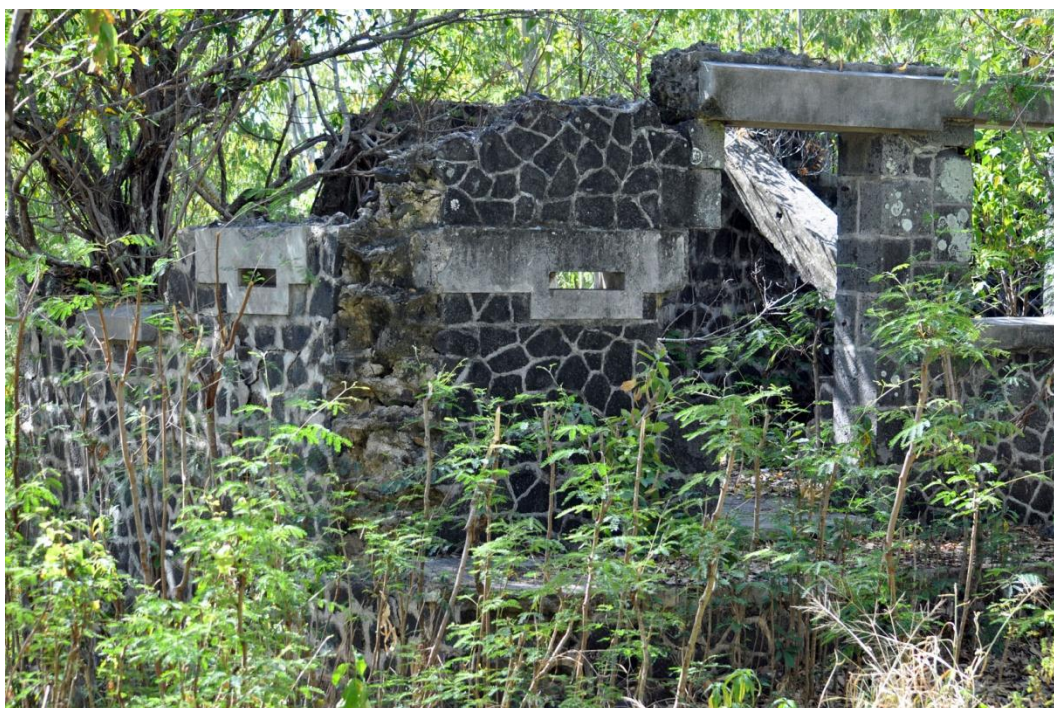
Built in the same style is the sentry or guard post at the entrance to the camp along the ridge. As well as guarding the entrance, as is made clear by the position of the loopholes on the front corner. The rear room has high iron-barred windows on the three external sides. It did not, however, have a concrete roof.

Figure 45. The sentry building at the entrance to the ridge top camp. GDS 2012 1205

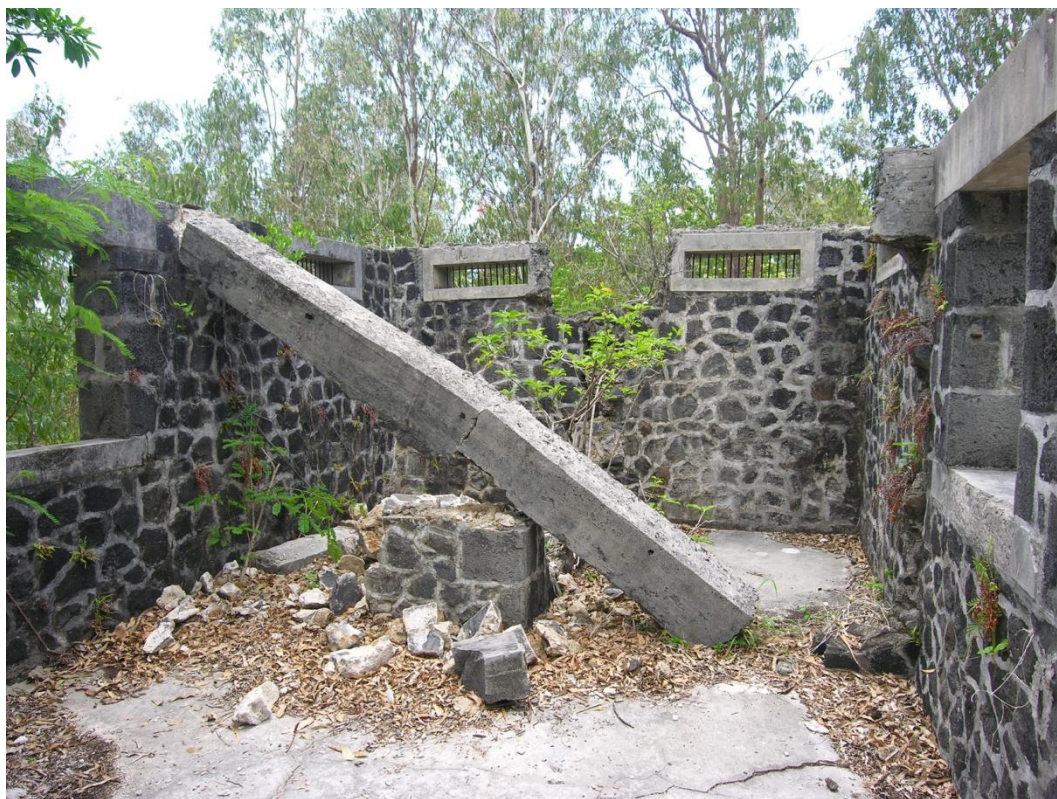
Figure 46. Interior of the sentry building. 07mdmc0236

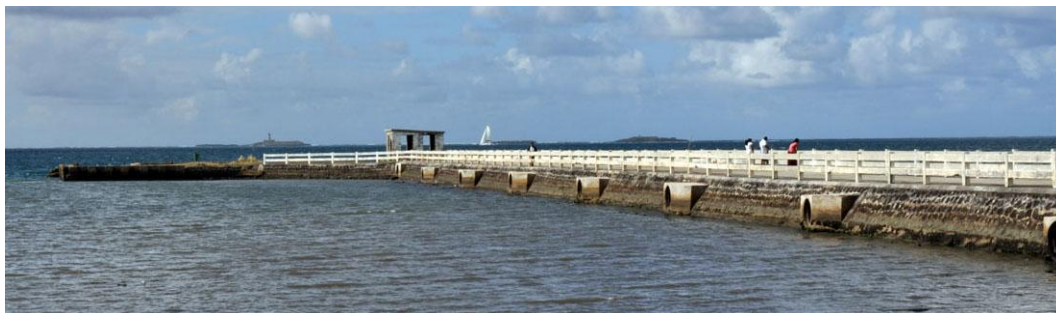
Figure 49. Bois des Amourettes, the north side of jetty showing the precast concrete pipes added to ends of the original inlets. GDS 2012 0704

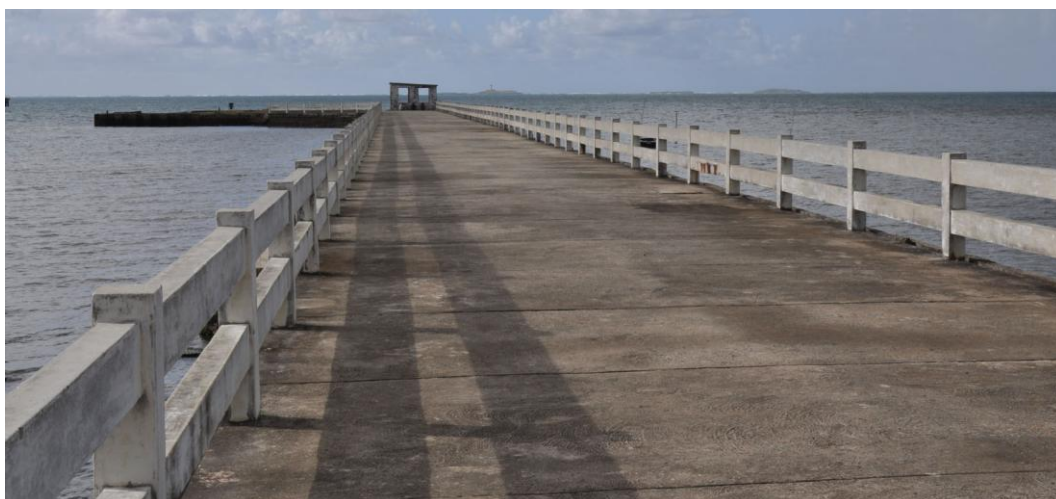
The jetty (Figs 48-50) was constructed in WW II and revamped on several occasions since then. Local fishermen say that the water used to be much deeper than it is today. This is presumably a result of silting caused by the jetty itself. The WW II jetty was L-shaped with a small guard post on the end (Figs 52-53). It is of reinforced concrete casemate construction (Fig. 56) filled with basalt rubble which was taken from the terraces that were dug out of the fuel storage tanks on the slope behind (see below). There were inlets or channels to let water through, to which precast concrete pipes were added much more recently. The end of the Jetty is in poor condition, part having collapsed (Fig. 54) and been repaired with an inferior basalt and cement wall (Fig. 55). Walls of the structure on the end are built entirely of precast concrete blocks. The base on which it stands, the roof and lintels are all of reinforced concrete. The concrete base is larger than the building, this platform apparently being the only portion of the jetty that was provided with a smooth surface, the remainder being crushed basalt. The current concrete surface and the concrete balustrades are all of recent date (Figure 51).

Figure 51. Bois des Amourettes jetty with, from left to right, the lighthouse on Ile aux Fouquets, Ile Vacoas and Ile de la Passe on the horizon. The structure at the end dates to WW II at which time the surface was stone. The concrete surface and balustrades, like the inlet pipes, were added in the second half of the 20th century. GDS 2012 0348

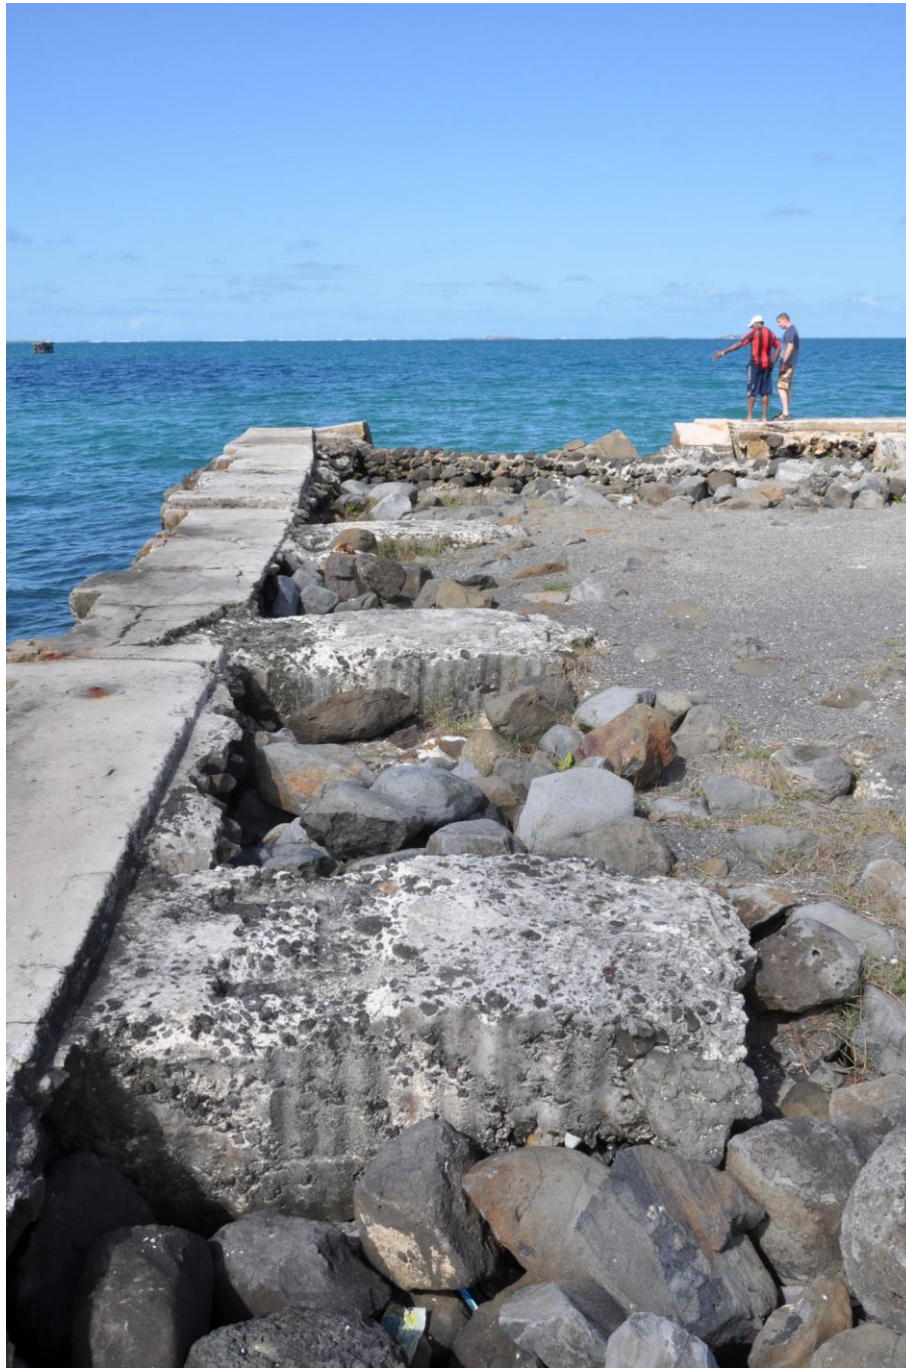
Figure 56. Bois des Amourettes, the arm WW II jetty with the imprints of corrugated metal shuttering employed to make concrete casemates. The mooring point in the sea can be seen at top left. GDS 2012 0591

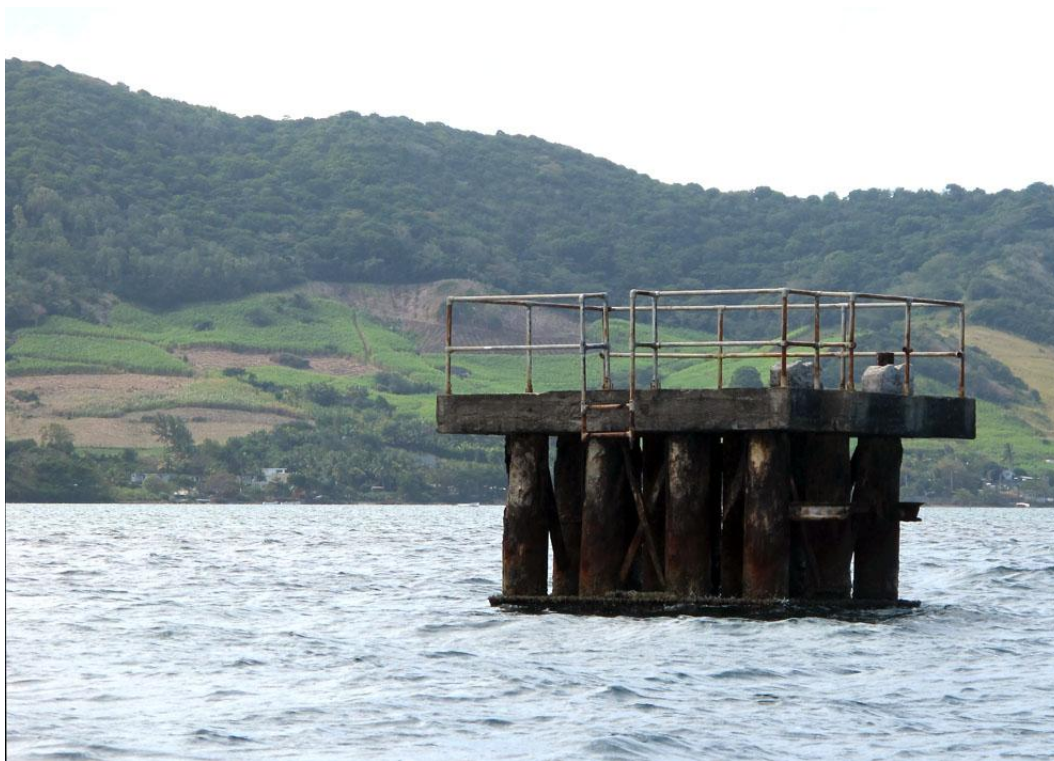
Constructed at sea close to the edge of the channel where tankers could anchor is a substantial iron platform (Fig. 57). A pair of iron pipes with thick rubber coating ran from this to the pump house behind the modern road. On historical Google Earth imagery the pair of pipes resting on the lagoon bed can be clearly seen. Ashore the pipes rested on concrete piers, each made of three precast blocks, built on the narrow jetty (Fig. 58). The south side of the concrete jetty is protected from the long-shore current a revetment of looses basalt. Here one of the two pipes has been removed for use in supporting the modern road where it crosses watercourses. Many sections of pipe, some still retaining the thick rubber coating, are to be found in position while others are dismantled and stacked next to the main pump house.

Figure 57. The platform at sea. mbcg0308

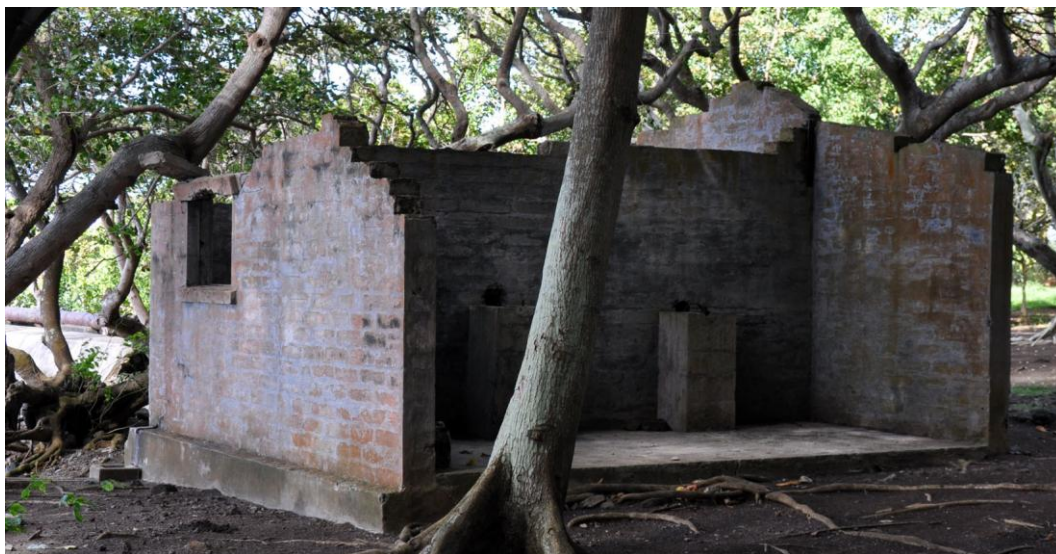
Figure 59. Bois des Amourettes the small Pump House on the shore. GDS 2012 0784

The pump house on the shore comprises two long rooms beneath a lightweight double pitched roof (Fig. 59). The narrower rear room, on the landward side, appears to have been open on the long side. The concrete base is substantial, in keeping with a structure housing machinery. Walls are built entirely of precast concrete blocks. There are fittings for two pipes, of smaller bore than the main ones leading from the sea which bypass the building. The exact purpose of this pump house is unclear.

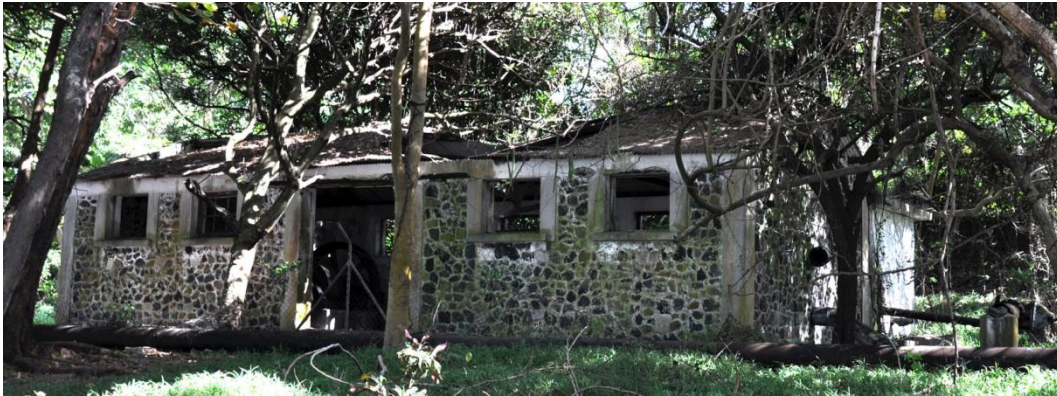
The pump house is a low rectangular building with a double pitched roof (Fig. 62). Construction techniques and materials are exactly the same as those found at the warehouse just described. The front façade has a wide central doorway flanked by pairs of windows. The rear wall contains five equidistant windows and a doorway to the generator room. The roof, largely collapsed, comprises corrugated asbestos sheeting supported by a timber frame. This is perhaps, but not certainly, original. Of the same date, whether or not that is WW II, are the wooden window frames which swivel horizontally so as to provide ventilation without letting in excessive moisture. Built against the northern end of the back wall, accessed directly from the main room, is a small room containing a single concrete generator bed. This room has a concrete slab roof. While this room was clearly added it can be assumed that the installation of a generator in this position was part of the original scheme.

Outside there are various associated features in addition to the extant piping. These include a valve at the south end (Fig. 69) and various valves at the north (Fig. 62 at right). The machinery is rusting and incomplete but, even if it could never be made to work again, it is

certainly not past preservation. The building too, apart from the roof, is sound. There is a stack of pipe sections to the right of the pump house as well as much piping still in place.

Figure 62. The Bois des Amourettes Pump House from the road. GDS 2012 0778

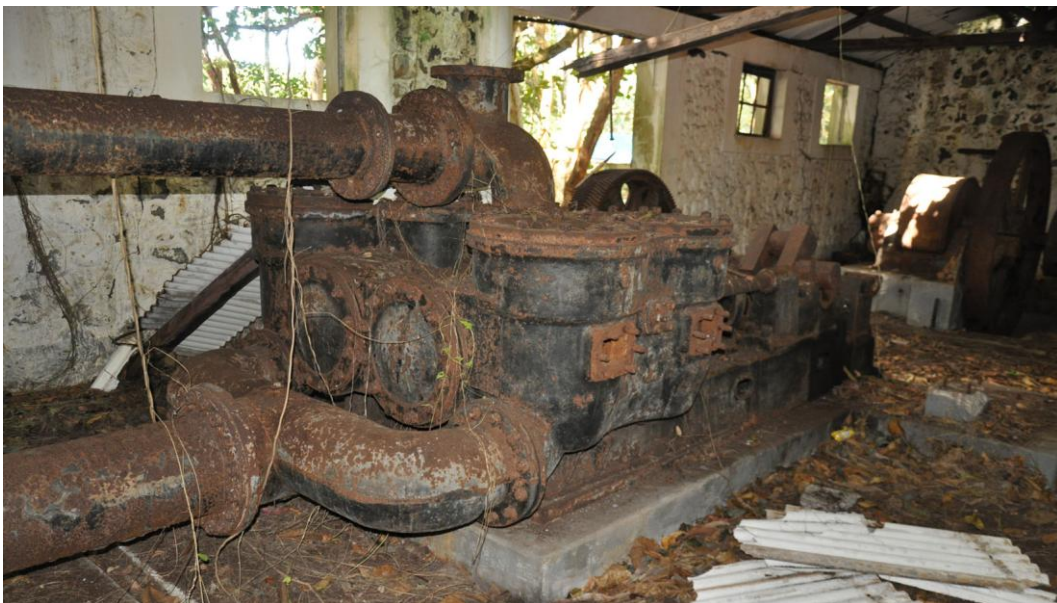
The pump house contains a Ruston-Hornsby Class 'HR' 2-cylinder horizontal, open-crank oil engine at the south end (Figs 64-65).¹⁷ RUSTON LINCON ENGLAND is embossed on one side and the Ruston-Hornsby badge is attached. At the north end is the pump (Figs 63 and 66-67). The valves are marked Crane-Glenfield who were probably the manufactures of the pump itself. The engine drove the pump which was intended to pump fuel into the five storage tanks on the hillside behind.

Figure 63. Bois des Amourettes Pump House showing the Pump with the Ruston diesel engine at right and the central doorway. GDS 2012 076

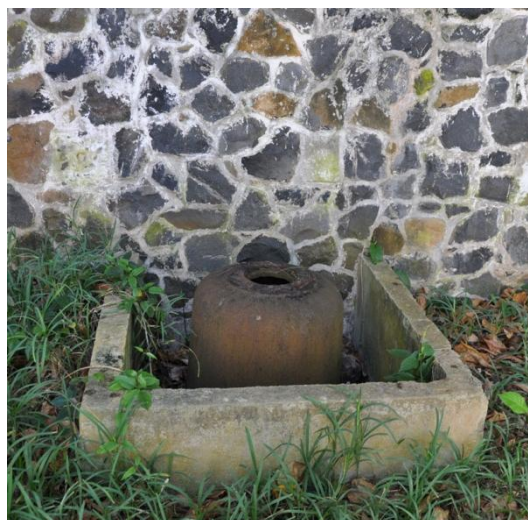
Figure 69. Bois des Amourettes Pump House, external valve. GDS 2012 0752

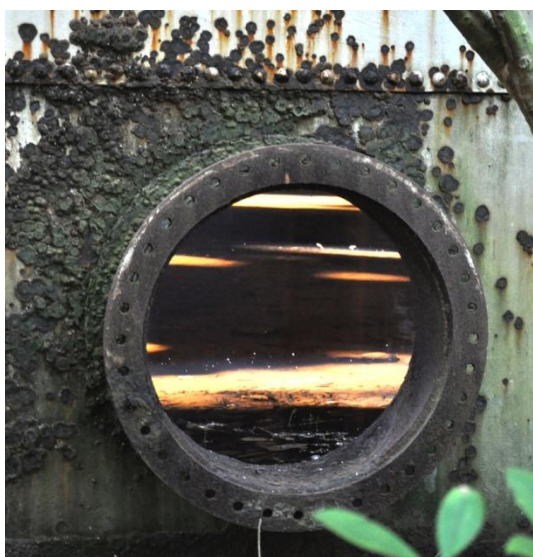
Each tank rests on a concrete base. Today they are rusting and unsafe (Figs 71-73 and 75). Vegetation is sufficiently dense to dissuade the casual visitor, as are the mosquitoes, but there is no fence.

Figure 73. Bois des Amourettes tank outlet
GDS 2012 0769

That there is a need for a full survey, combined with archival work, of the military installations at Bois des Amourettes does not need to be stressed. What to do is more difficult. Fuel storage tanks, long abandoned, are rusting away. They are dangerous and unfenced. The jetty is used and periodically maintained, and has thereby lost much of its WW II authenticity.

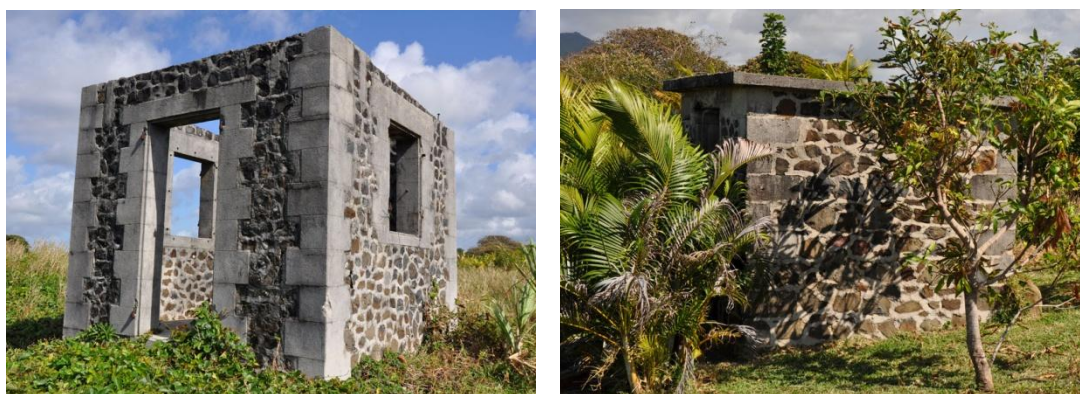
Two apparently identical buildings, one the east side close to the block houses and one in the gardens in the centre of the area (Figs 78-79). There is a central door, a large window in each side wall and shed roof. The door, at the front, faces the sea. They would seem to overlook the two tracks leading to the blockhouses, one running parallel to the shore from the northeast (Figs 84-86), the other across the centre of the area (Fig. 87). The corners and architraves are of precast cement blocks, as are lintels (but not sills). Walls are of uncut basalt, the stones being of relatively small size. The northern building was provided with a timber frame to support a light roof. The iron ties that anchored the beams to the wall top are set into concrete (Fig. 86 at left)

Figure 86. The two lookouts showing precast corner blocks and lintels and basalt masonry style. The northern structure, at left, has metal anchors for a timber framed shed roof, while the building in the garden seems to have been re-roofed. GDS 2012 0805; GDS 2012 0822

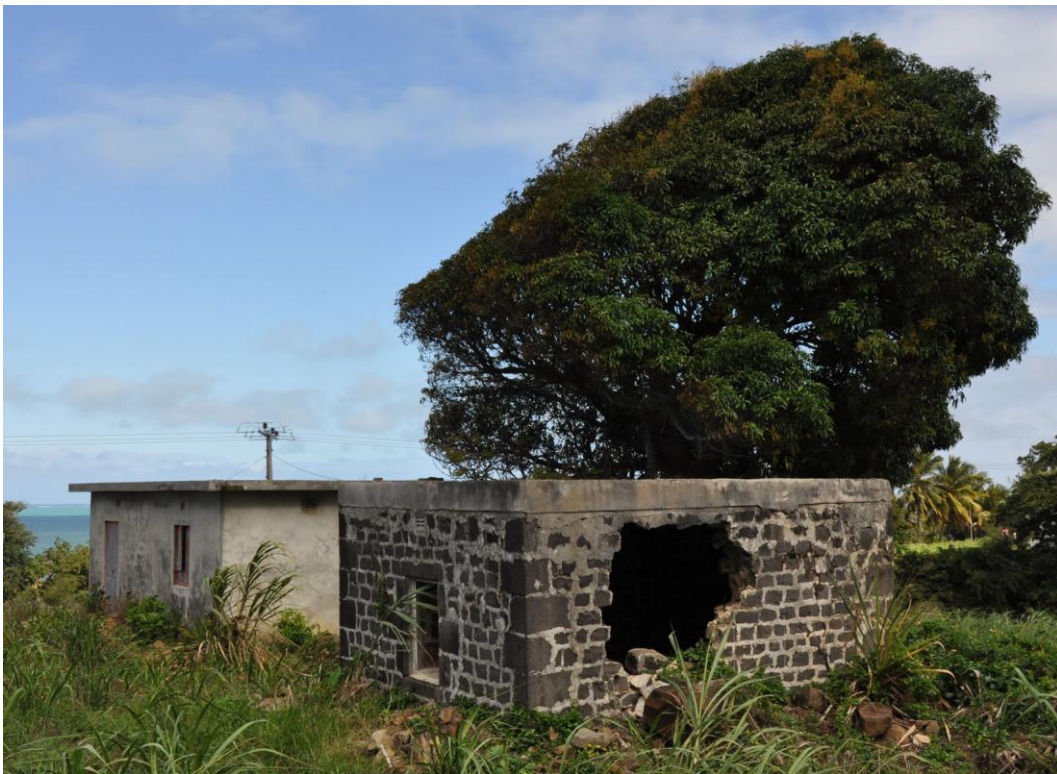
Figure 93. Building of unknown date and purpose to the west. GDS 2012 1153

West of the temple, next to a modern house, is a small basalt building with a concrete roof (Figs 93-94). The walls are of squared stone with faced quoin stones and lintels. The original roof was slanted, the adaptation to a flat roof also being made of basalt with a concrete vent. Neither date nor purpose have been ascertained; the building could have been military in one or more of its pre-modern phases, but was not necessarily so. It is not dissimilar to the building at Pointe du Diable shown on Figure 21.

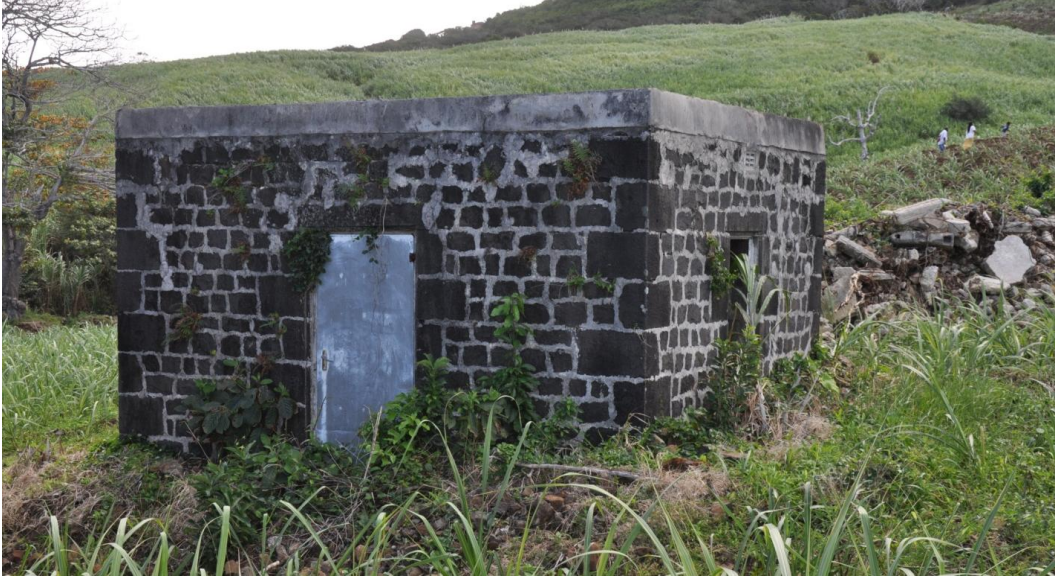
Figure 94. The same building looking towards the mountain. GDS 2012 1152

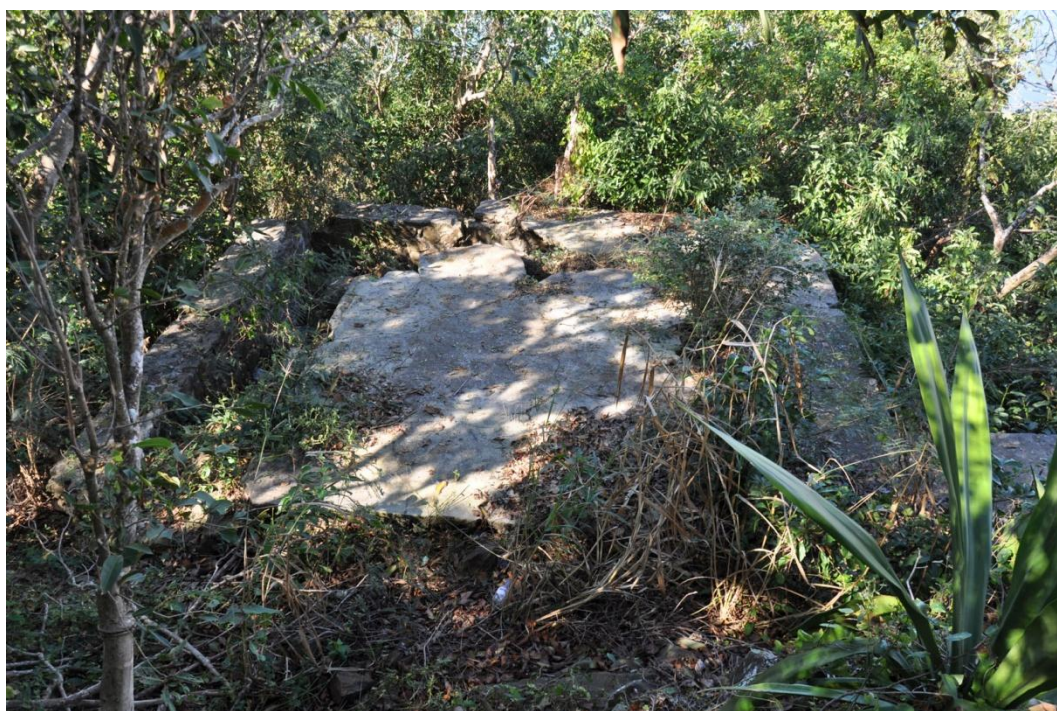
On the first joint of the western claw of Lion Mountain is a lookout post that was built to scout for enemy aircraft (Fig. 95). It was accessed via the field road that leads up from the Batterie de la Reine past and above the structures just described, much of which is to this day surfaced with concrete from the time of the WW II defences. This road ends at the base of an impressive flight of steep stairs, with several turns (Fig. 96). The stairs are in good condition, the small lookout post less so. The projecting front of the observation had sides at 45 degrees to permit views along the coast as well as directly forwards. The post was built on a rectangular base that provided a shaded area in front. If there were additional amenities they were not obvious on a rather rushed visit. Today the steps are used by hikers ascending Lion Mountain.

Figure 95. The lookout post for enemy aircraft on Lion Mountain. GDS 2013 1139

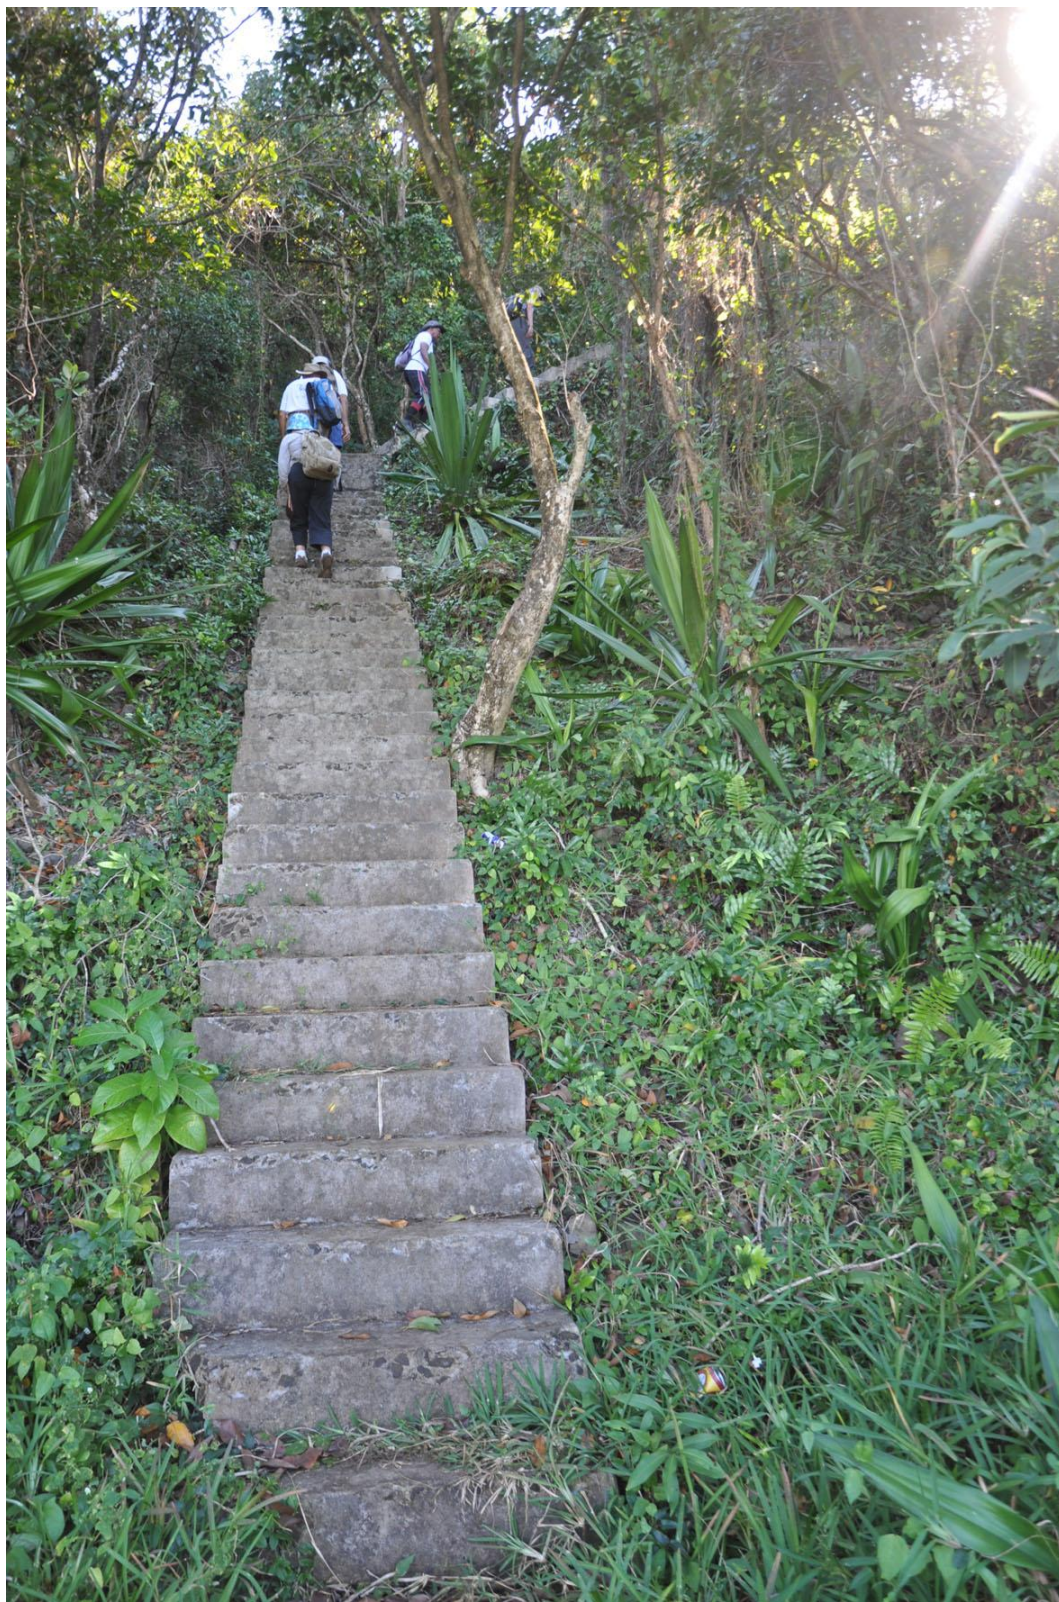
Figure 96. Hikers ascending the lower portion of the long flight of concrete steps leading to the enemy aircraft observation post on Lion Mountain. GDS 2013 1132
