WORLD WAR TWO MILITARY INSTALLATIONS ON THE SOUTHEAST COAST OF MAURITIUS: A PRELIMINARY SURVEY

Geoffrey and Françoise Summers

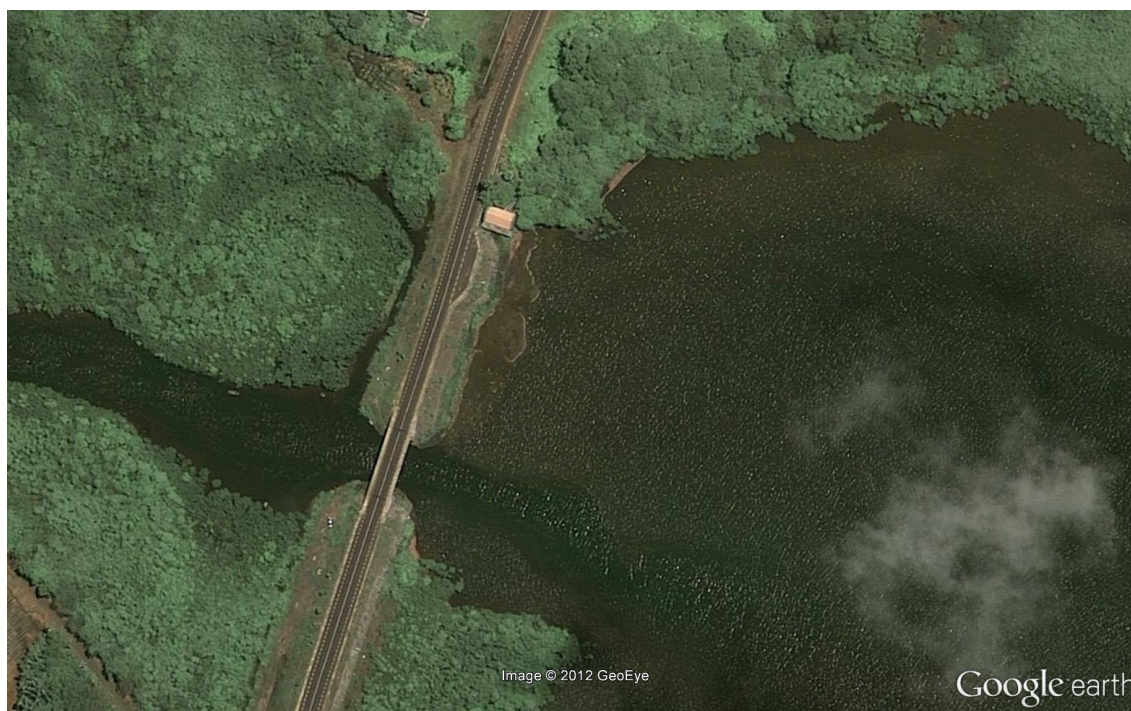
Figure 97. The large building, perhaps WW II, at the mouth of the Rivière Champagne.

A large concrete building with a double pitched roof and several flat-roofed appendages is located to the north of the mouth of the Rivière Champagne (Figs 97-101). This complex, or the larger part of it, seems to date to WW II. It lies to the east and below the modern road, which is at a greater elevation than the top of the later corrugated metal roof. On the north side is the small jetty leading to the monument commemorating the first Dutch landing in Mauritius (Fig. 98). The Jetty does not appear to be of WW II date. On the opposite side of the modern road is tall cylindrical cistern built of cut basalt (Fig. 104). This is not obviously a WW II construction, but if older it would surely have been reused. The shore is now part of a program of mangrove restoration in the estuary. It is not easy to now understand the immediate terrain because construction of the modern road and bridge has replaced the earlier crossing of the secondary river mouth. Figure 102 shows the structure in relation to the shore and water line. It is obvious that the complex was associated with a sheltered and hidden landing place for the unloading of materials.

There is nothing to suggest that any part of the building complex predates WW II, all building materials and methods being entirely consistent with that date. The main structure was reused after the war, as evidenced by the red corrugated metal roofing. The complex is now in ruins as the reinforced concrete breaks up. Invasive vegetation is kept under some control.

On Figure 97 what appears to be a quay can be seen a little to the northeast. This is not now visible from the road and an attempt to visit was foiled by vegetation and swampy ground. It is almost certainly more recent.

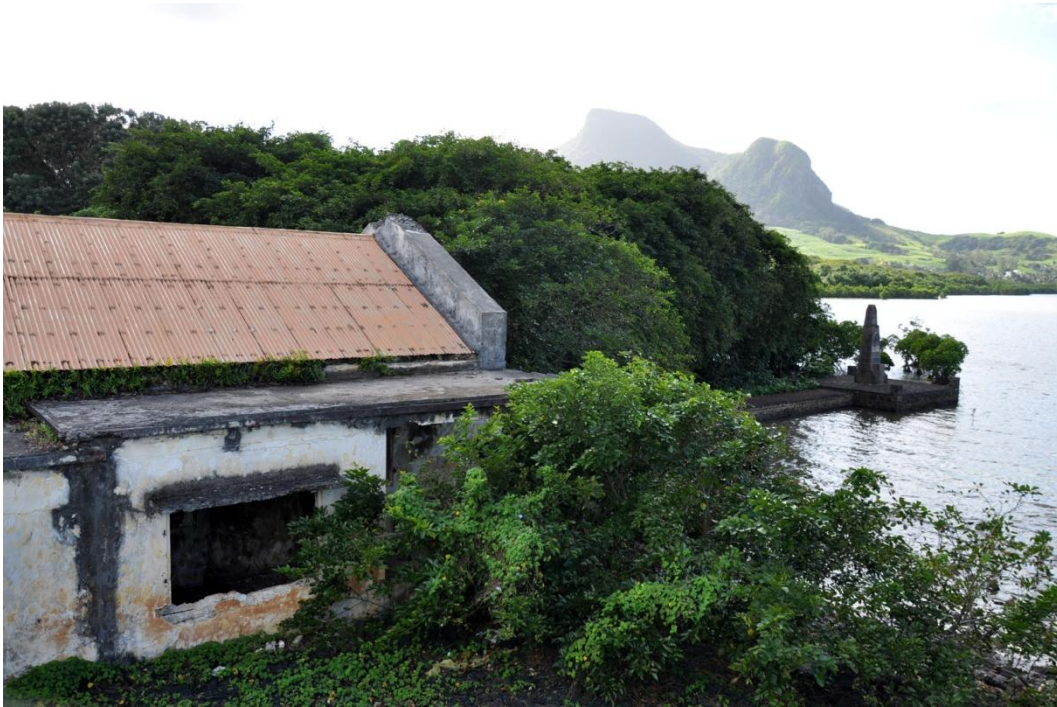
Figure 98. Large building complex, probably built in WW II, at the mouth of the Rivière Champagne with the monument commemorating the first Dutch landing at right and Lion Mountain in the background. (GDS 2012 0741)

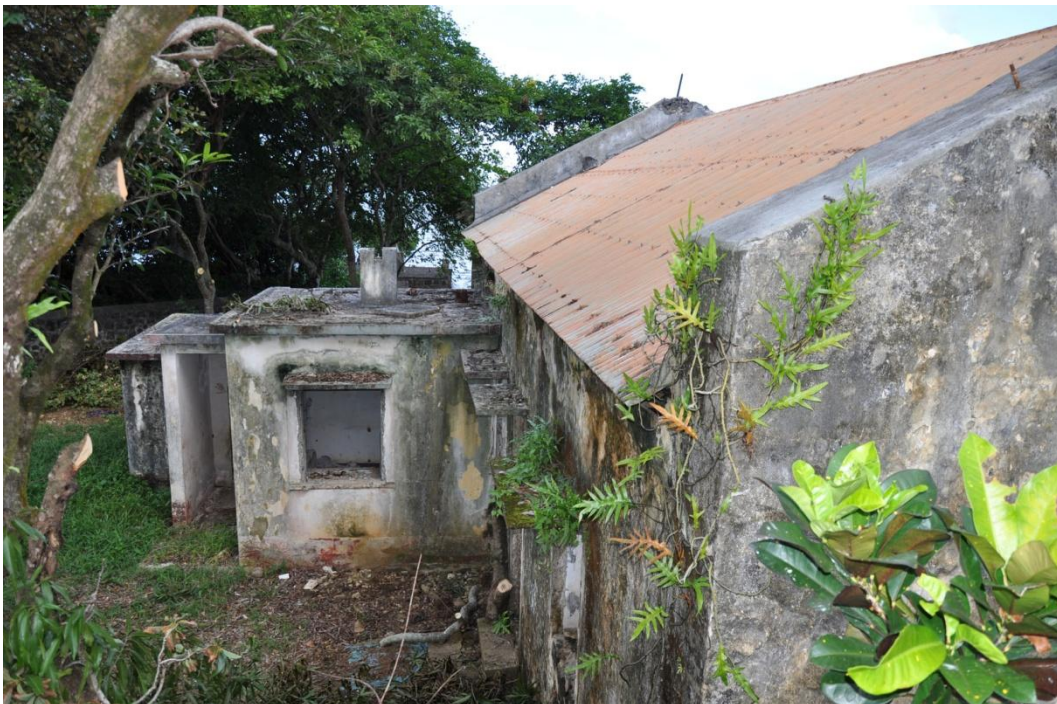
Figure 99. The complex looking seawards from the road. (GDS 2012 0723)

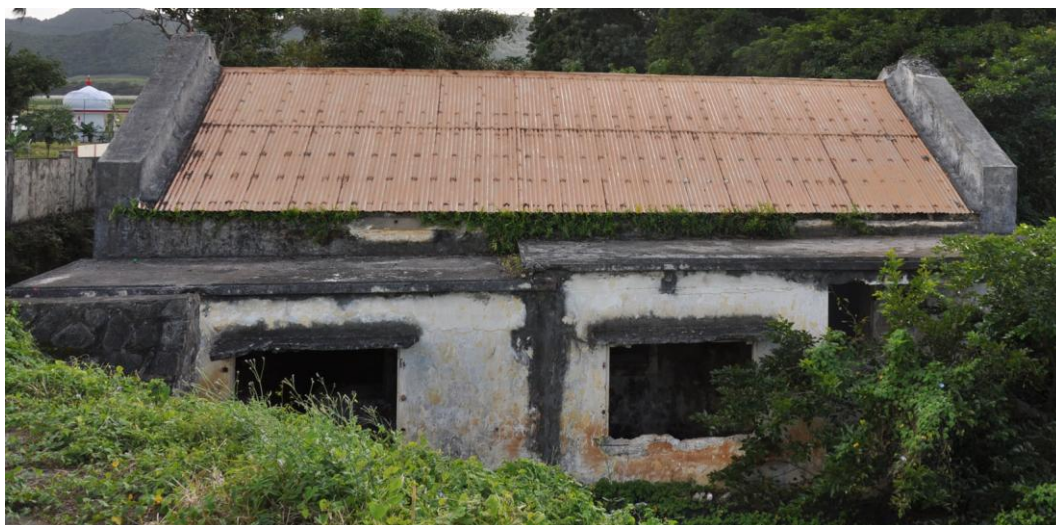
Figure 100. The south side of the complex. (GDS 2012 0740)

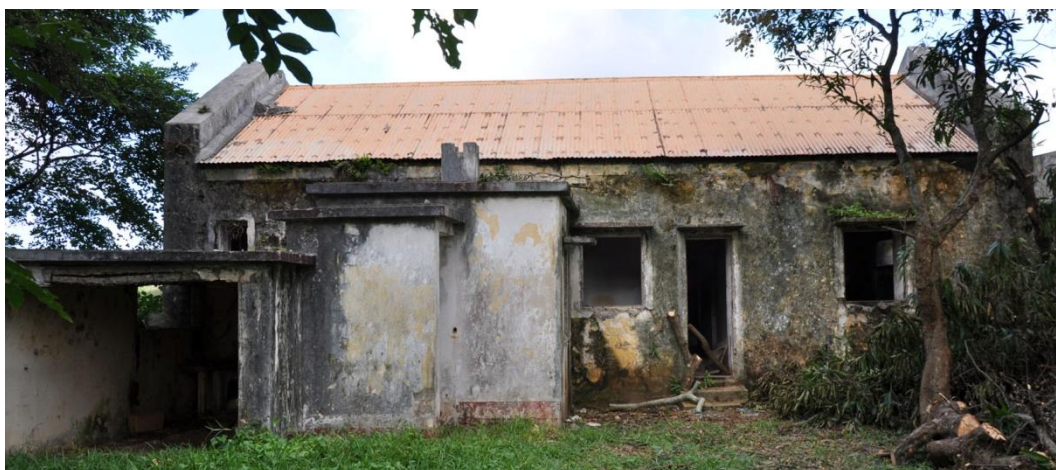
Figure 101. The north side of the complex. (GDS 2012 0733)

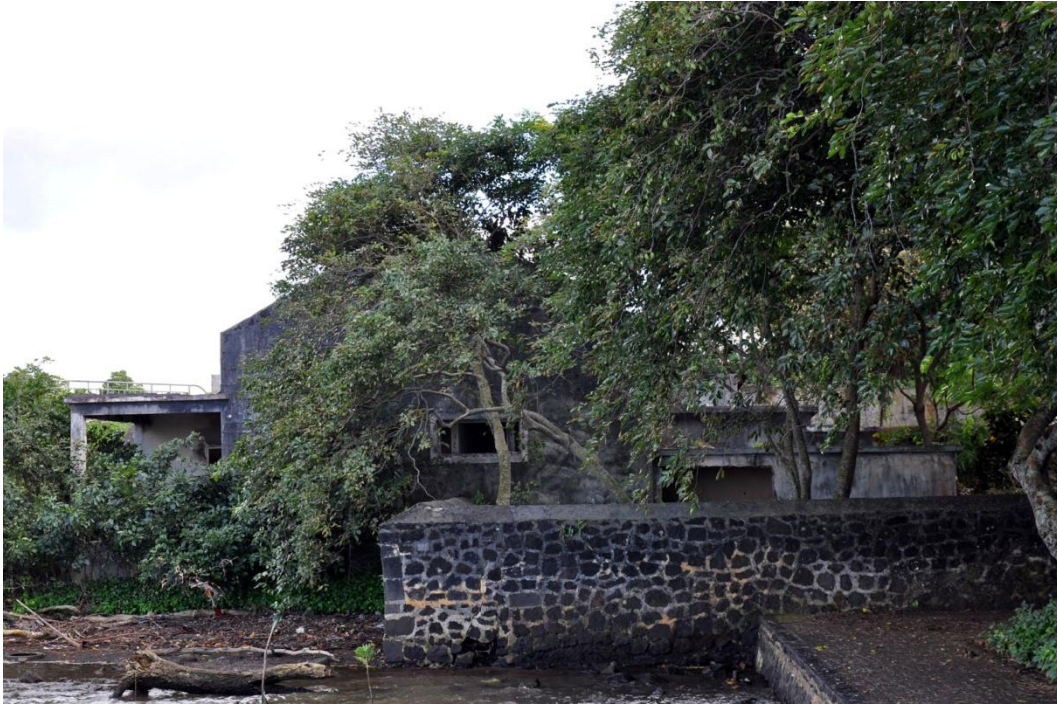
Figure 102. The east end of the complex showing its relation to the shore, with later wall in the foreground and the modern jetty to the Dutch landing monument. (GDS 2012 0732)

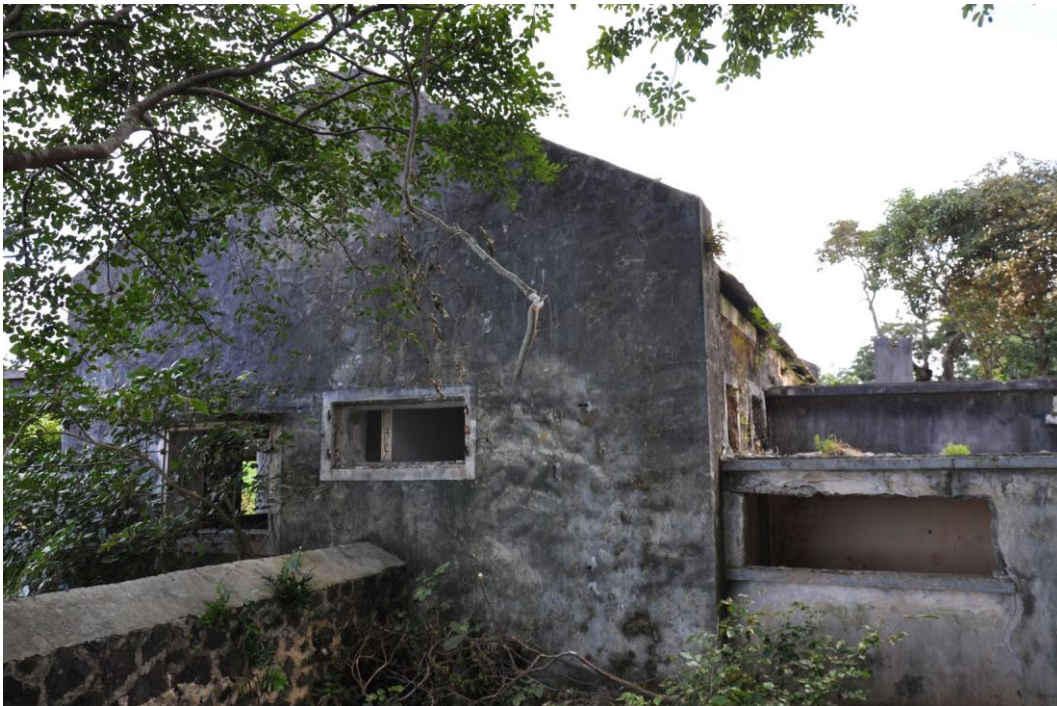
Figure 103. The east end of the complex with later wall in the foreground. (GDS 2012 0736)

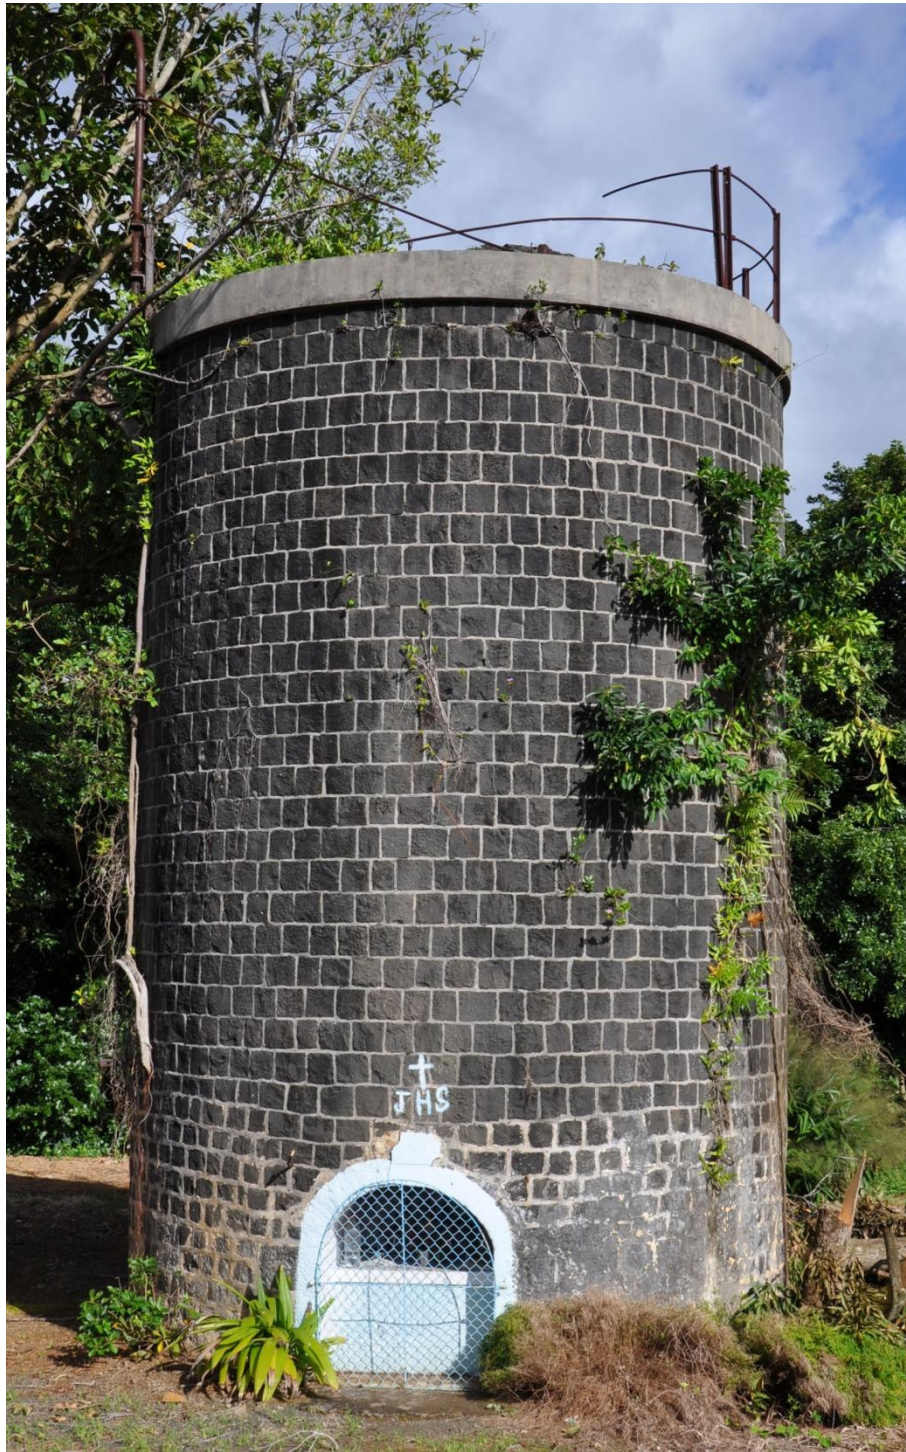
Figure 104. Stone-built cistern at the mouth of the Rivière Champagne, on the west side of the road opposite the WW II complex. Date of construction currently unknown. (GDS 2012 0742)

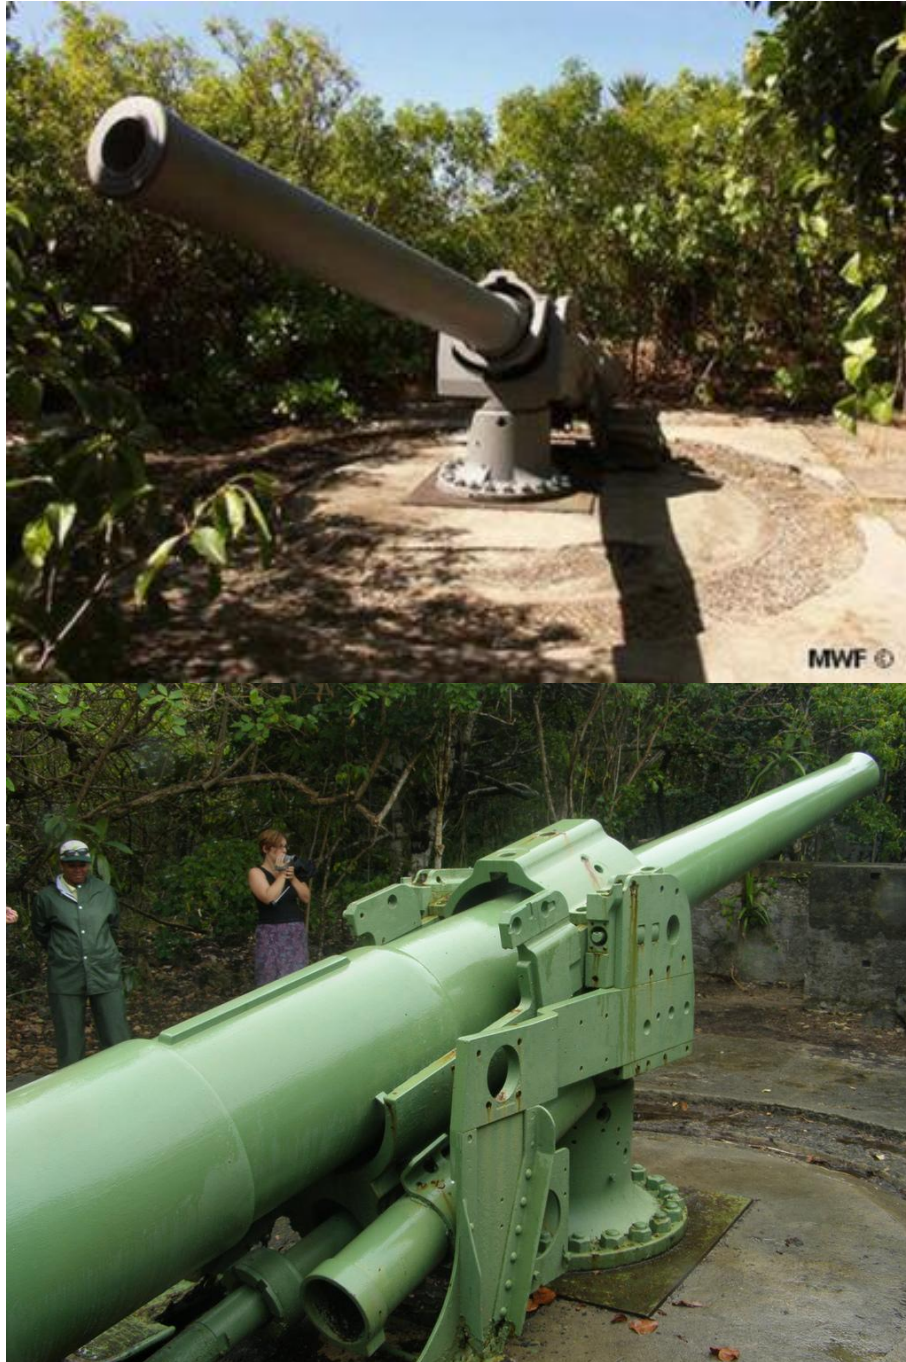
There were two 6" Mk VII BL 12 pounder guns, like on Ile de la Passe, and two 90mm 3⁰ FL guns (Fig. 107).¹⁹ These, marked with the crest of King Edward VII were made in 1902 for British battle ships and reused for coastal defences in WW II (Fig. 108). Pictures of one gun being transported to the islet are in the possession of the Mauritian Wildlife Foundation (Fig. 109). Of these, one of the 6" is still mounted and is a feature of the tourist trail while the other lies where it was abandoned. According to Peter Miller (in conversation February 2013) this second gun was never installed because the lack of utility of these weapons was quickly understood. The two observation posts on the edge of the islet are now in very poor condition (Figs 110-111). The roof of one collapsed soon after these photographs were taken. These are exactly the same design as the two at Pointe aux Feuilles and one at Pointe du Diable described earlier in this report. Some small structures, were built of imported bricks and reinforced concrete roofs, others had ravenal walls and thatched or corrugated roofs on stone and cement platforms.

Figure 107. The mounted gun on Ile aux Aigrettes. <http://www.flickr.com/photos/9977224>

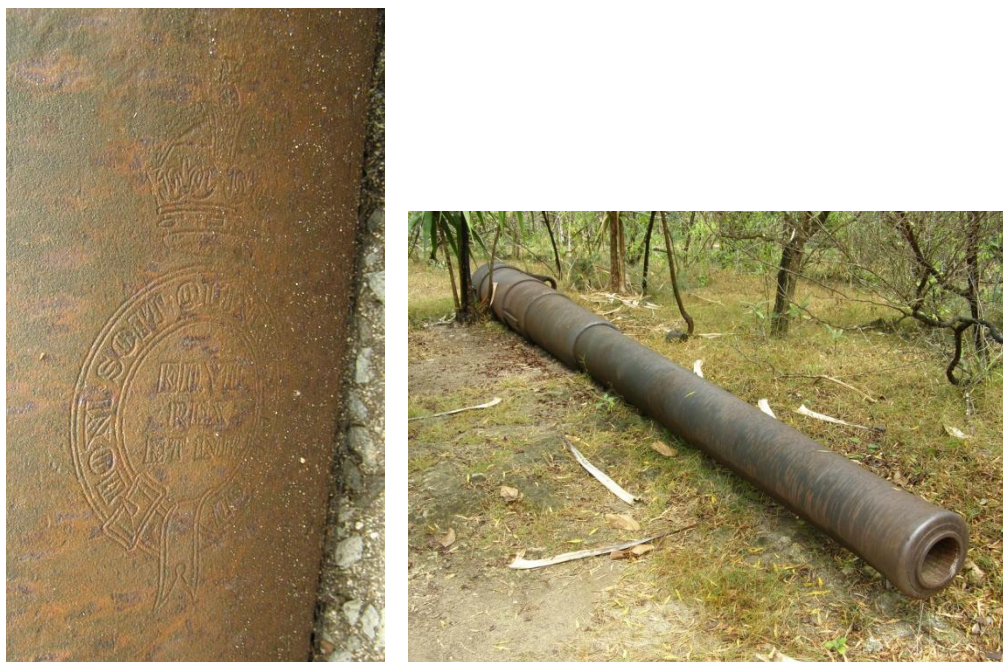
Figure 108. The dismantled gun on Ile aux Aigrettes with its mark of King Edward VII.
<http://www.flickr.com/photos/9977224>

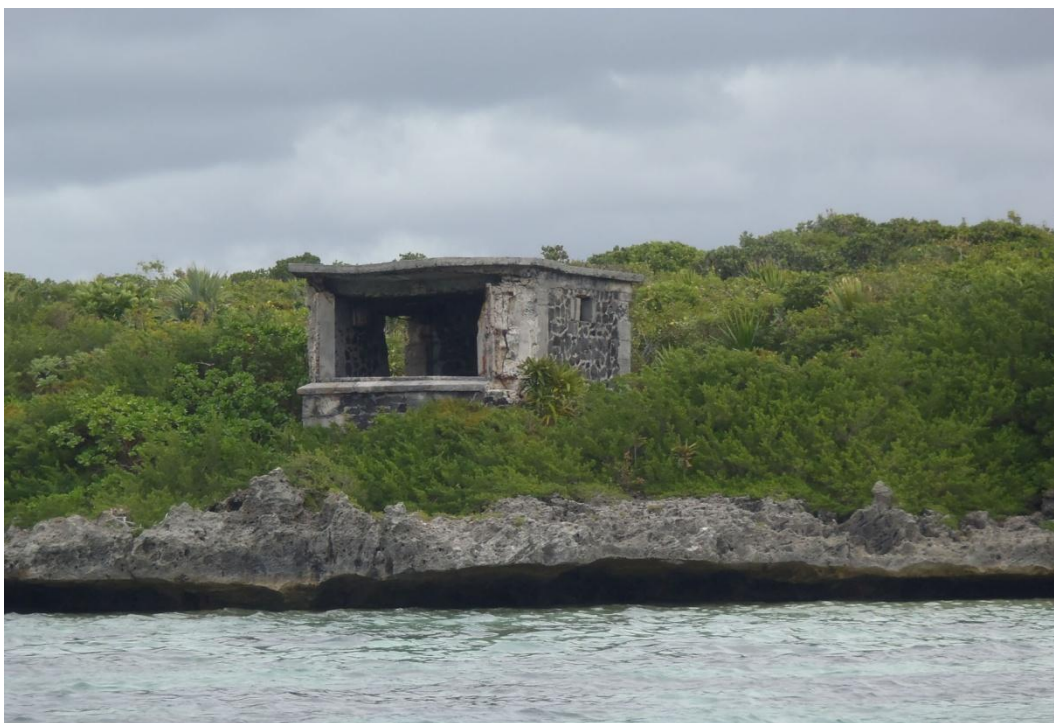
Figure 110. Ile aux Aigrettes northeast observation post. GDS 2012 P8050013

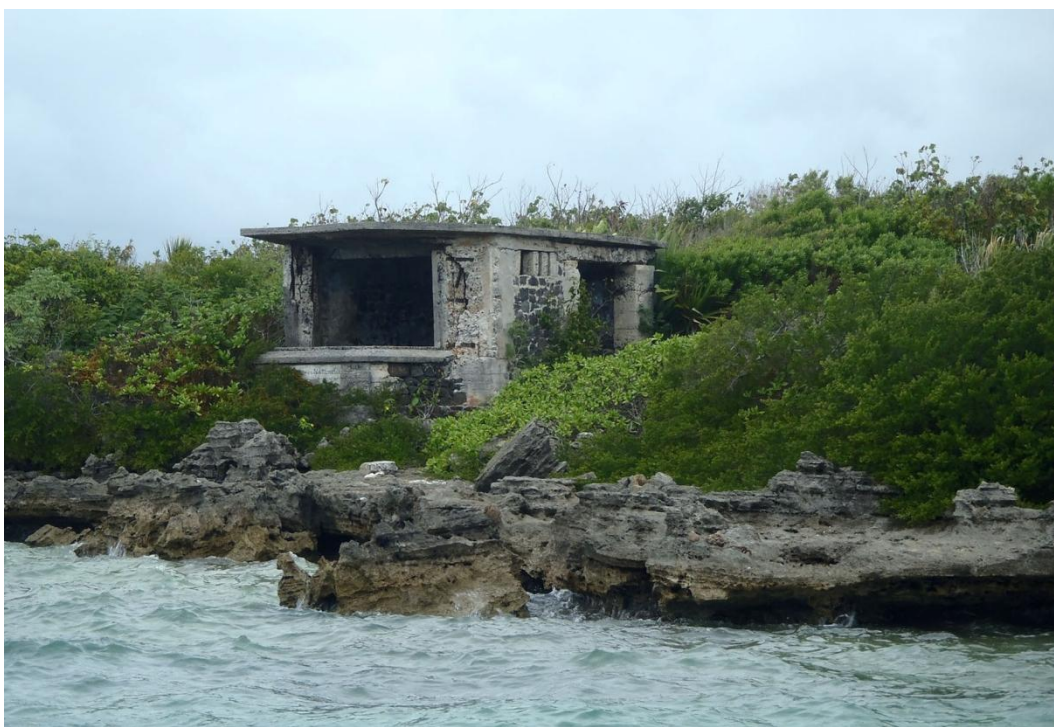
Figure 111. Ile aux Aigrettes southeast observation post. GDS 2012 P8050014

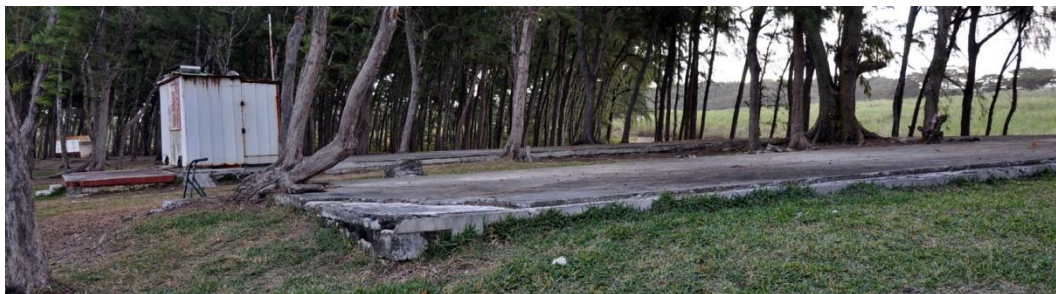
The authors have made an extensive report on Le Chaland in connection with the proposed development of a new hotel. Most of what was constructed for the Royal Navy Air Station, which was handed over to the Royal Air Force in 1945, has long since disappeared beneath the modern airport and what is now the Shandrani Hotel (Fig. 112). What survives is to the southeast of the hotel land, but even here some structures have vanished beneath structure belonging to the national coast Guard and the Police Diving School. Building platforms do exist on the sand dunes and in the dense vegetation behind. full recording of these is in hand. One of the largest complex of platforms is located to the southeast of the land requisitioned in 1942. This land, leased to the Admiralty after the war, was used for the Pioneer Corps from the time that it was transferred to Le Chaland, perhaps in 1949, until they were disbanded in 1956. This complex was taken over as the Naval Leave Center for the HMS Mauritius shore base in Vacoas (Figs 113-115).

Figure 113. WW II building platforms later reused as the Beach Club. GDS 2012 0858

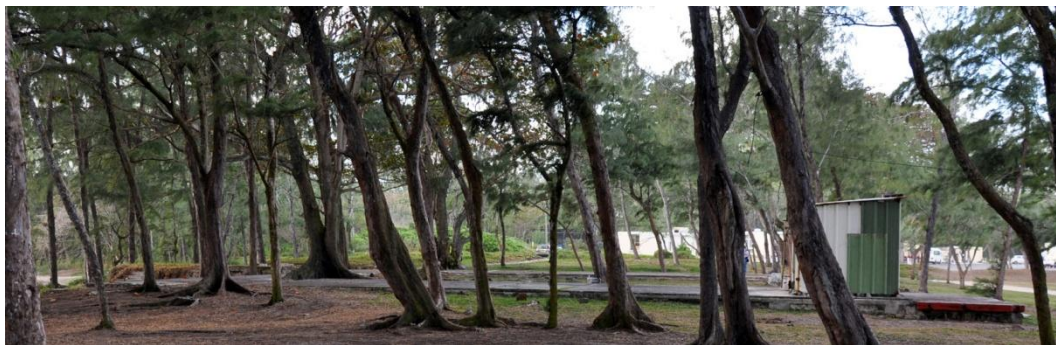
Figure 114. WW II building platforms later reused as the Beach Club with NCG buildings behind. GDS 2012 0864

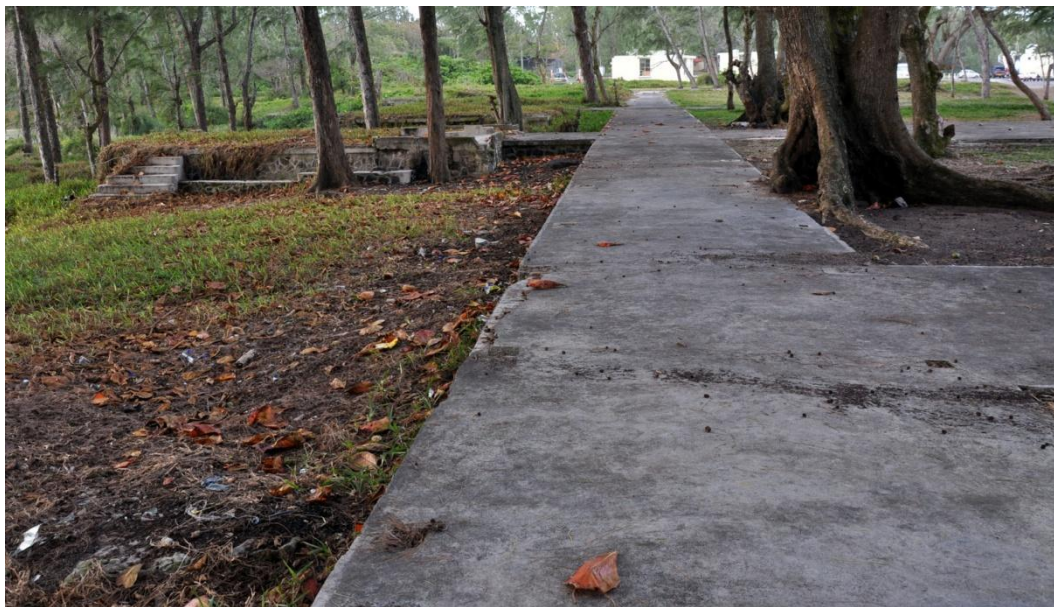
Figure 115. Hostpiatl building platforms later reused as the Beach Club with NCG buildings behind. GDS 2012 0863
